National Trust Bransdale & Farndale Woodland Management Plan
Photo and Images Gallery 2021

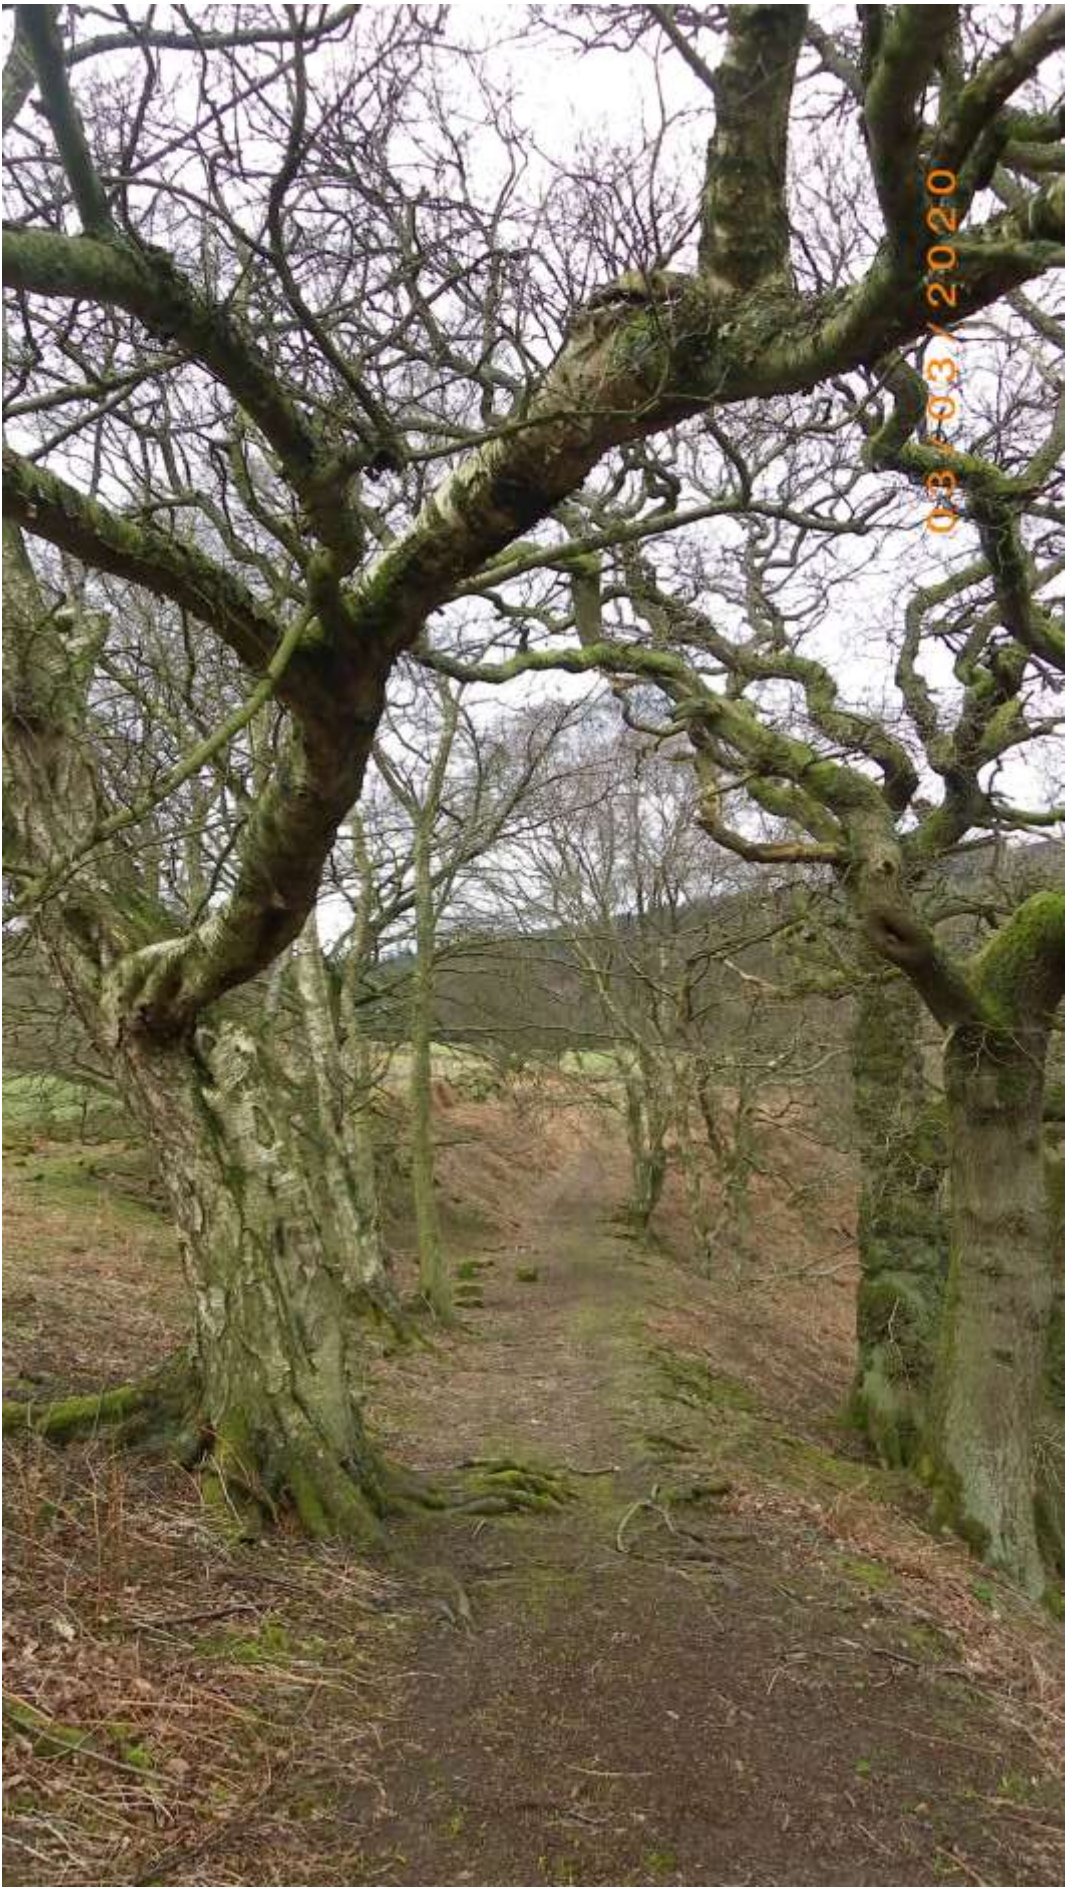
Photo 22 Cpt1c boundary not secure from grazing stock

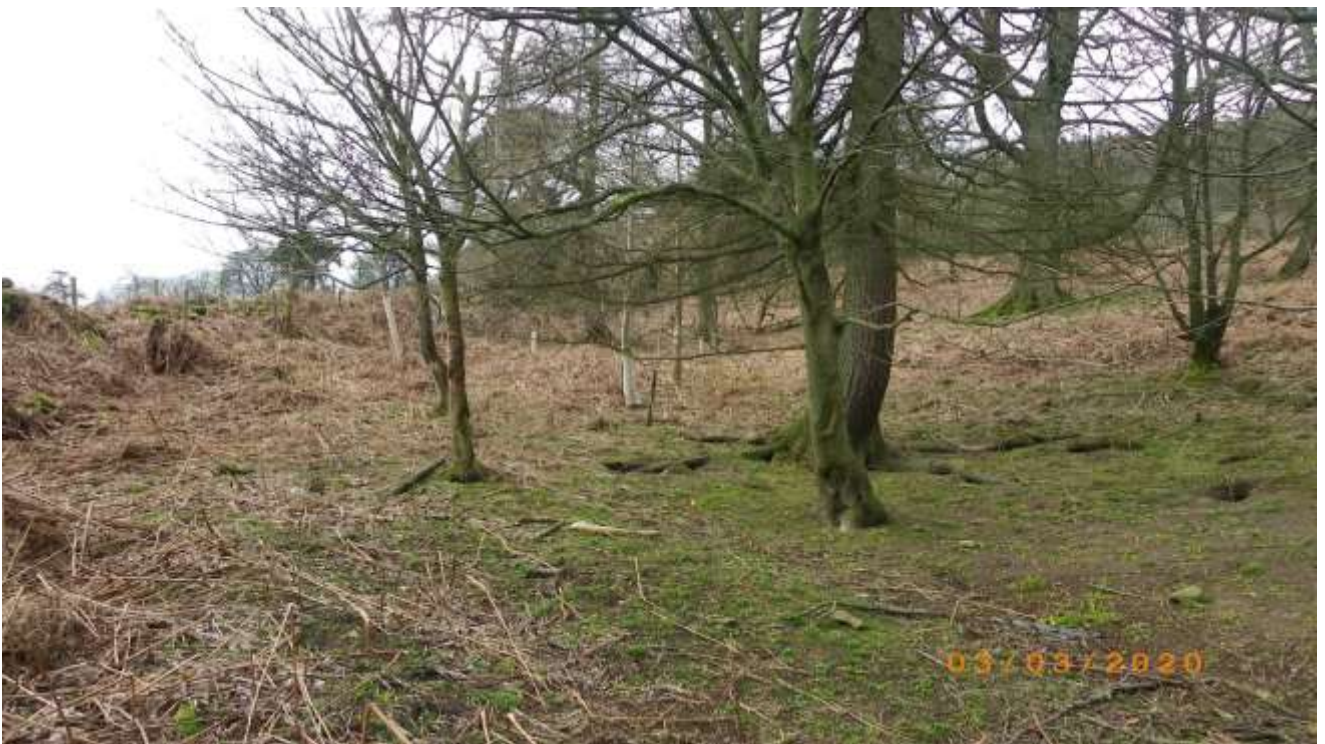
Photo 42 Cpt 2a browsing damage to trees probably grey squirrel

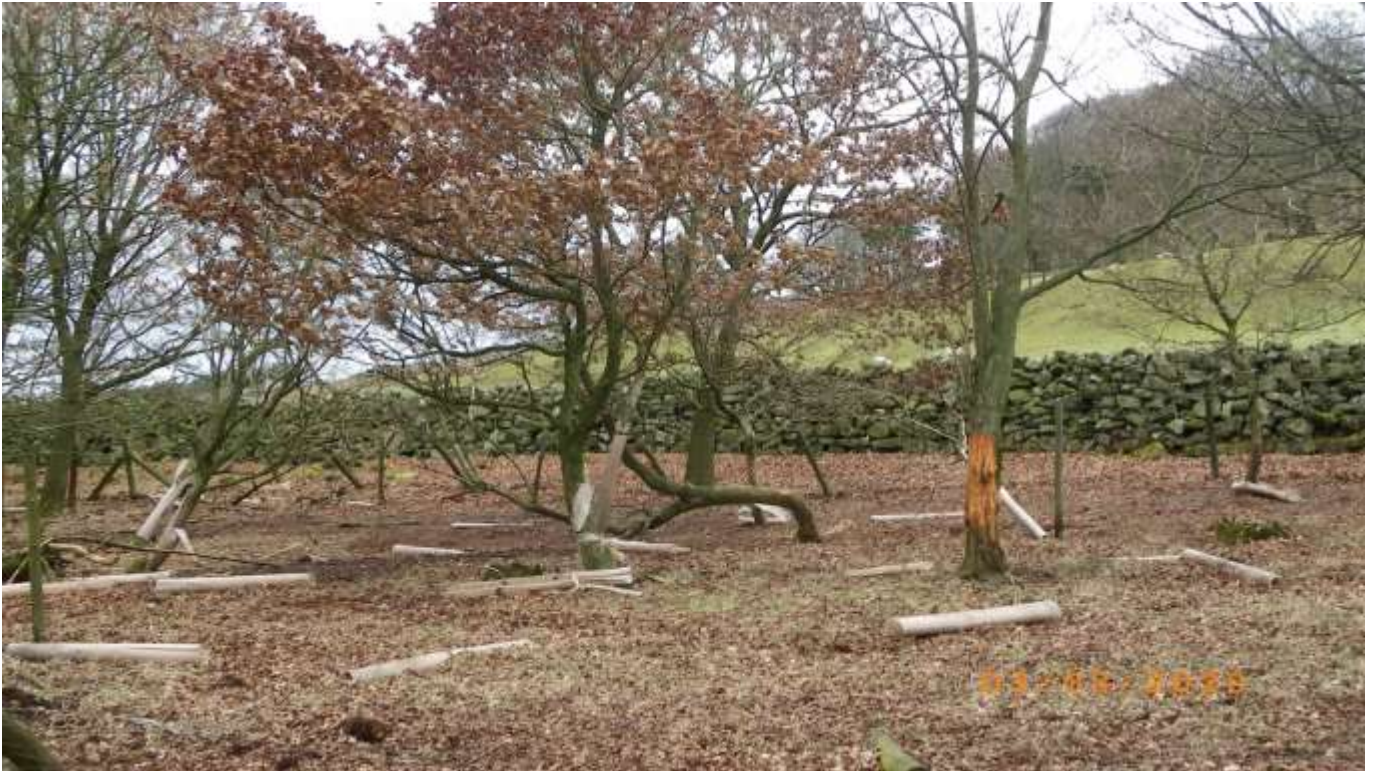
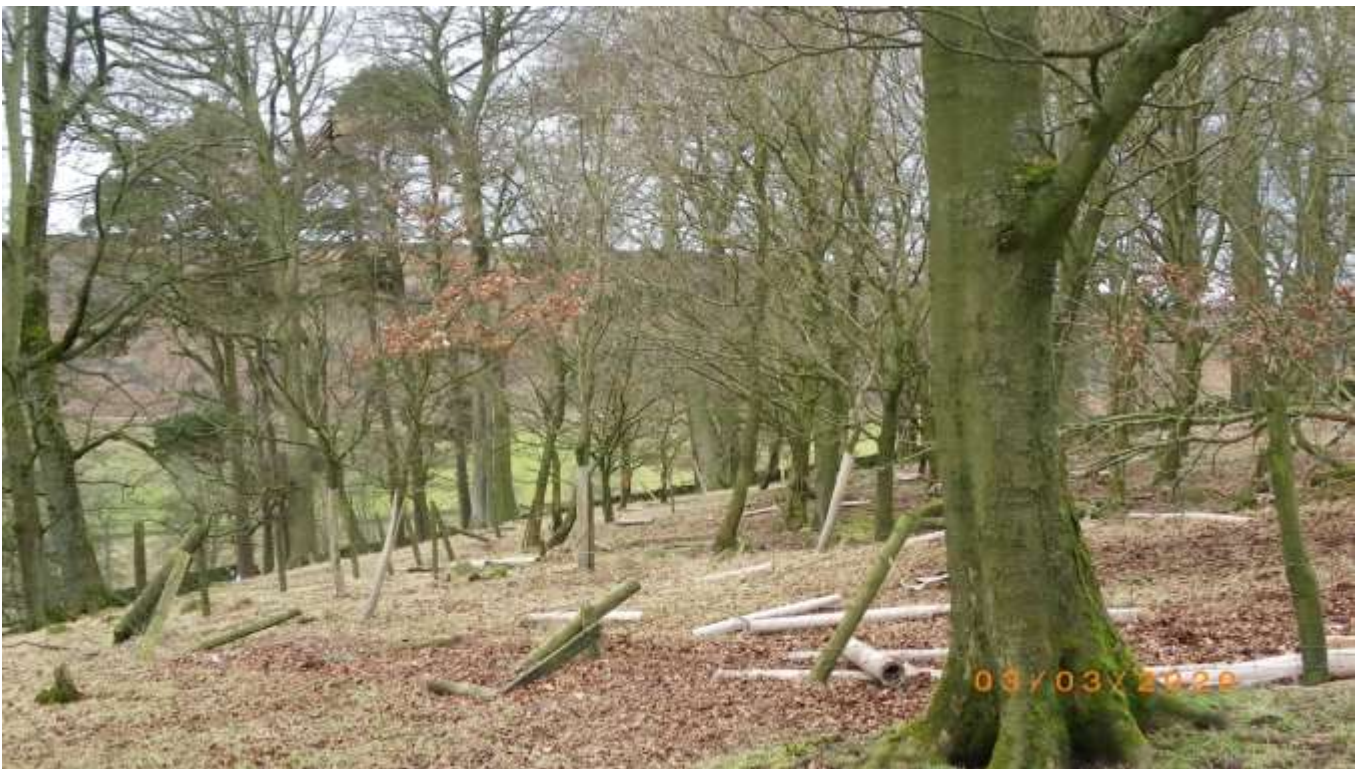
Photo 82 & 83 sheep damage to younger oak, sycamore and rowan planting; tube removal required.

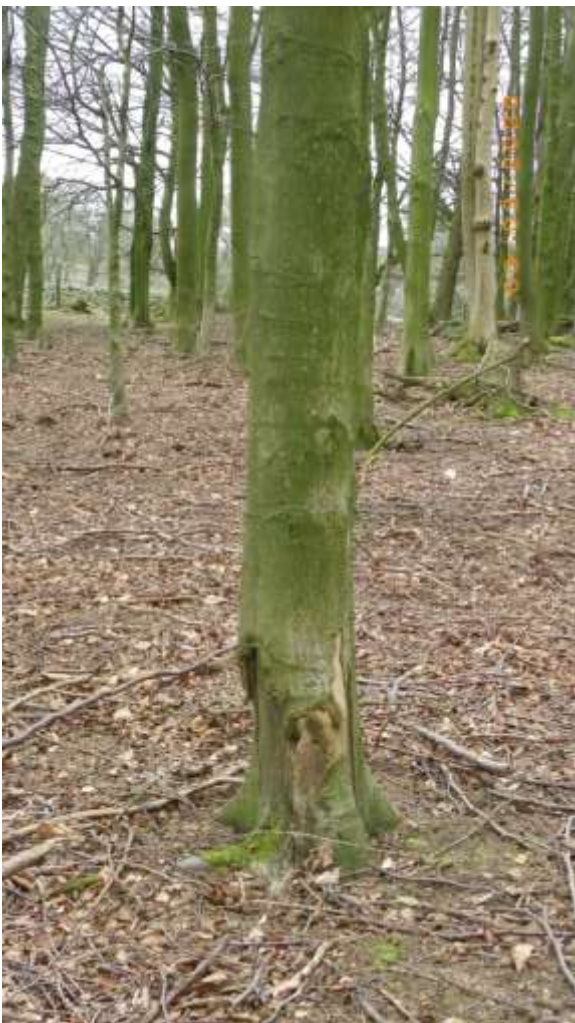
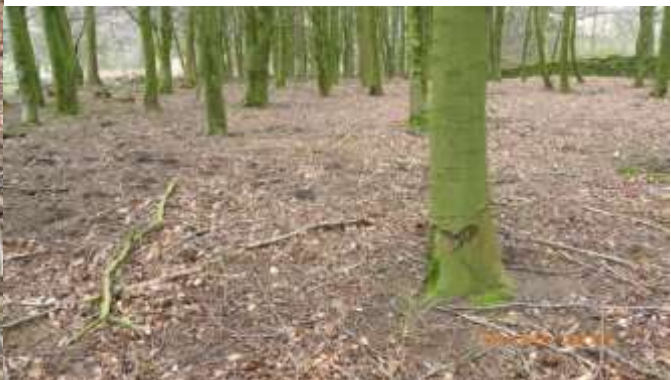
Photo 112 & 113 damage to beech in cpt7b possible rabbits, grey squirrel and sheep

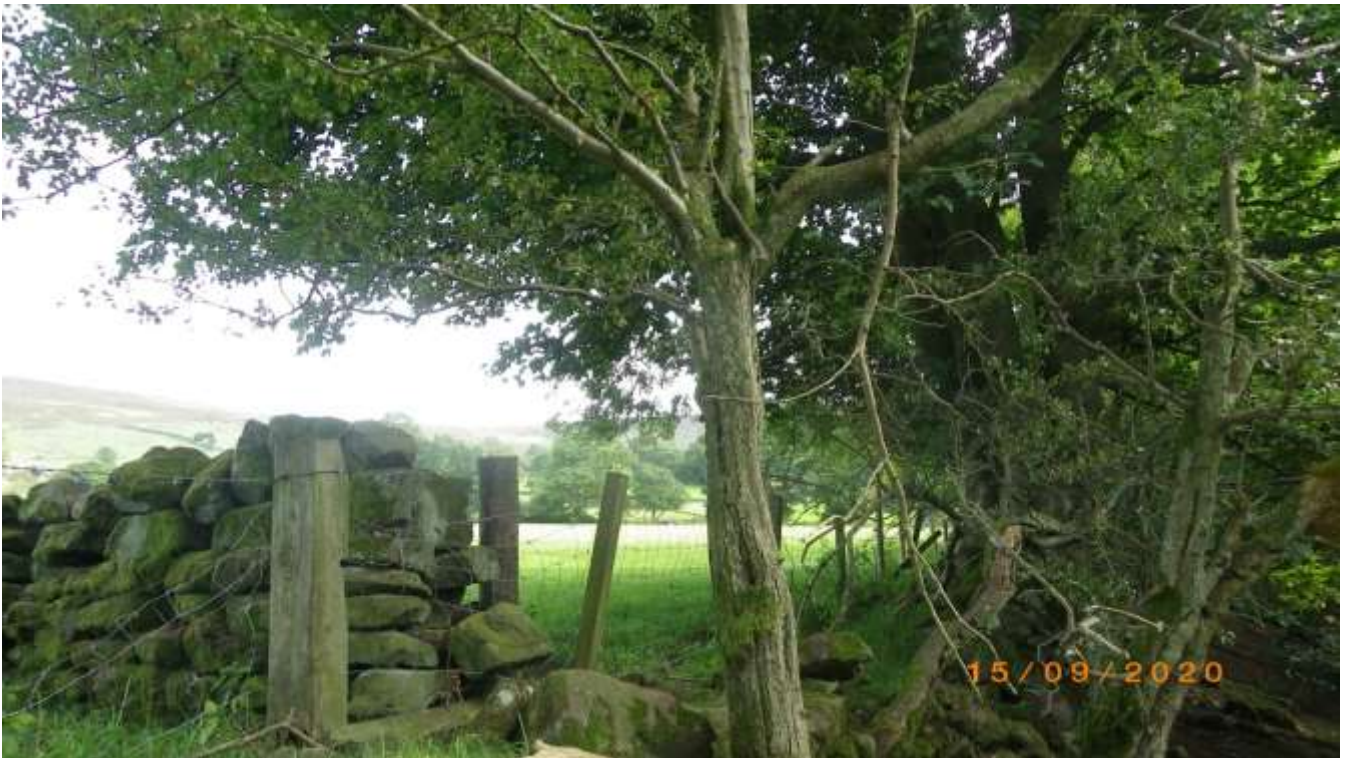
Photo 142 cpy9a eastern boundary poor condition in parts

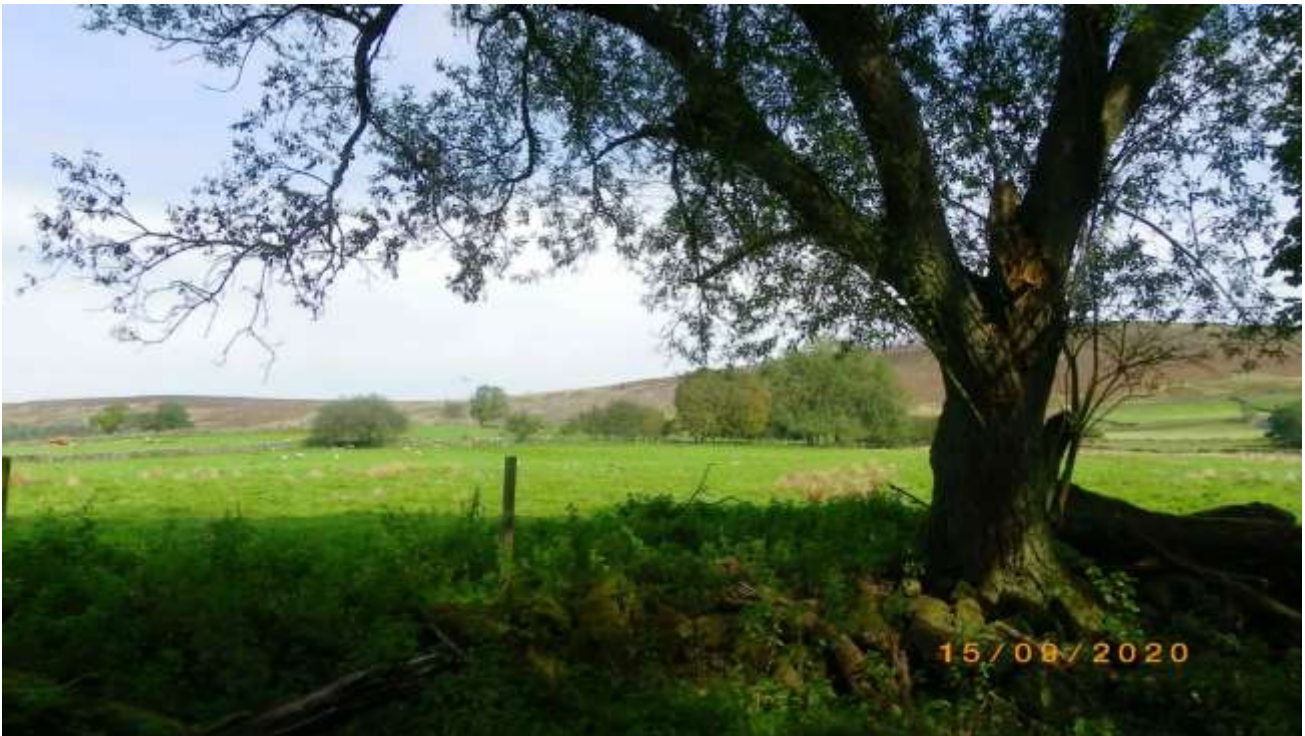
Photo 152 eastern boundary in very poor condition

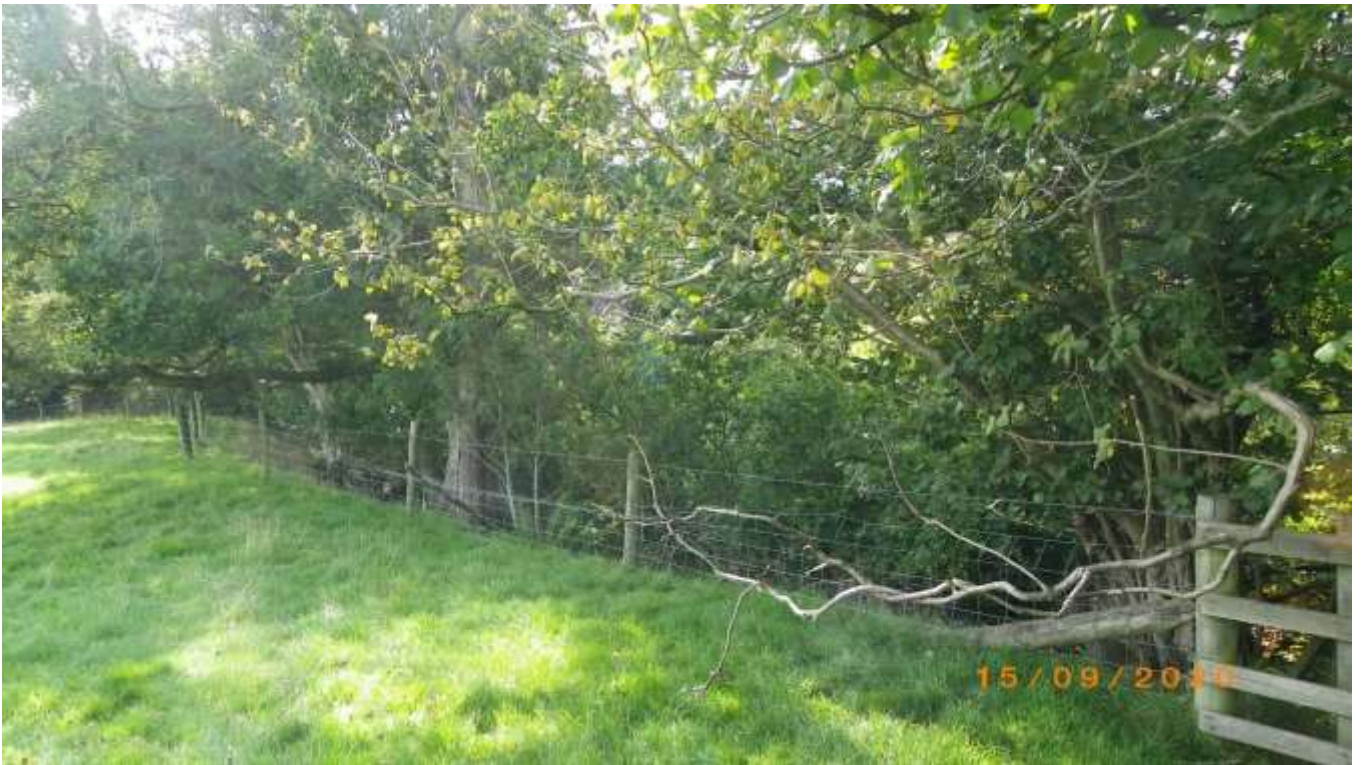
Photo 164 Cpt10b some fences in poor condition; see brown thick line on map 14

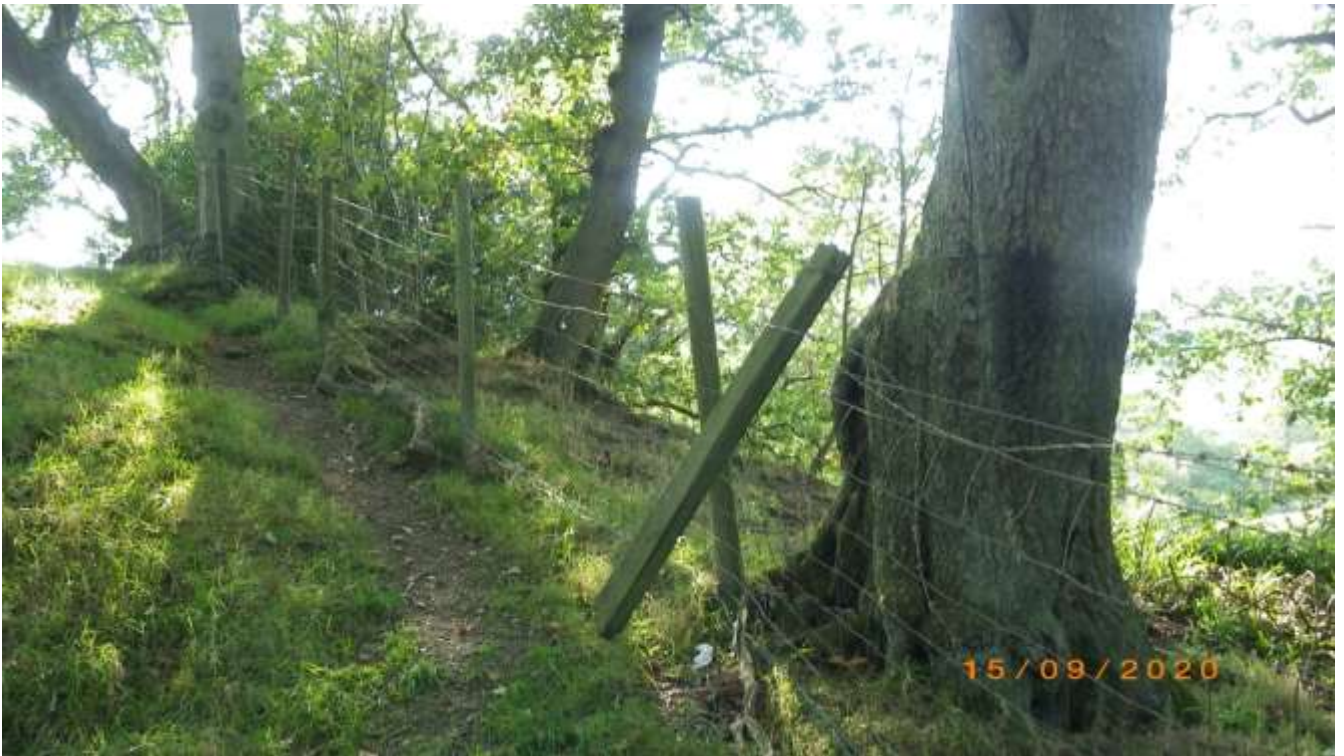
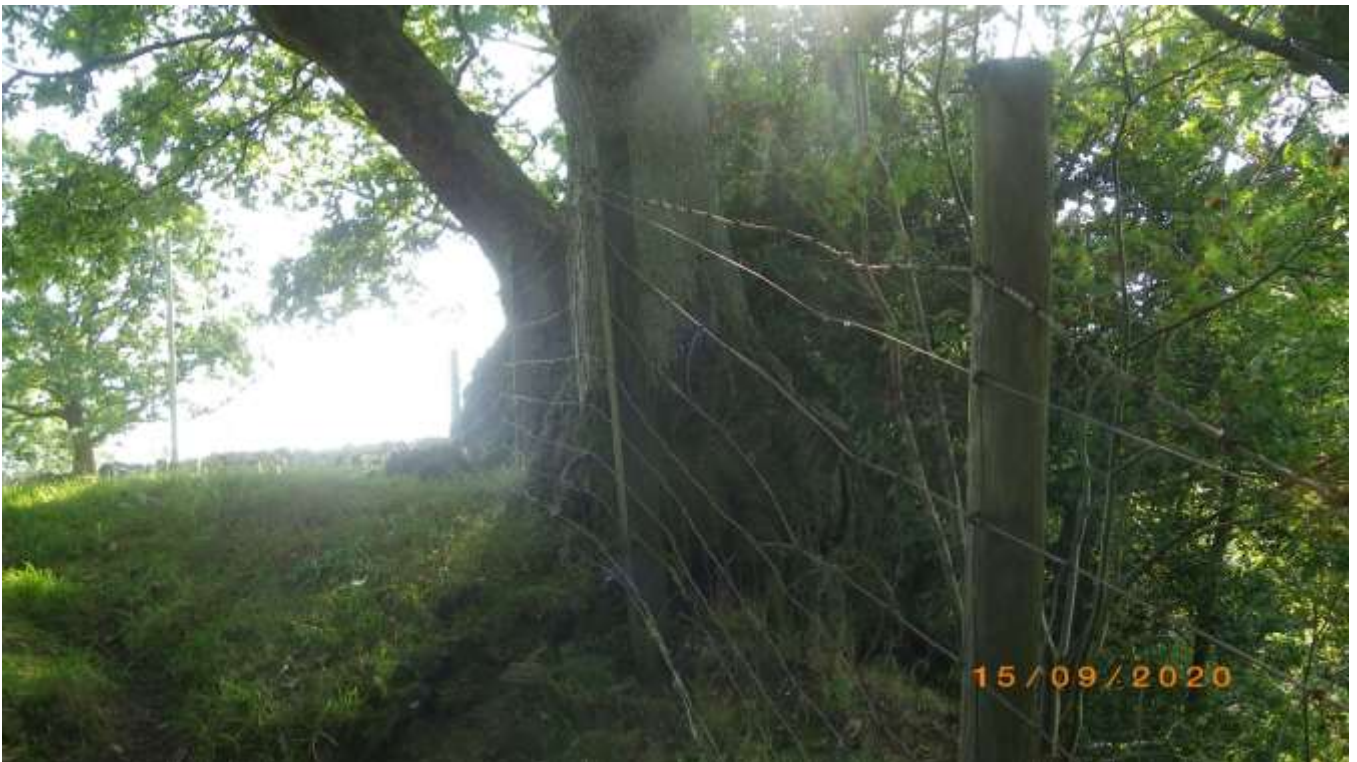
Photo 170 & 171 Cpt10a poor fence condition to south of wood

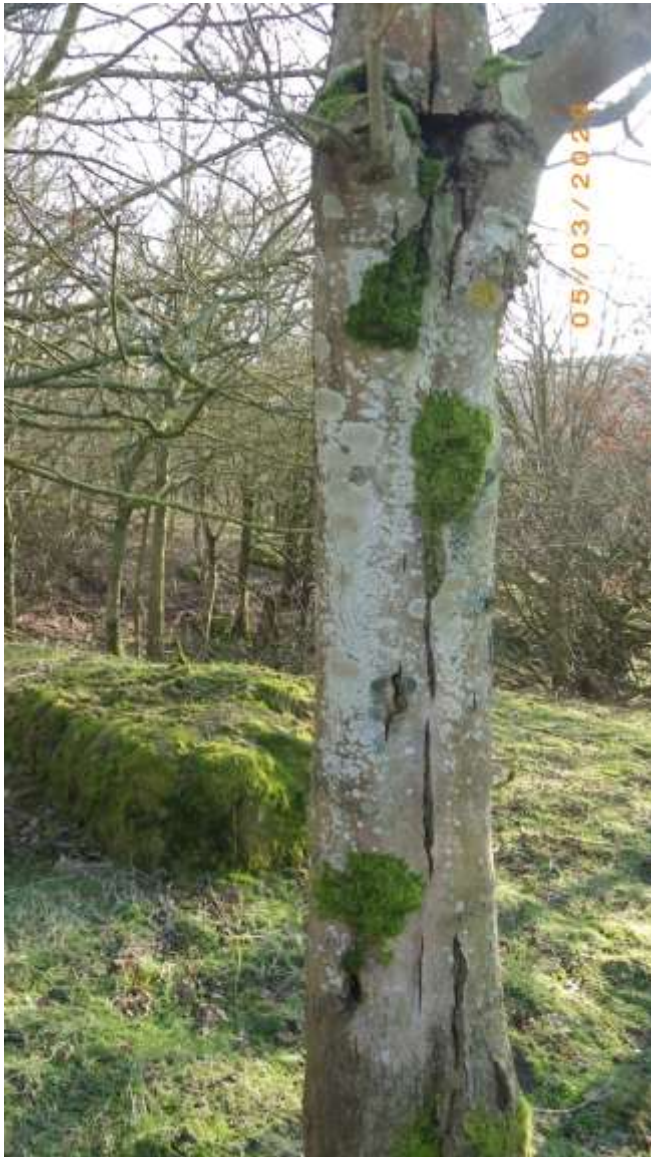
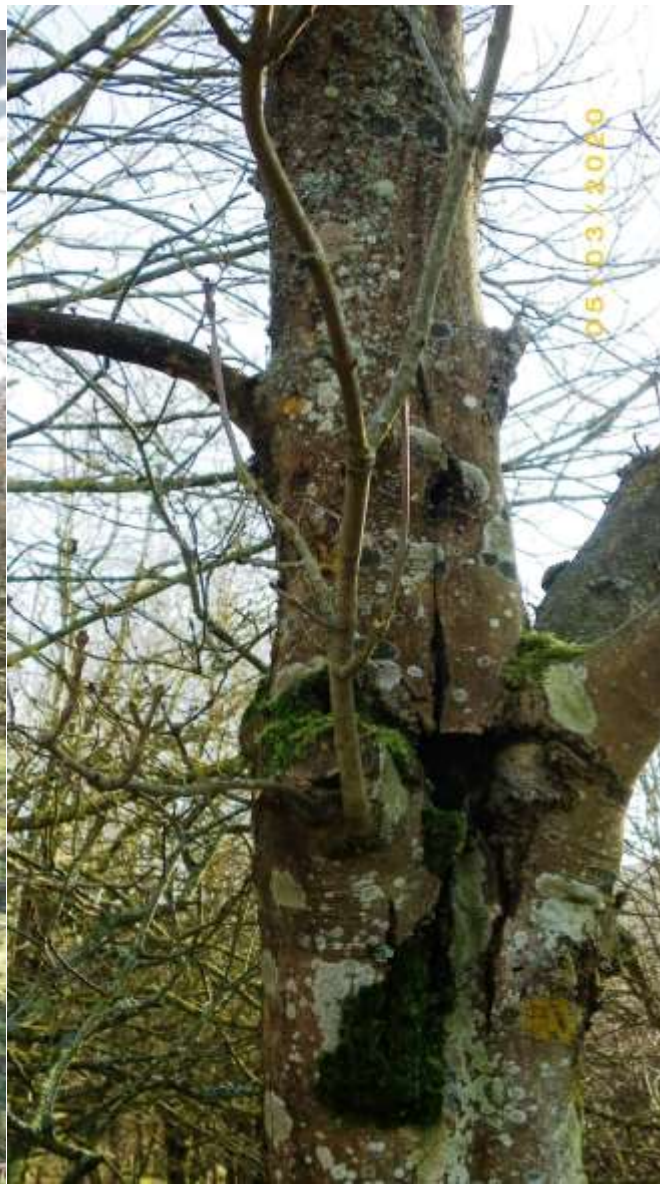
Photo 191 & 192 Cpt13a significant progression of chalara ash dieback with the elongate diamond shape lesion and the branch union

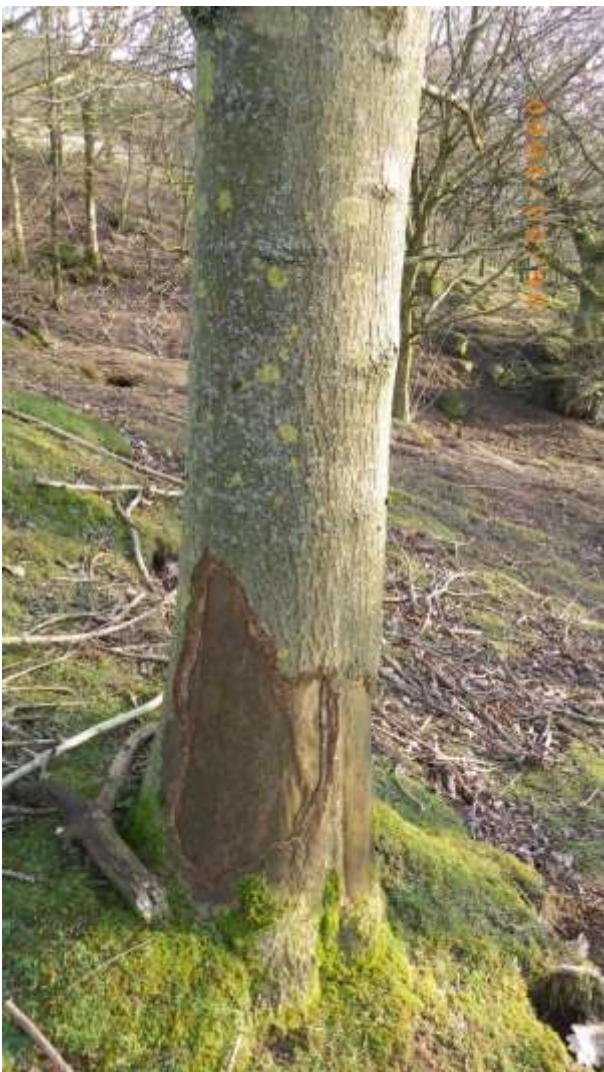
Photo 194 rabbit or sheep damage to stem base (significant rabbit warren on site)

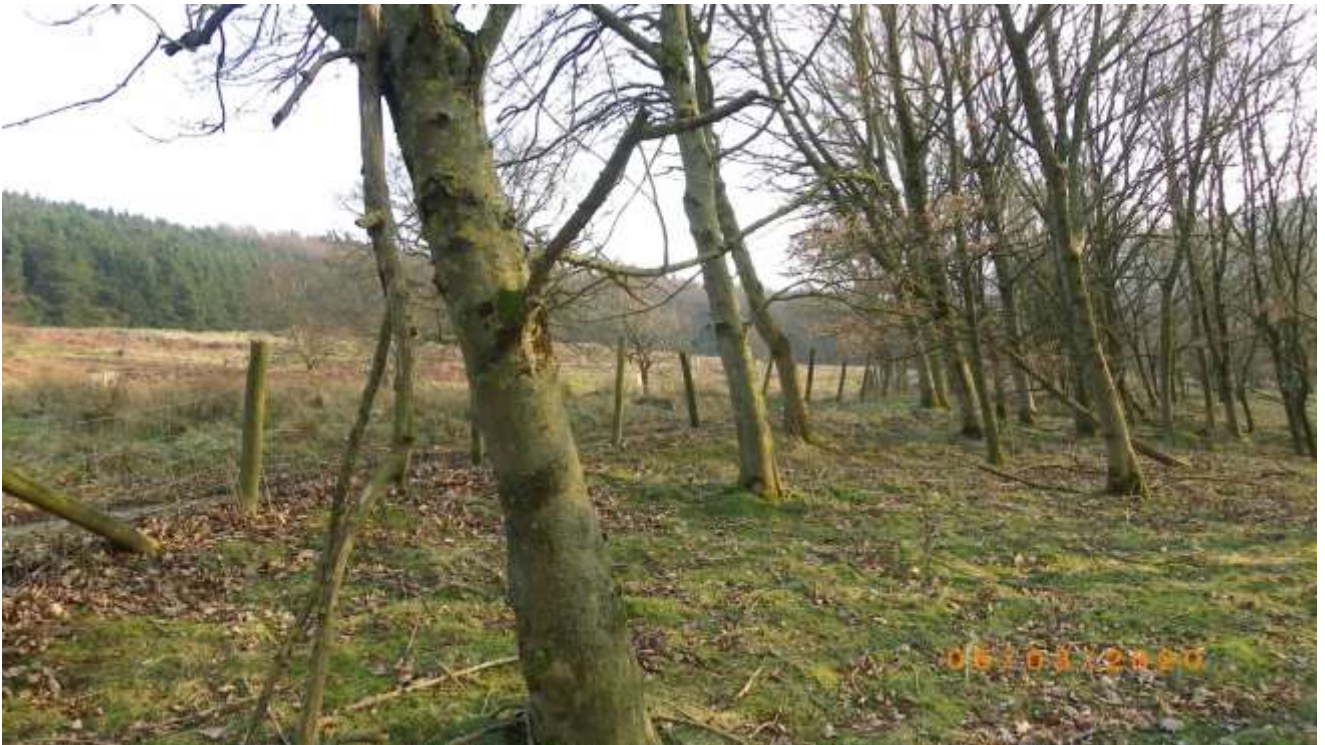
Photo 199 eastern boundary to cpt13a fence posts failing

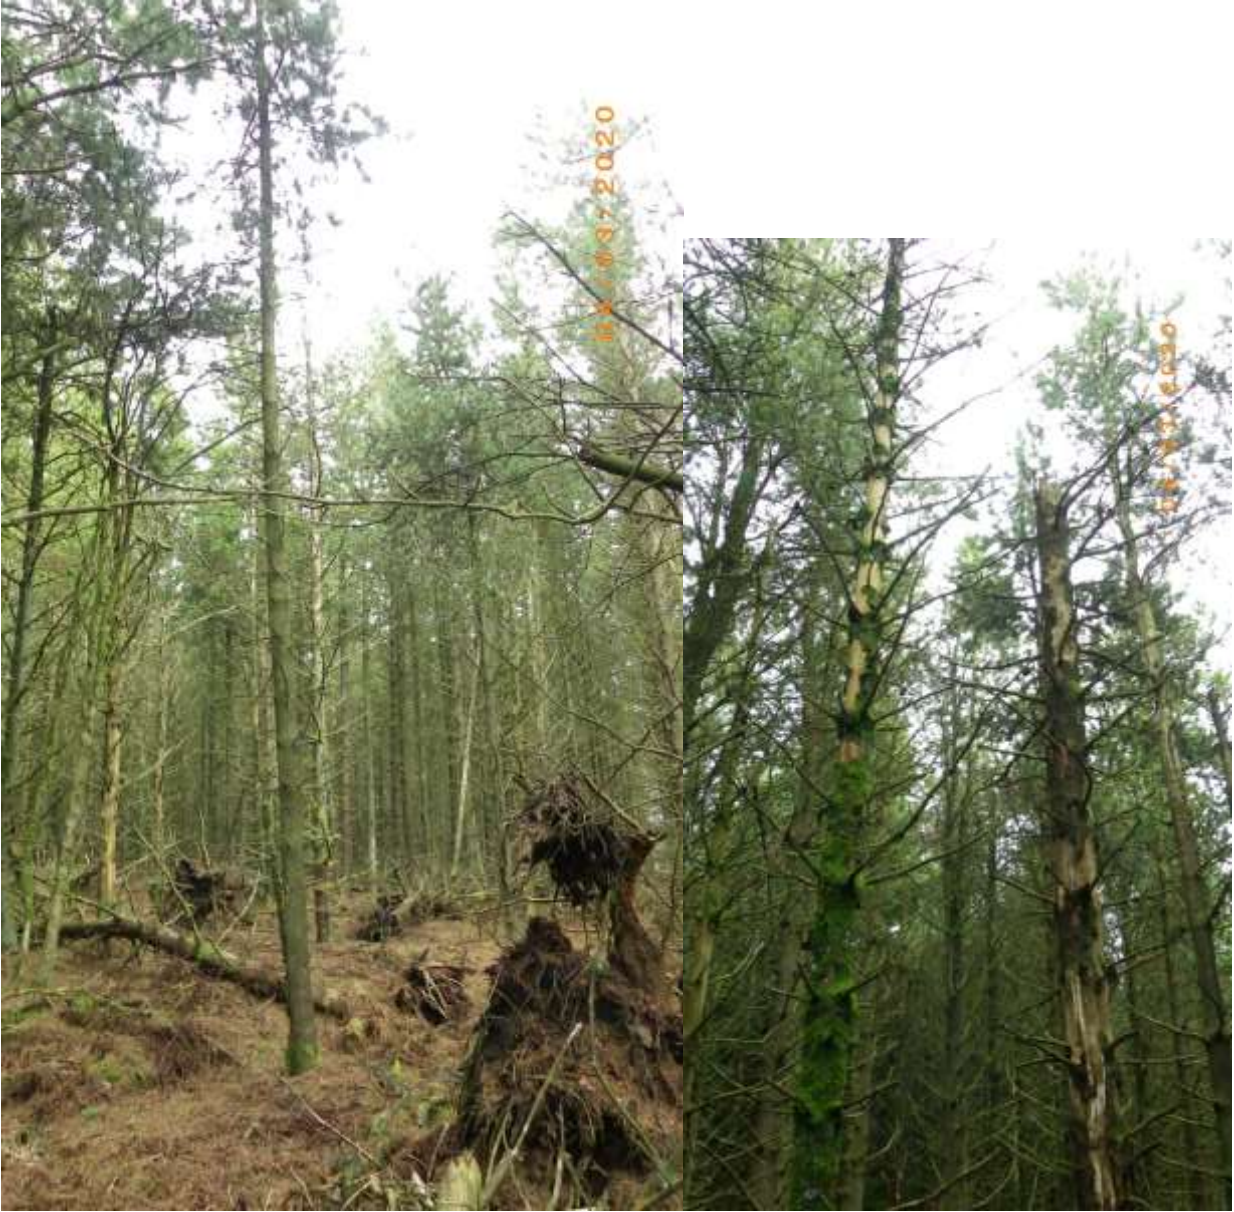
Photo 232 & 233 Barker Plantation wind blow & wind snap at the top of the wood to the south east of cpt14b
