National Trust Bransdale & Farndale Woodland Management Plan
Photo and Images Gallery 2021

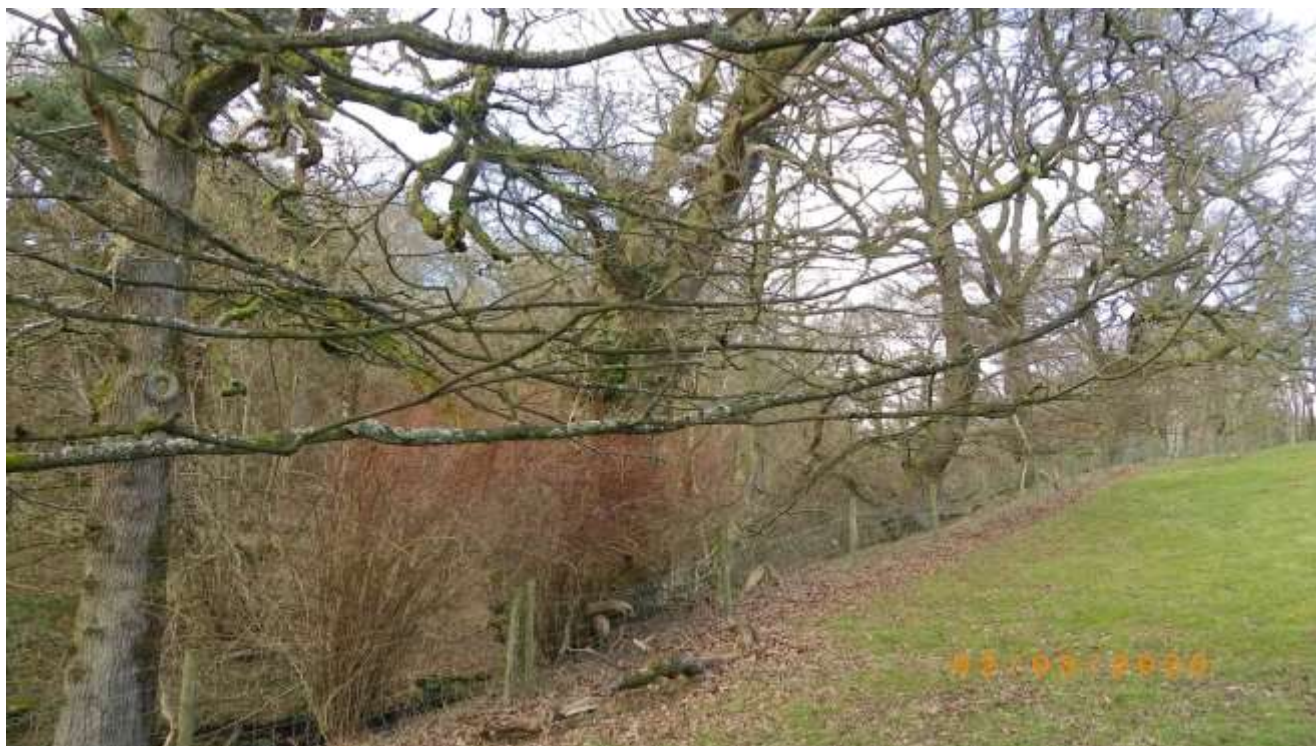
Photo 15 South east boundary of 1c stock fence to grass field is old.

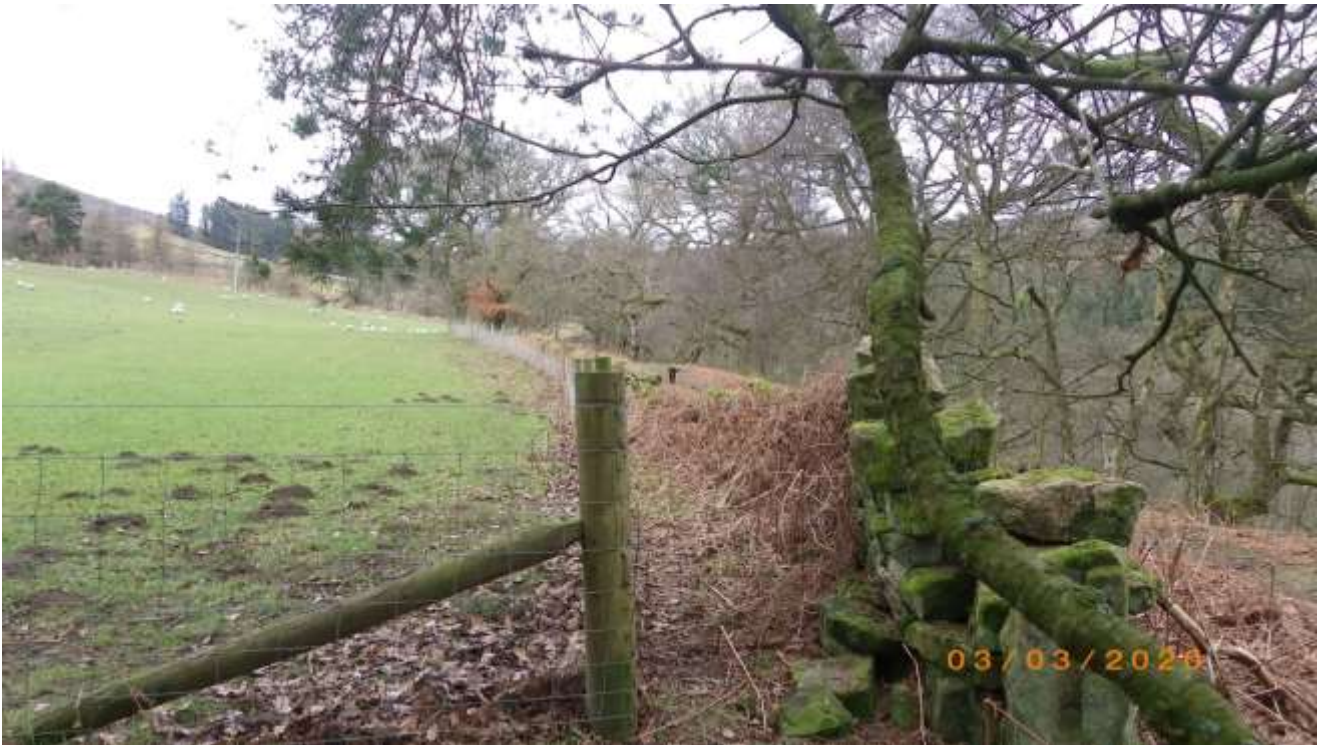
Photo 17 new stock fence adjacent to the old wall on the western boundary of cpt1c

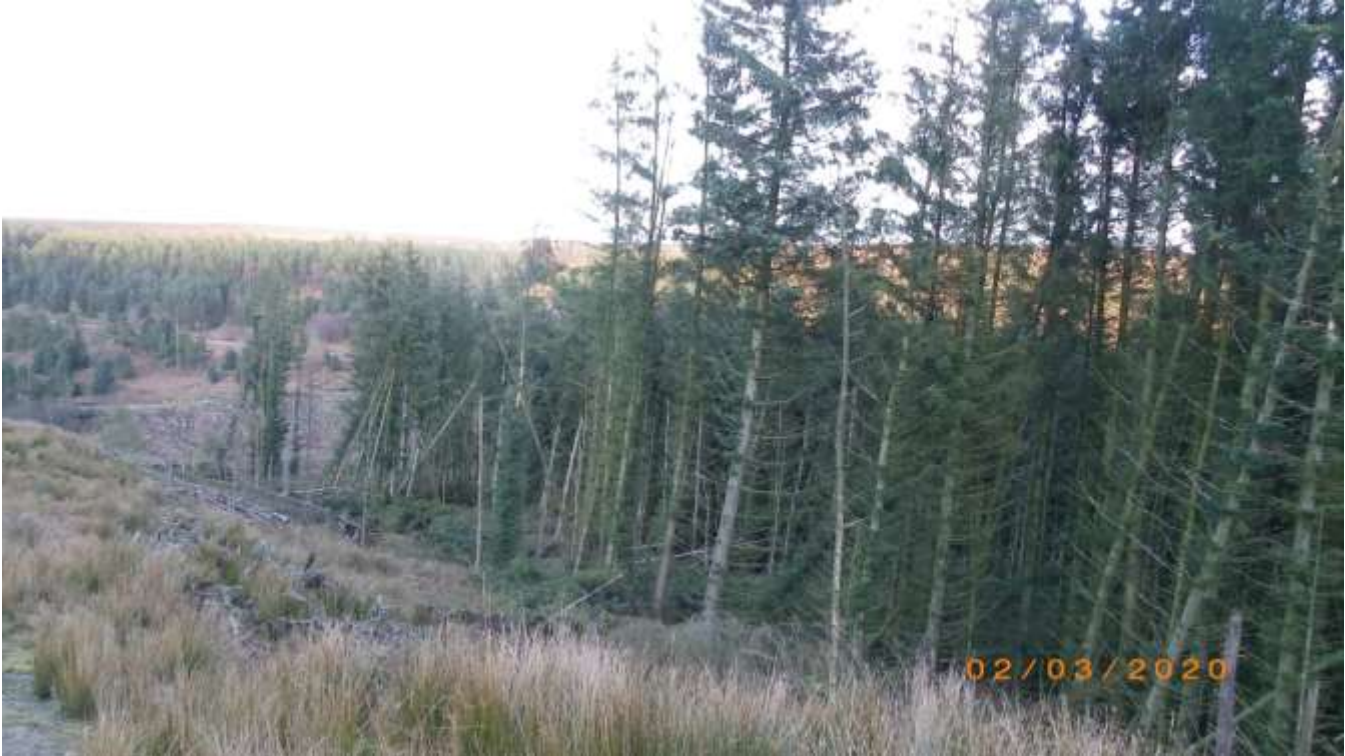
Photo 28 & 29 cpt1c windblow to the west and north boundary where FE have clear felled their stands

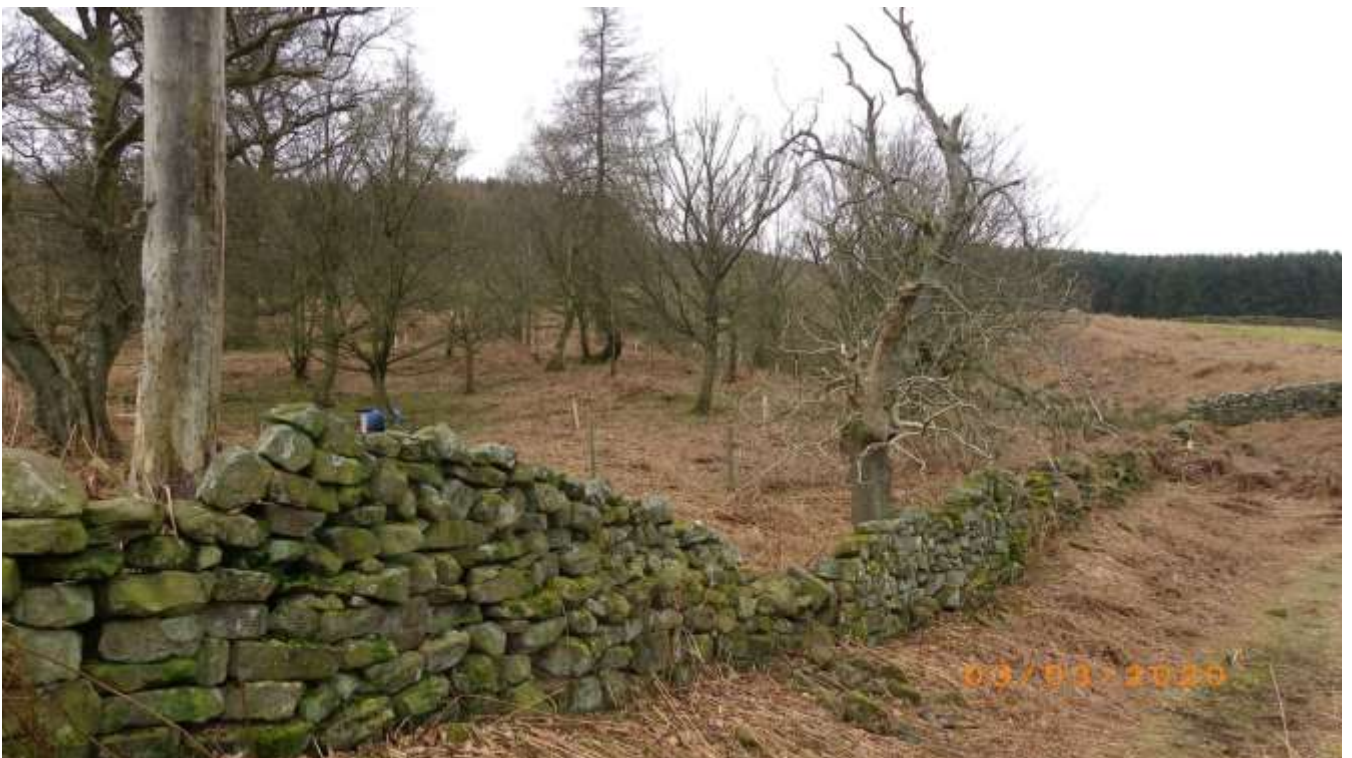
Photo 34 Cpt 2a the eastern boundary wall

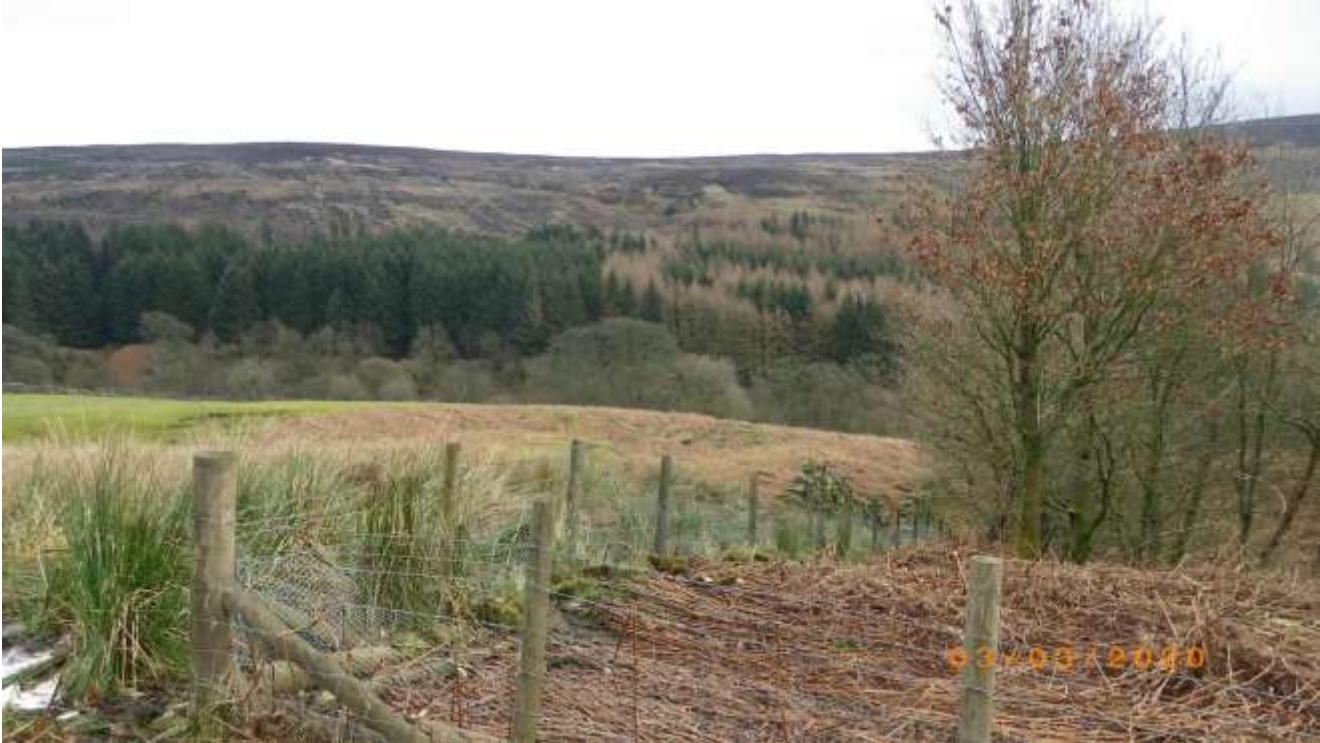
Photo 37 Cpt 2a Northern boundary stock fence heading down the hill; remains of the wall to the outside

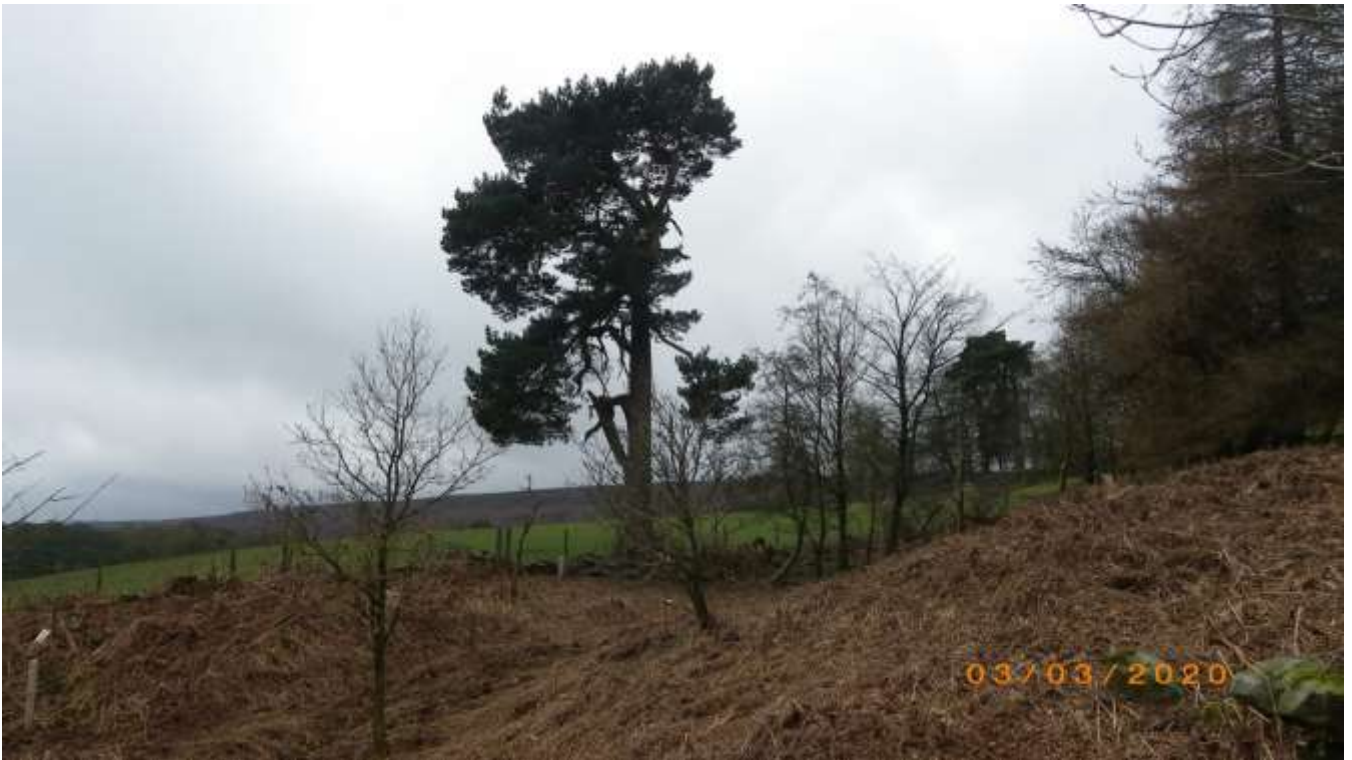
Photo 39 Cpt 2a mature pine on the southern boundary

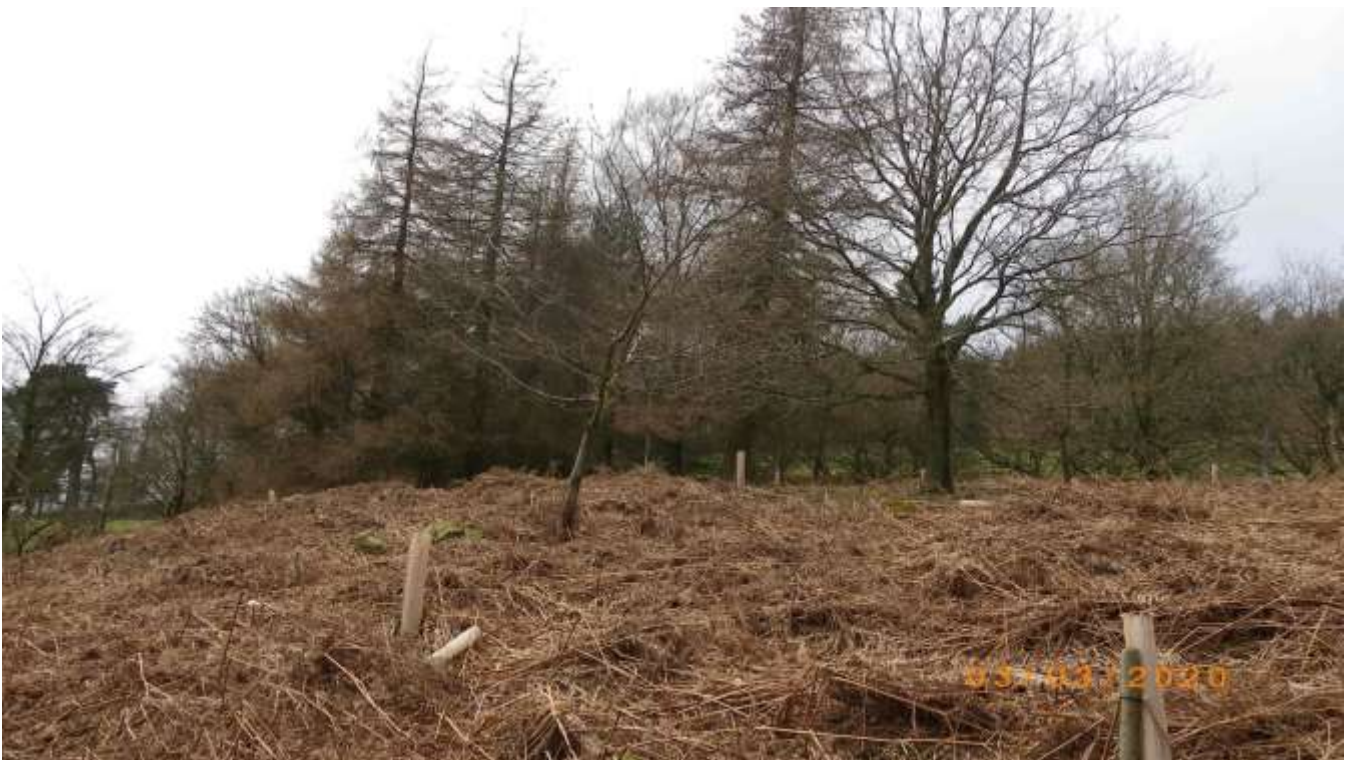
Photo 40 Cpt 2a deep bracken and redundant tubes

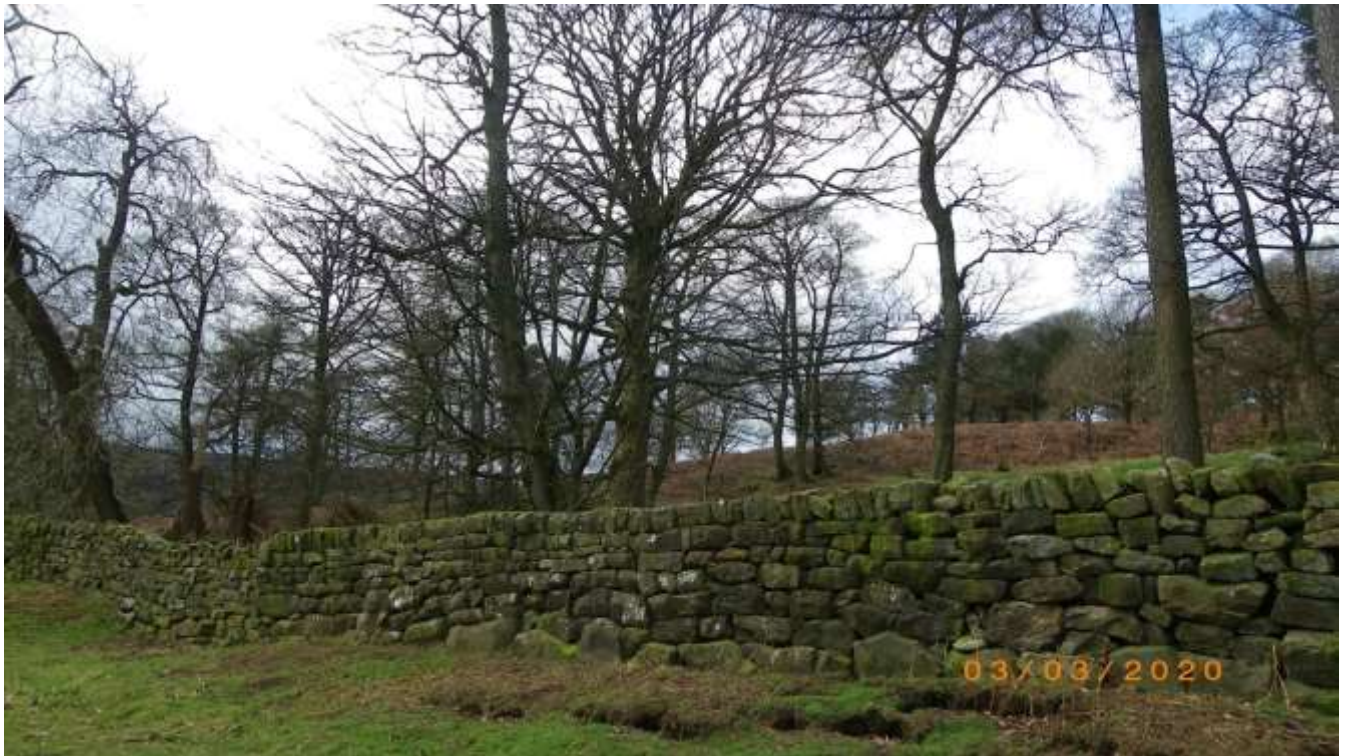
Photo 49 south east boundary to Heater Plantation good condition

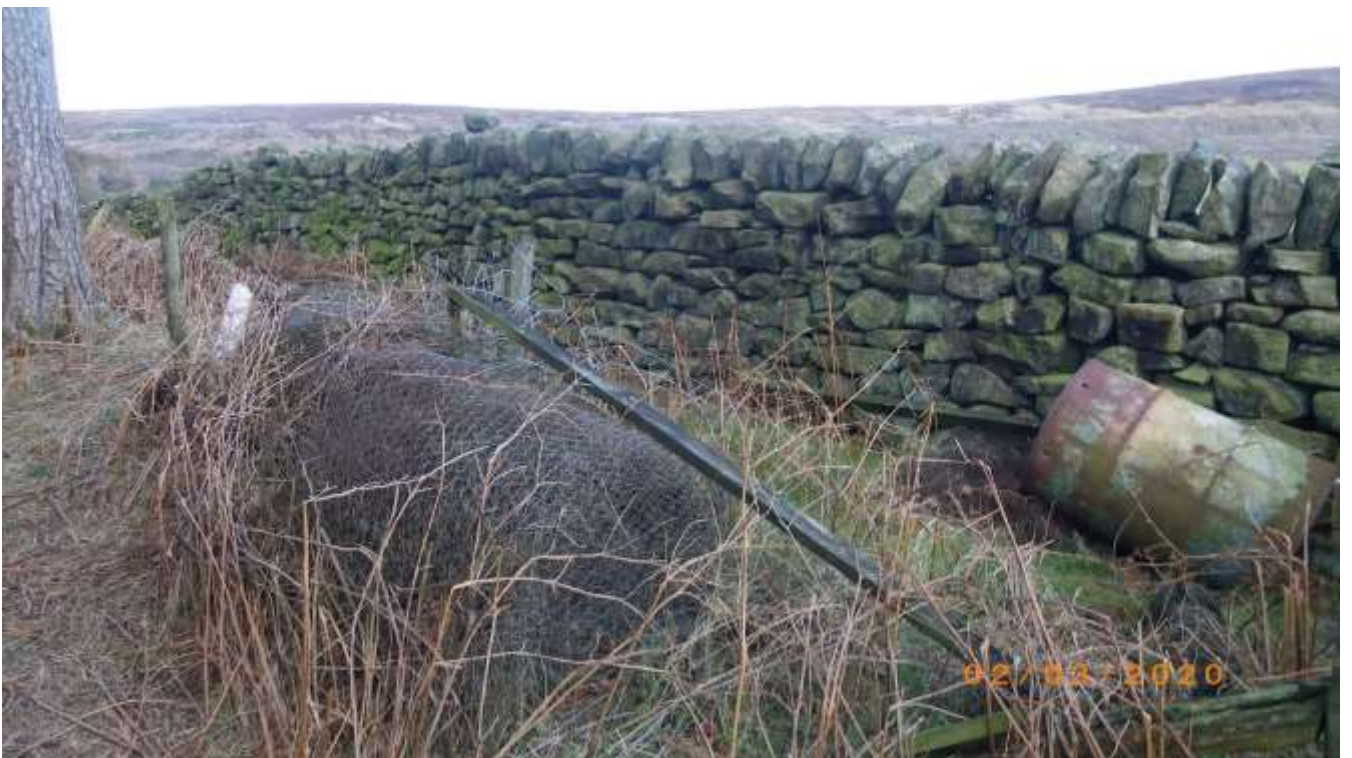
Photo 53 Cpt3a old fencing stacked for removal

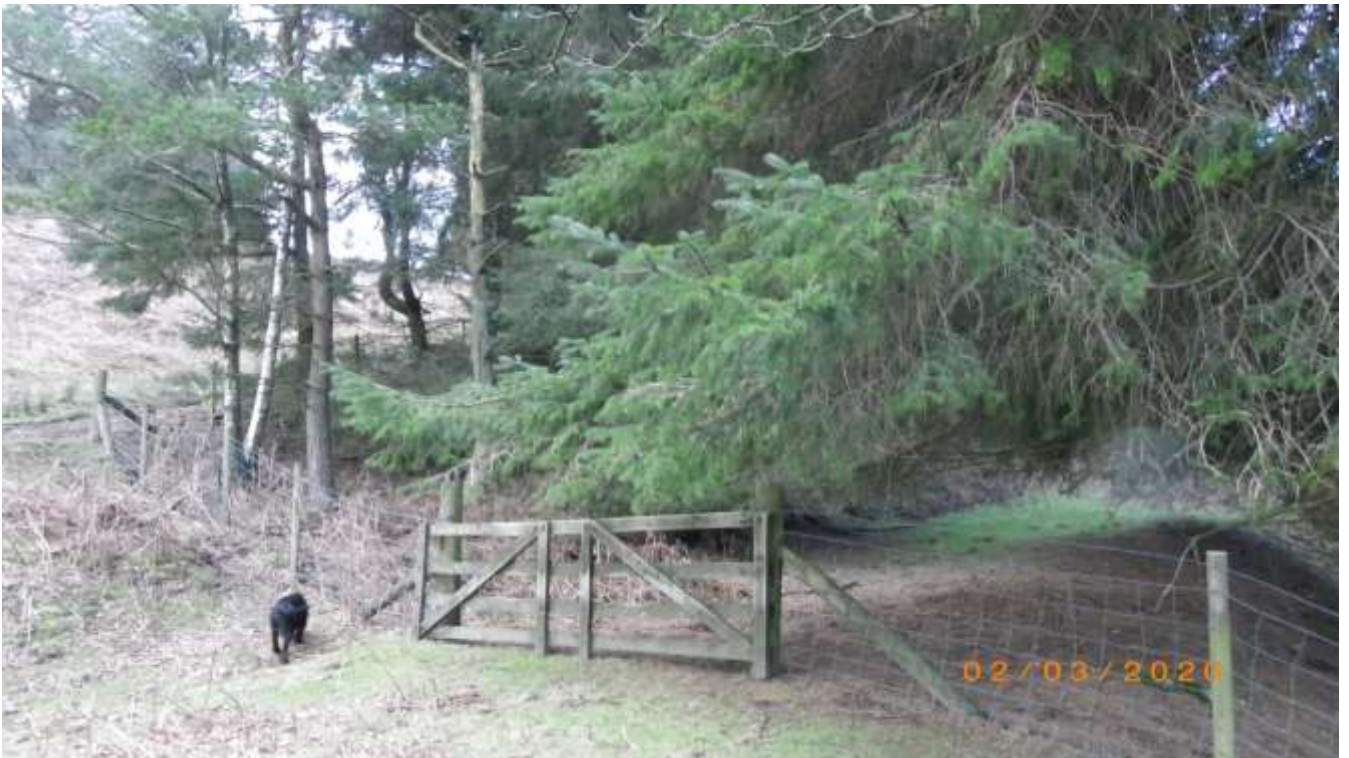
Photo 55 south west boundary to cpt4a

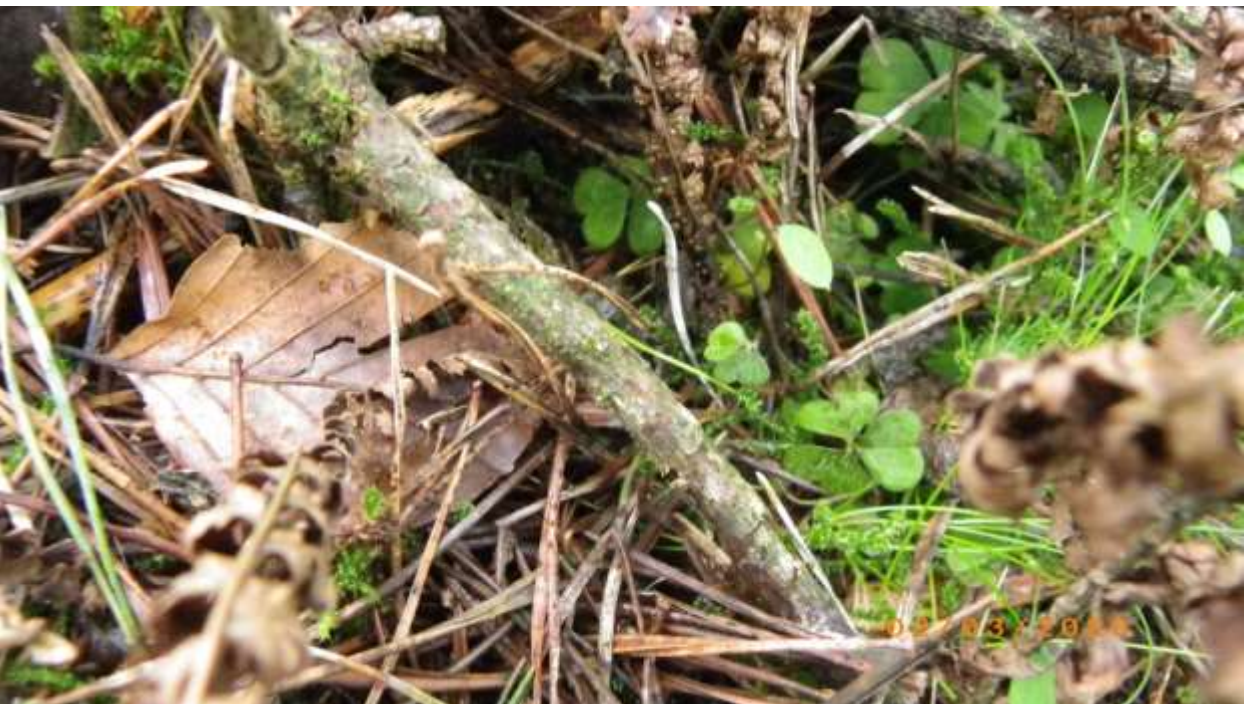
Photo 60 Cpt4a wood sorrel visible in the leaf litter to the s/w boundary

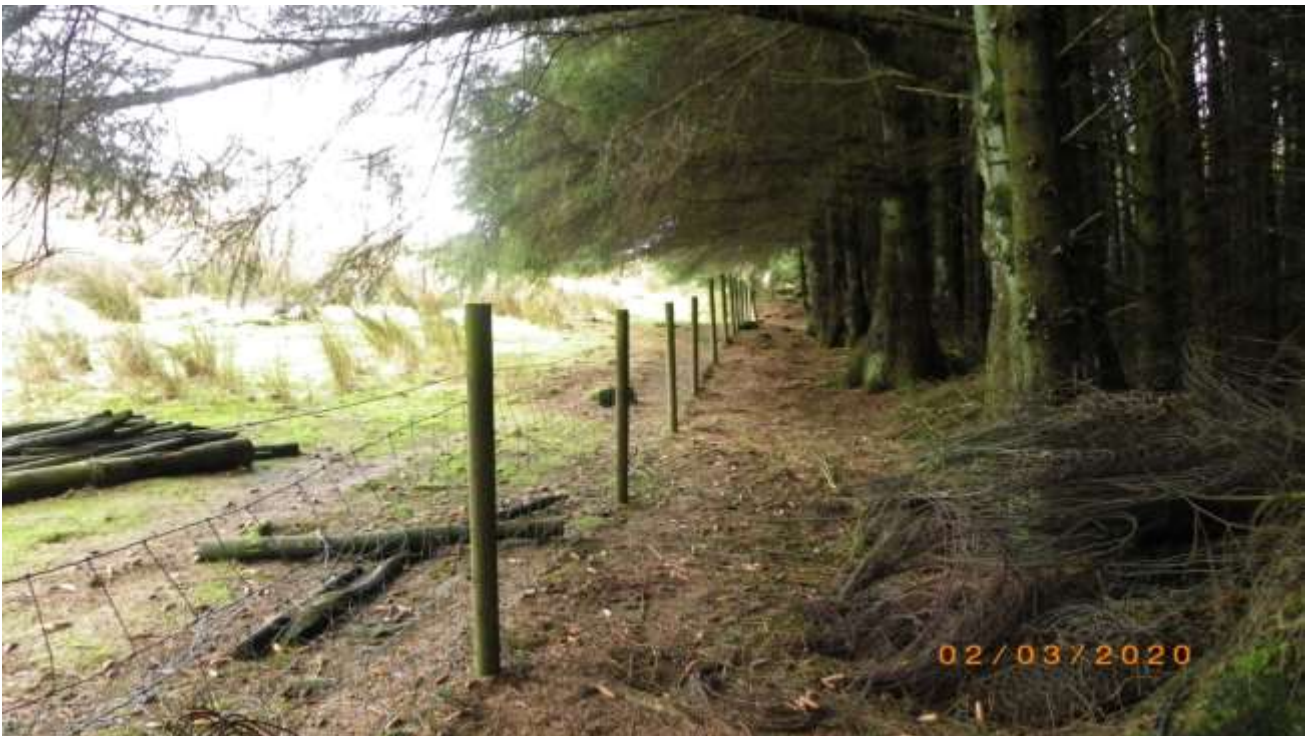
Photo 64 Cpt4b stock fence to the westerly boundary

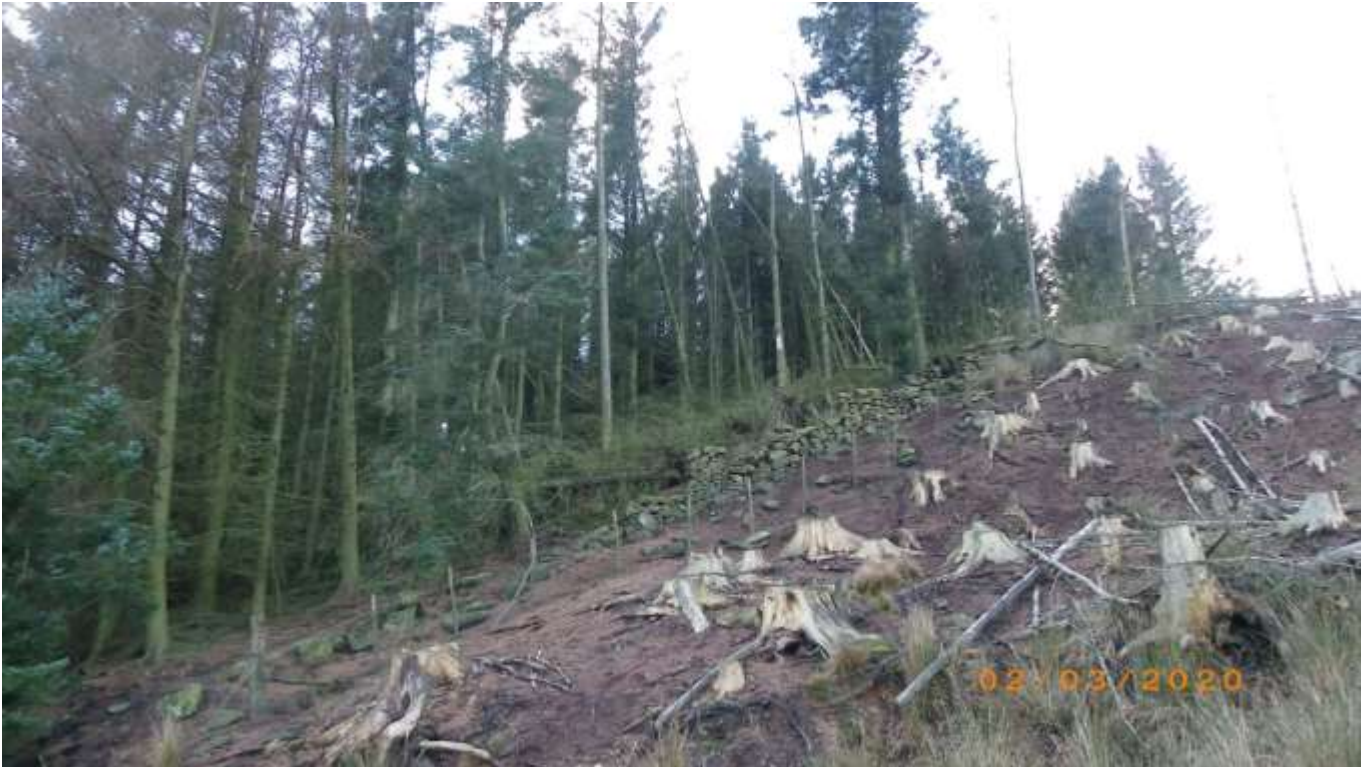
Photo 68 redundant dry stone wall to the northern boundary & FE clear fell on neighbouring land

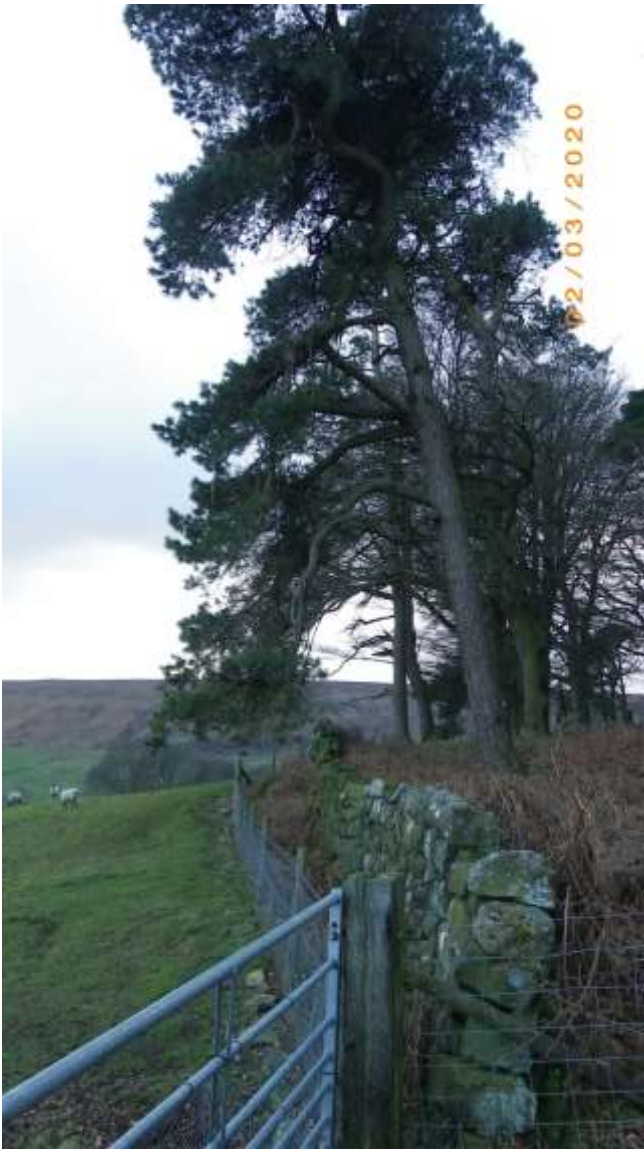
Photo 70 the southern boundary wall of cpt5a is stock fenced to the field side

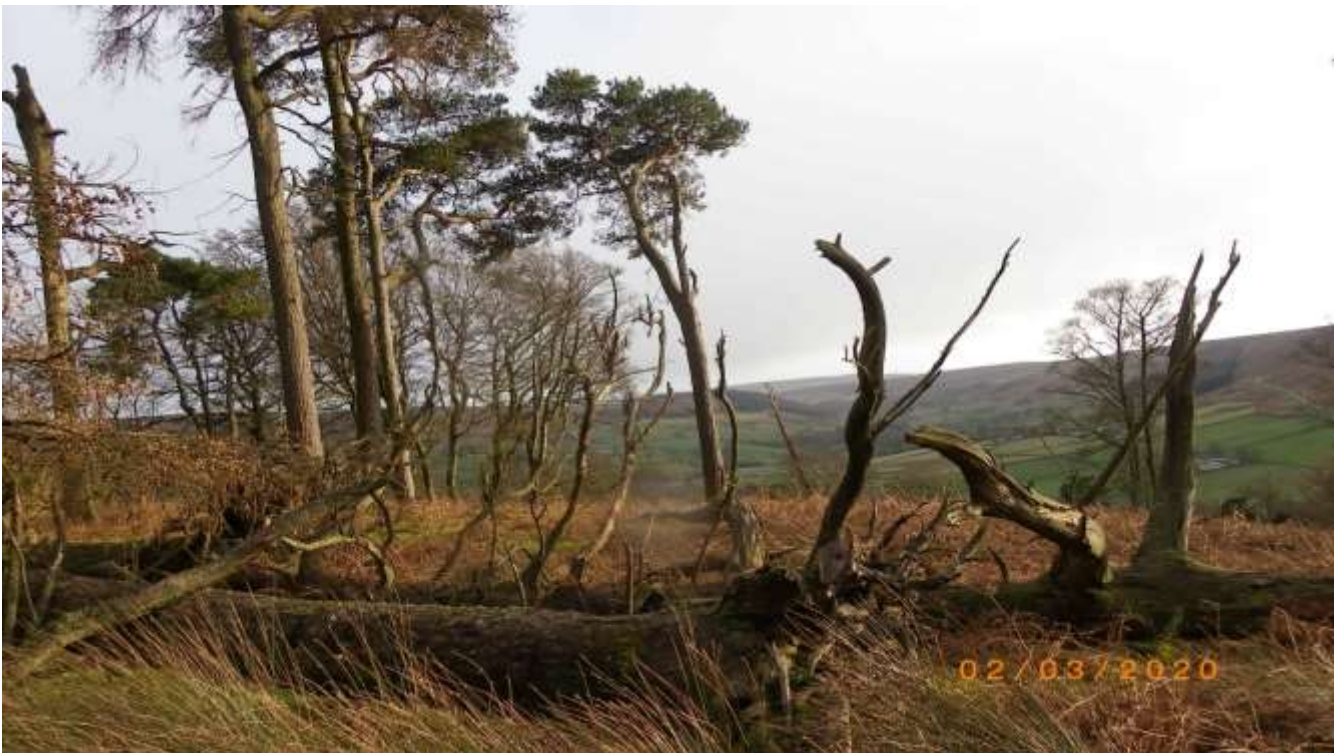
Photo 73 mature pine, larch and fallen deadwood retained at the top of cpt5a

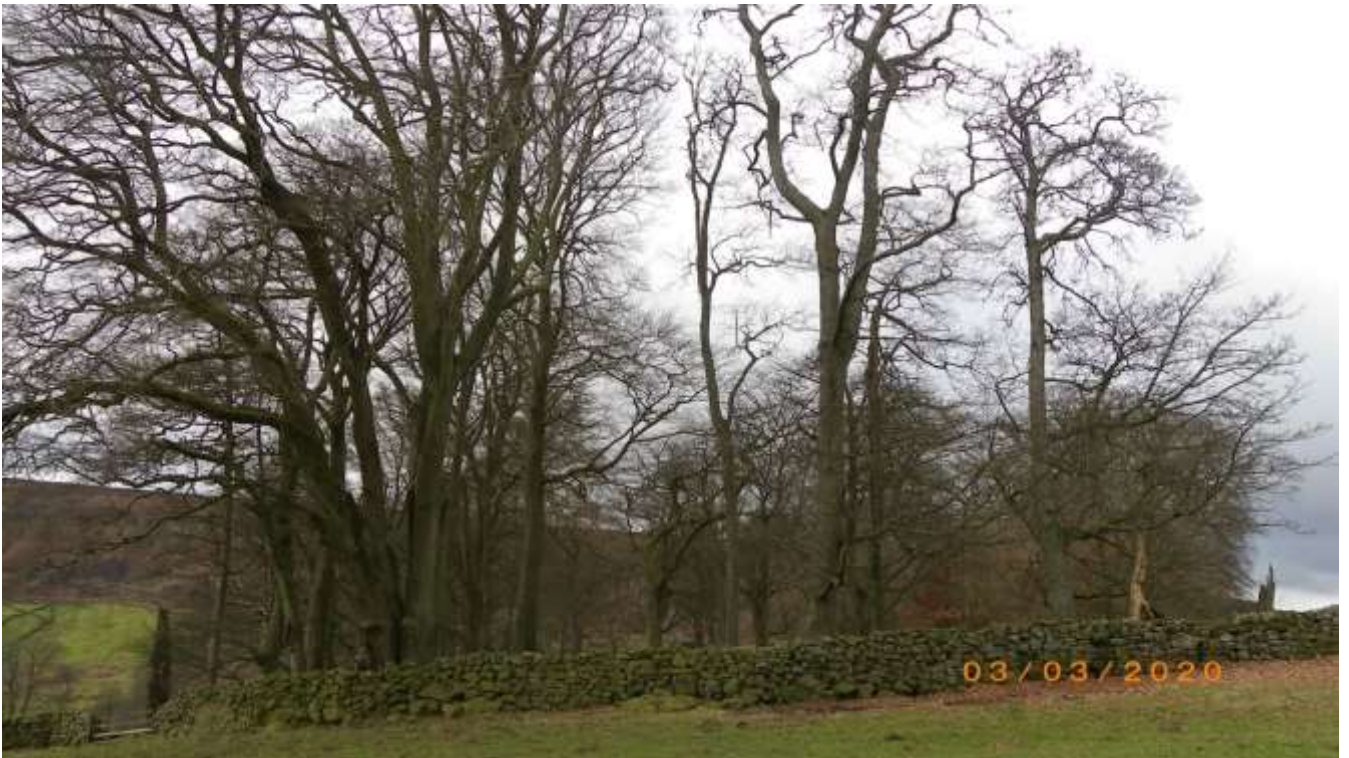
Photo 80 Mature beech dominant with oak, sycamore, rowan and pine cpt6 Round Plantation

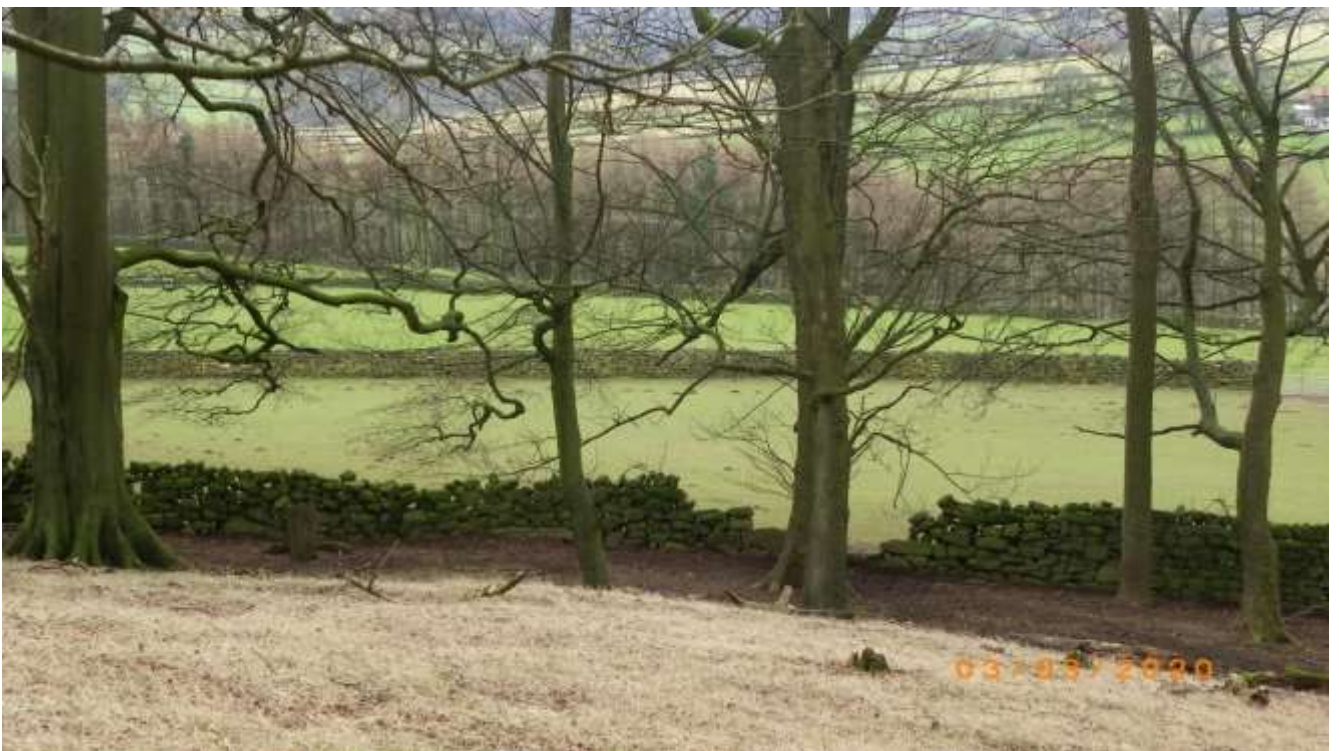
Photo 85 Cpt6a 4 or 5 large wall gaps not hurdled so sheep in the wood

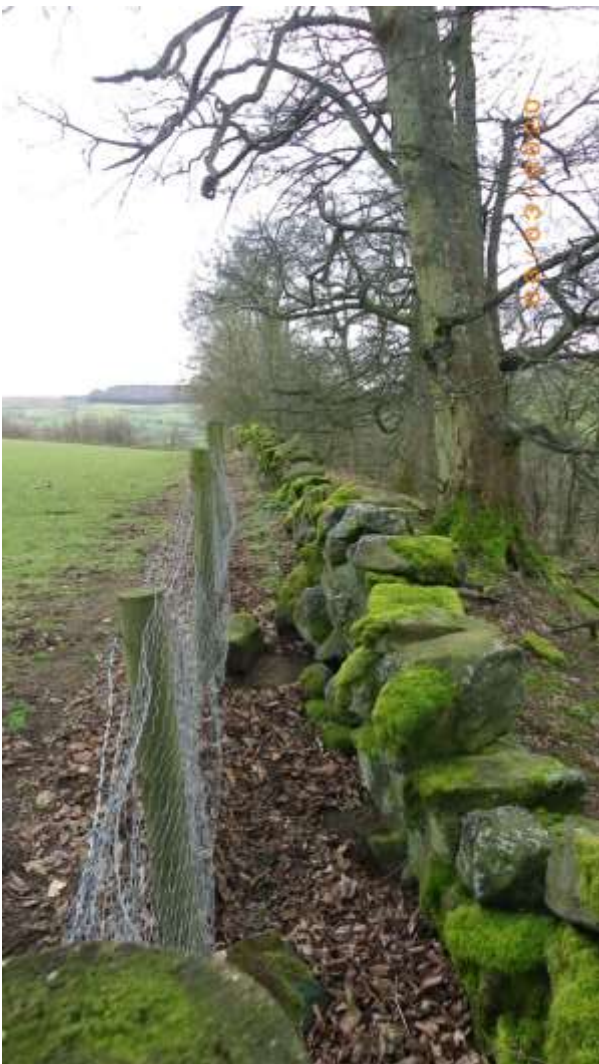
Photo 88 Cpt7a eastern boundary, old wall and stock fence to field side

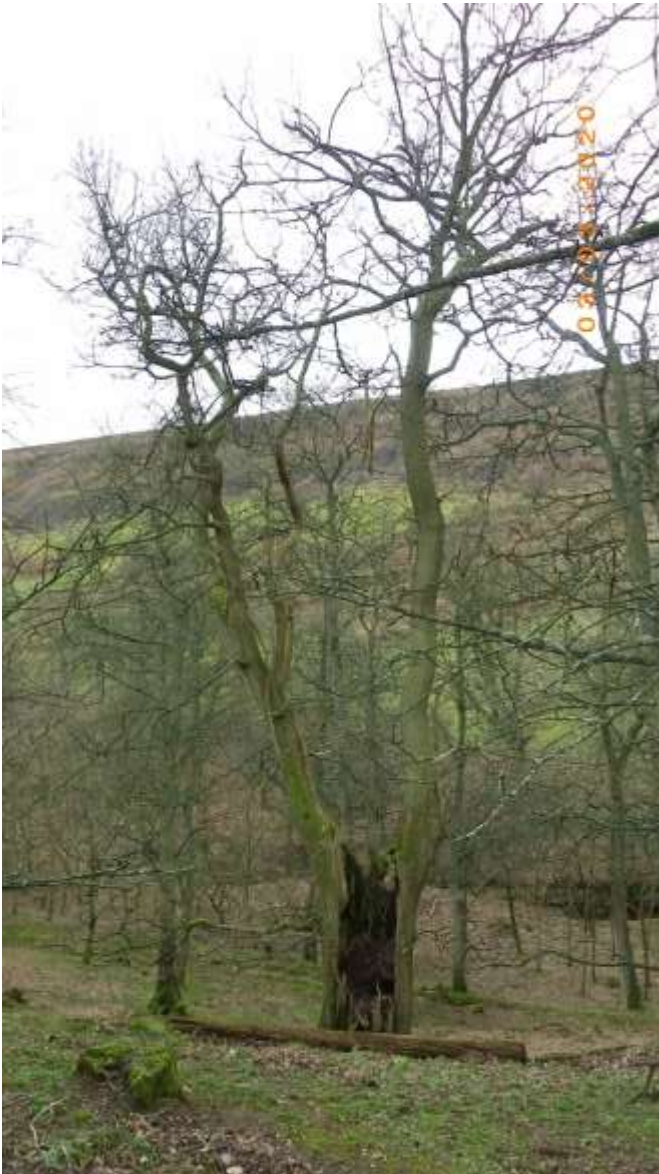
Photo 91 Cpt7a Beck Plantation standing and fallen deadwood present

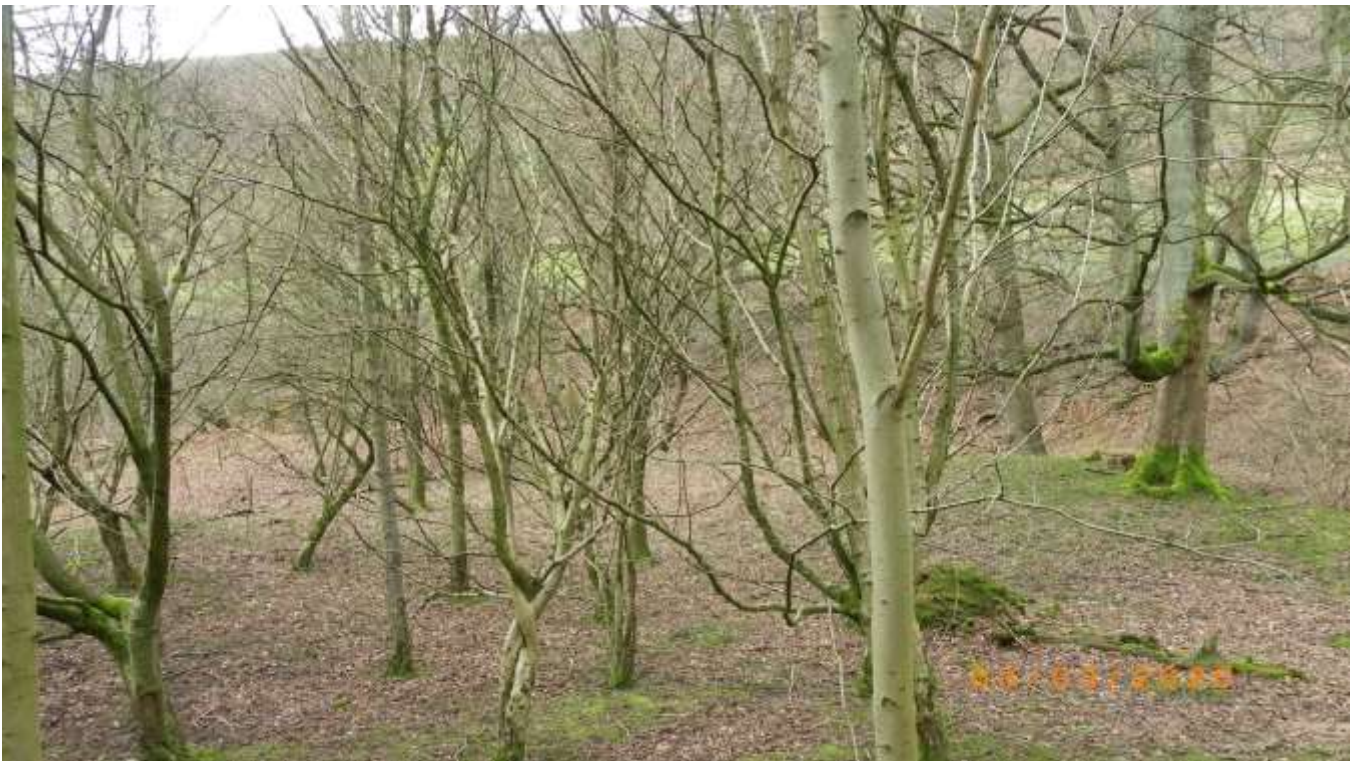
Photo 94 Cpt7a younger stock has some rabbit and grey squirrel damage but is established

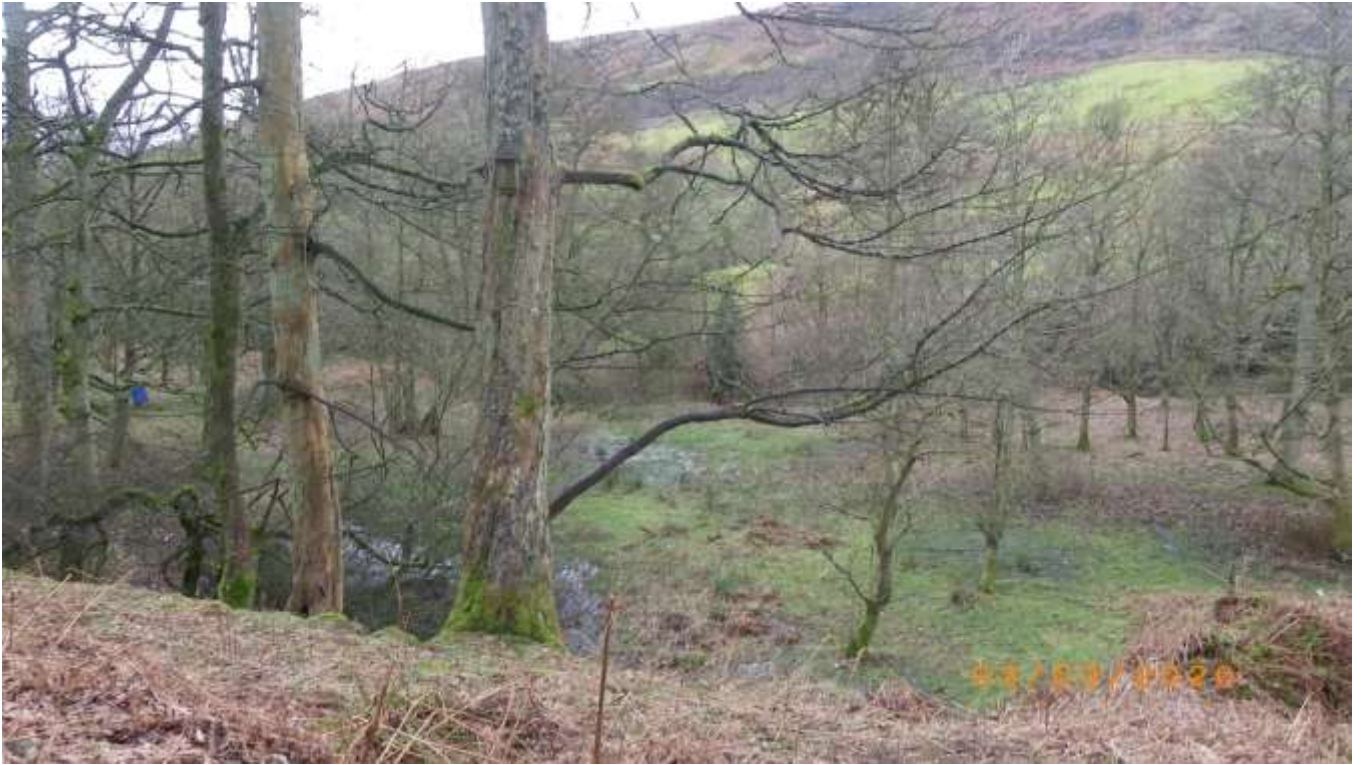
Photo 95 & 96 Beck Plantation Cpt7a with wet open glades and alder carr along the riparian zone to Hodge Beck

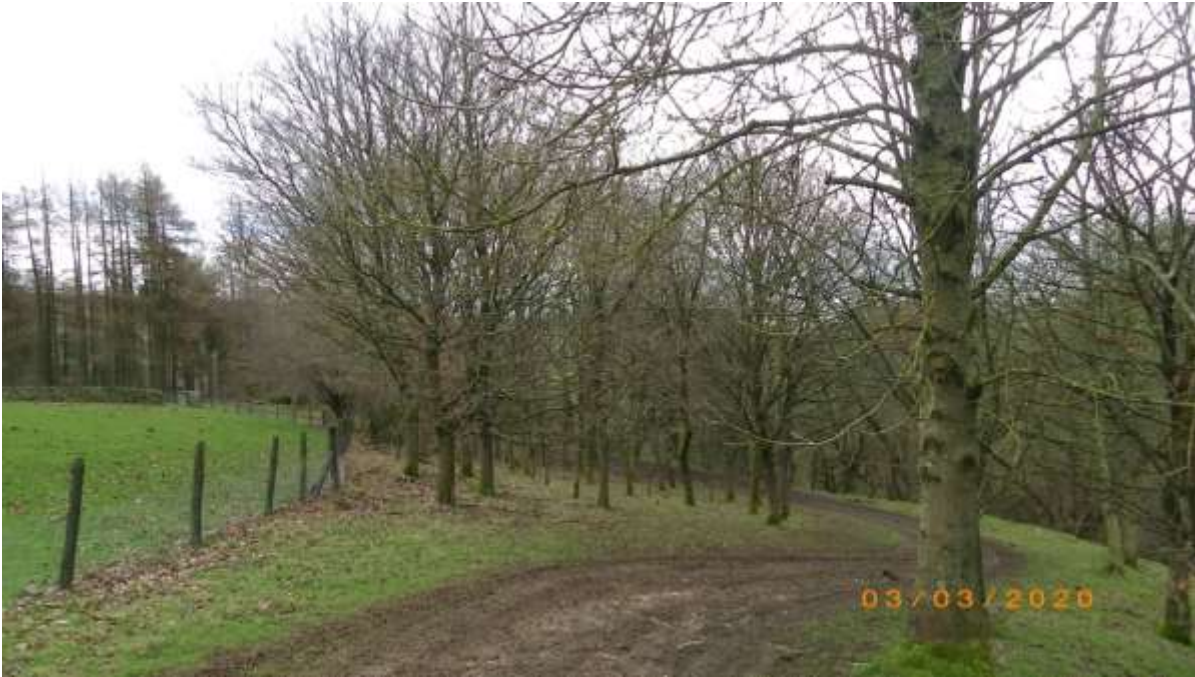
Photo 97 Cpt7a younger oak, ash and wild cherry planted adjacent to the access track; well established.

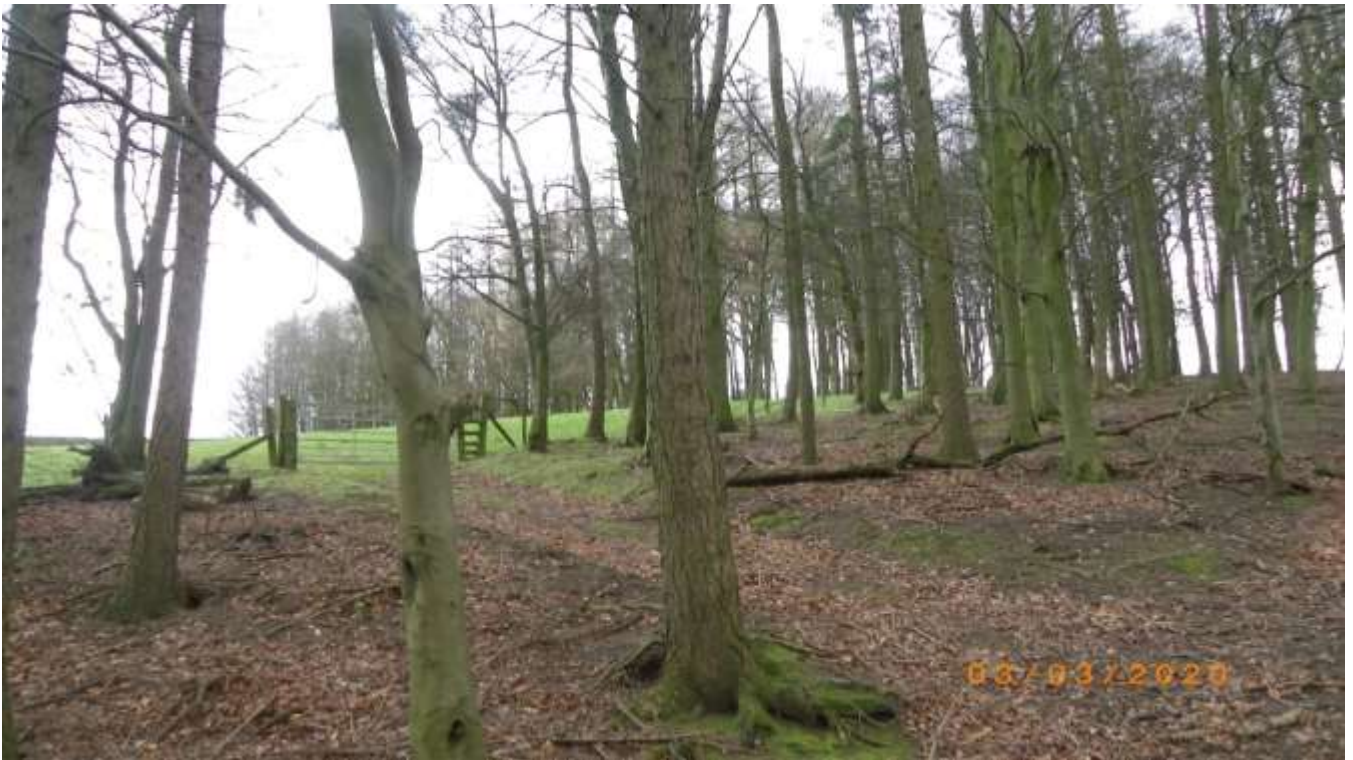
Photo 107 & 108 Beech with the larch to the middle of cpt7b part of the Hall Wood
