National Trust Bransdale & Farndale Woodland Management Plan
Photo and Images Gallery 2021

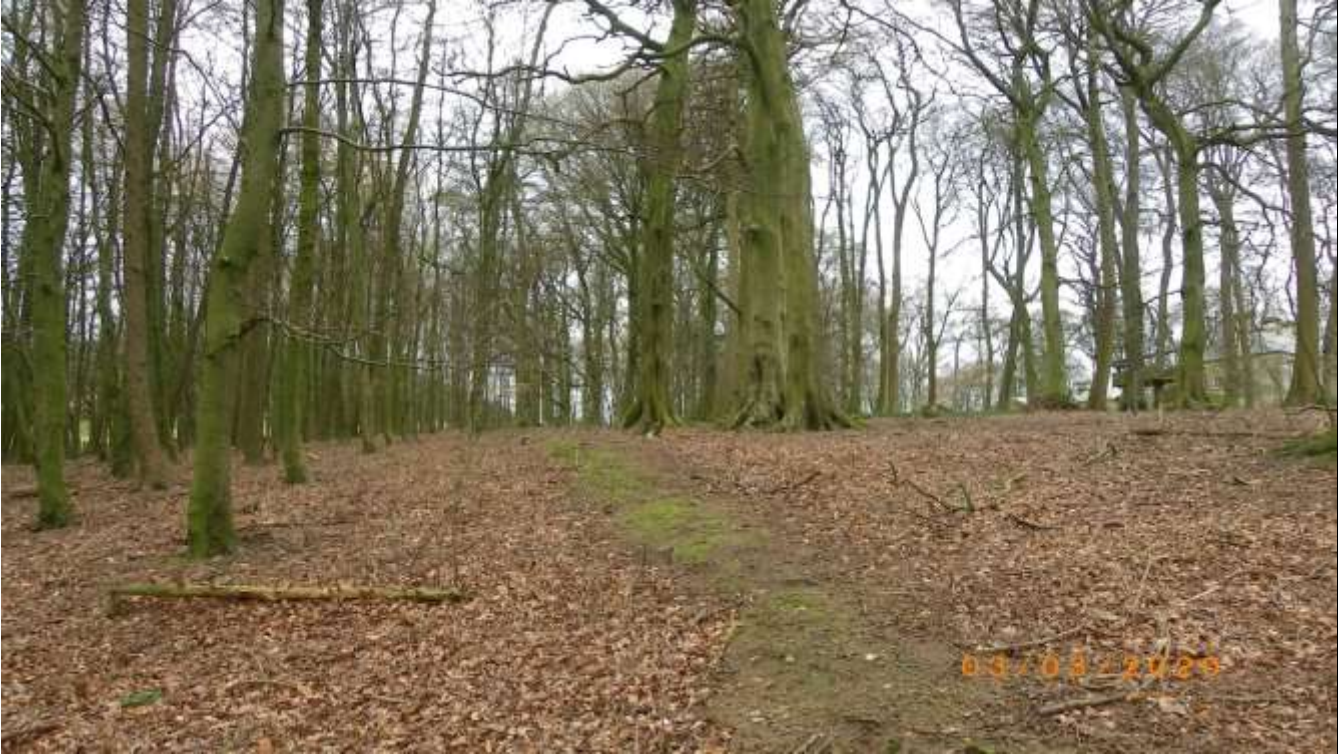
Photo 109 Old boundary between the larch & beech plantation and the parkland gardens around the Hall.

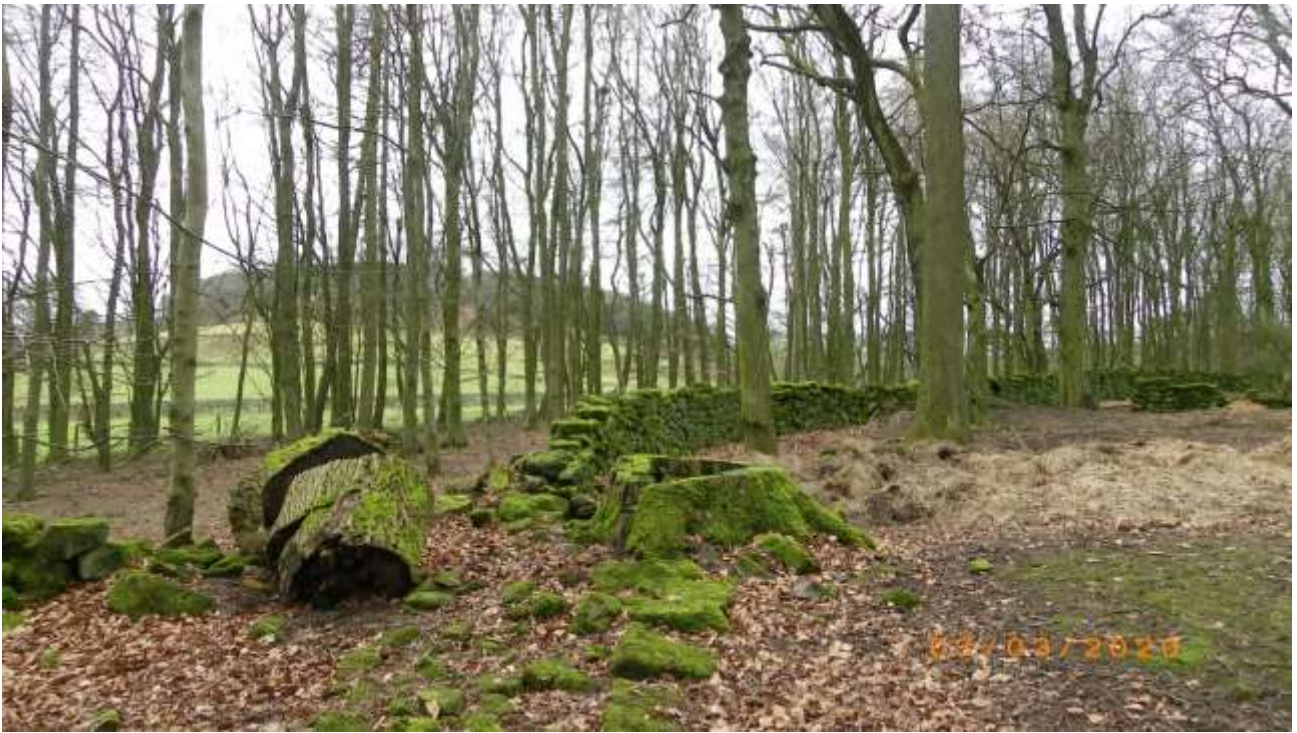
Photo 111 Remaining wall between 7b and the parkland garden

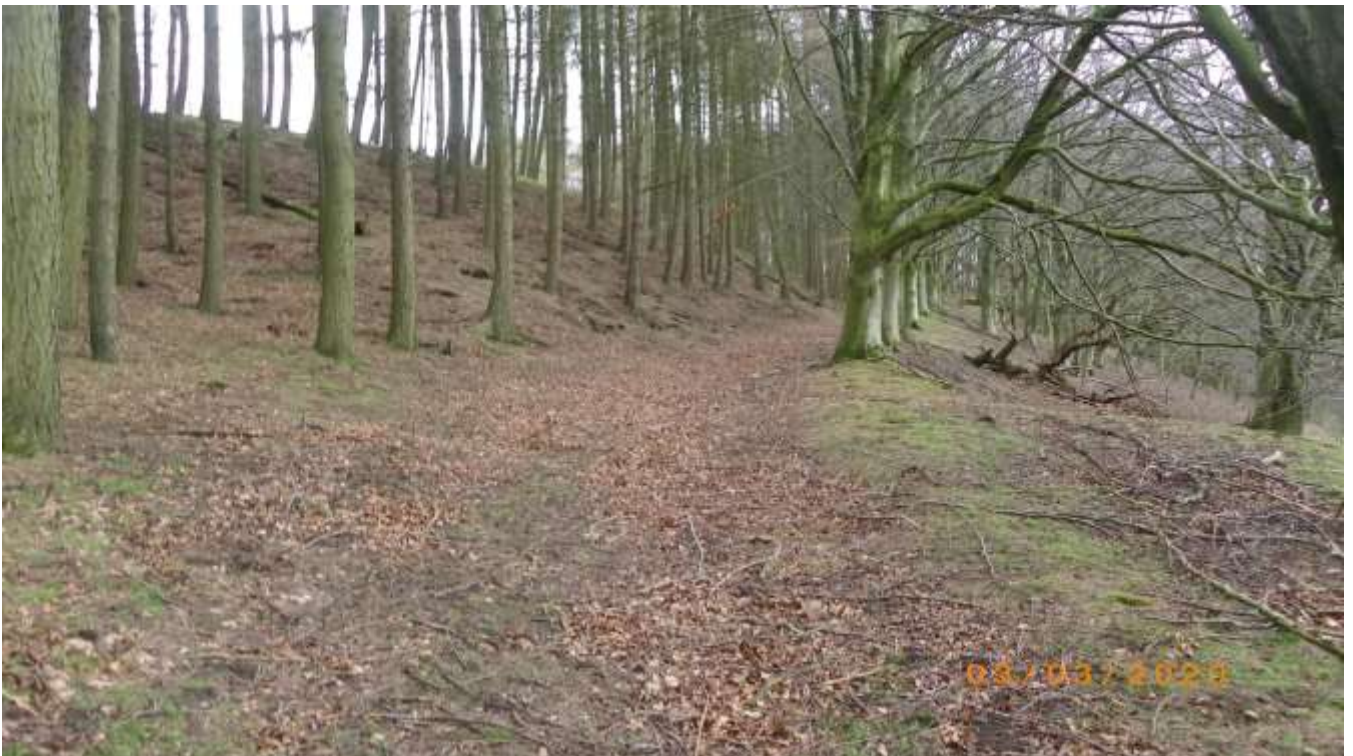
Photo 114 Cpt7c The Hall parkland and garden grounds; beech avenue to the south of the track

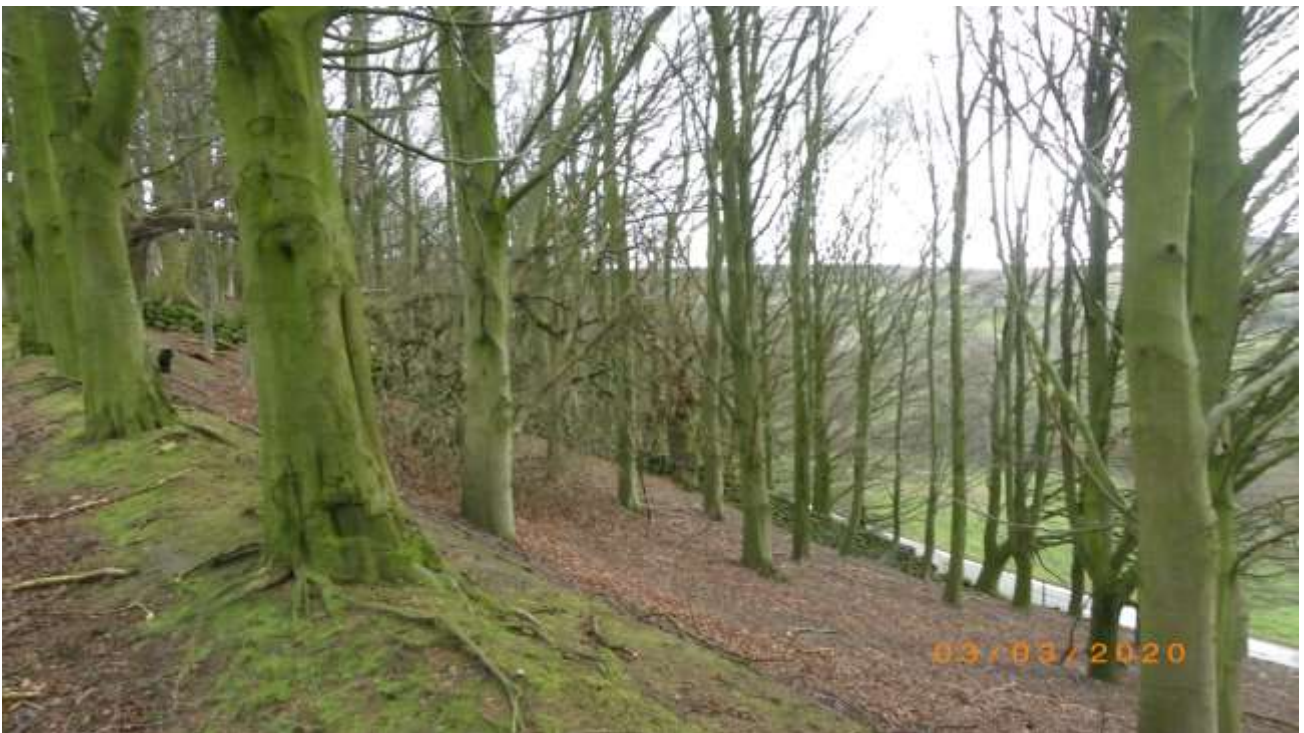
Photo 116 Cpt7c beech on south facing slope; note wall separates the Hall gardens.

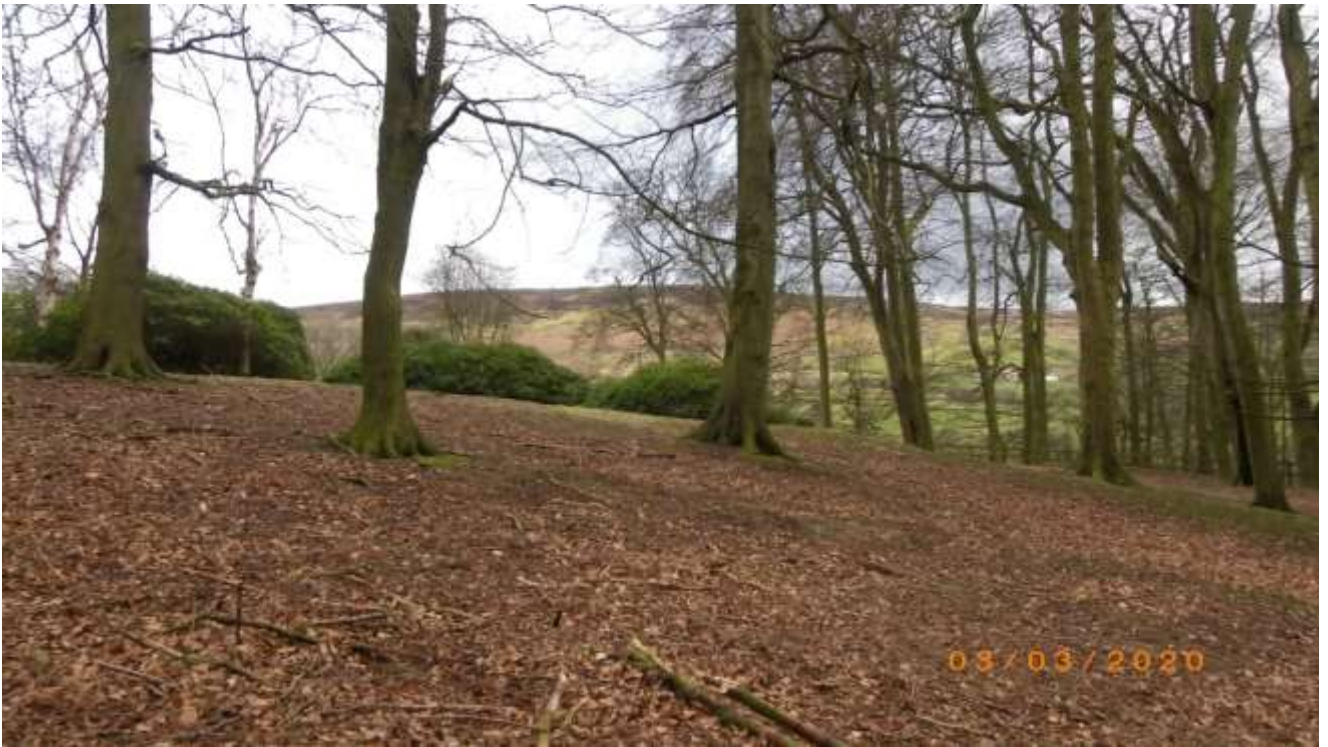
Photo 120 & 121 Cpt7c mature beech and sycamore in the wooded garden around the Hall

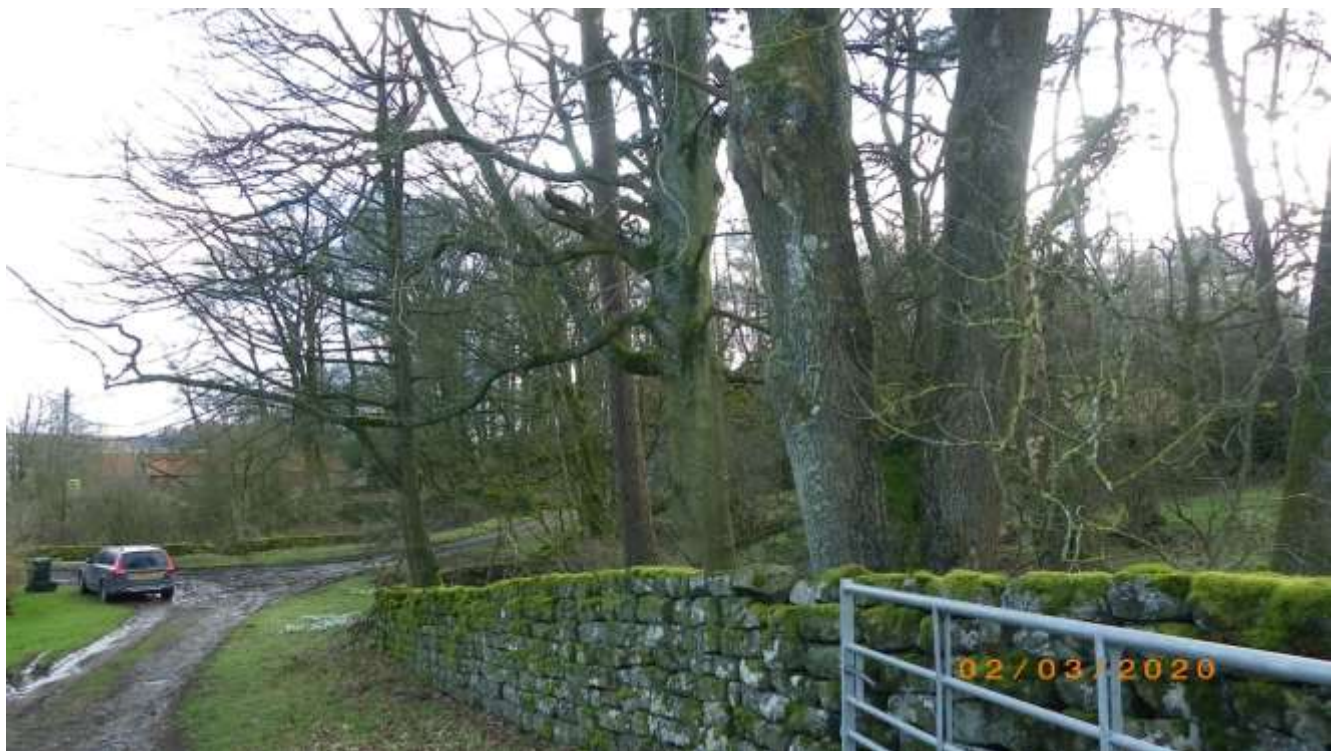
Photo 125 Cpt 7d copse east of Bransdale Lodge and west of Cockayne Lodge.

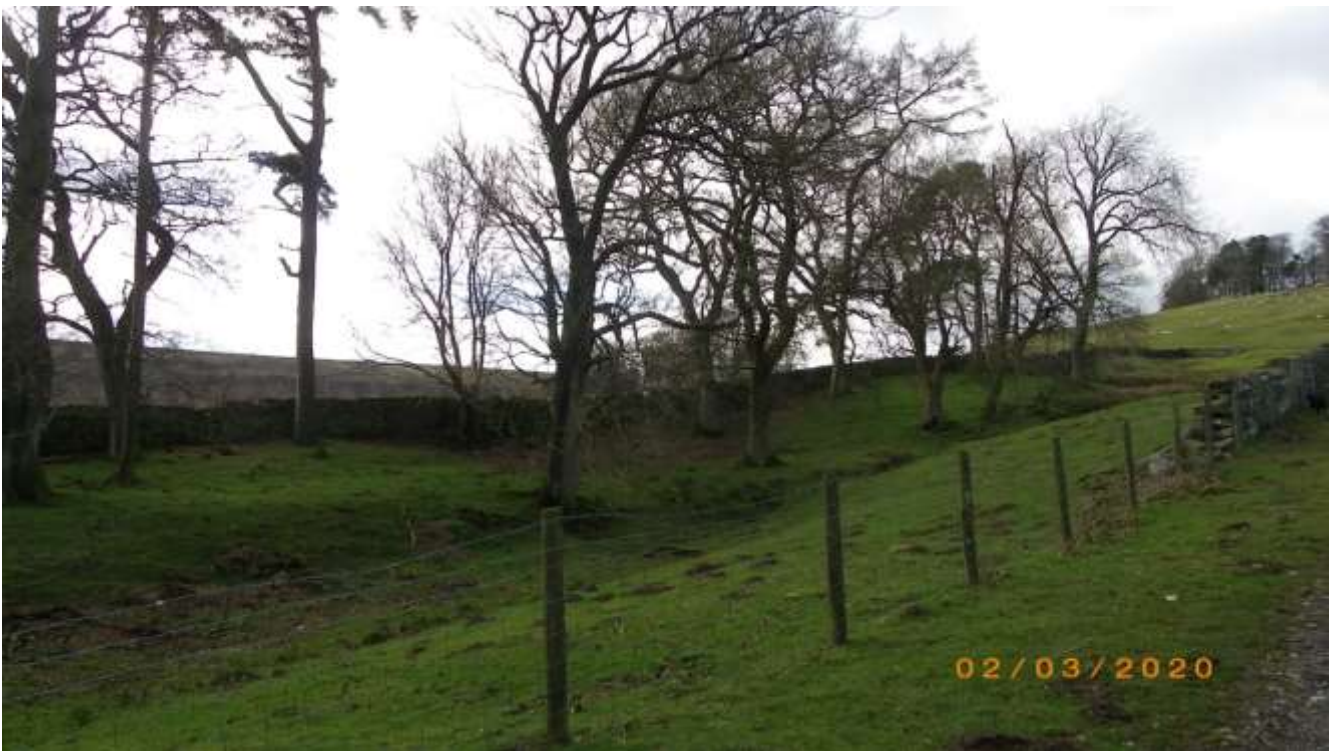
Photo 127 the north of cpt7d has only a few mature trees and is probably grazed.

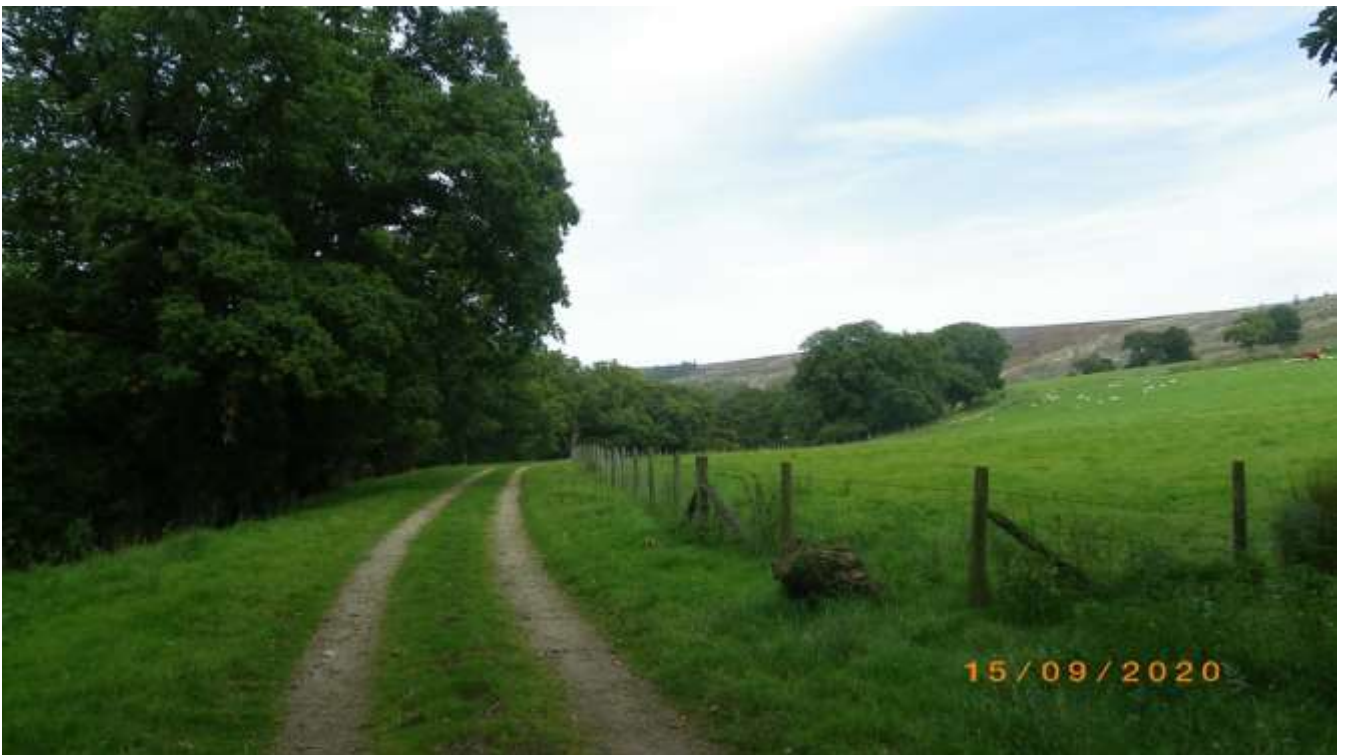
Photo 130 Access track to Bransdale Mill goes through cpt 8 (also bridleway route)

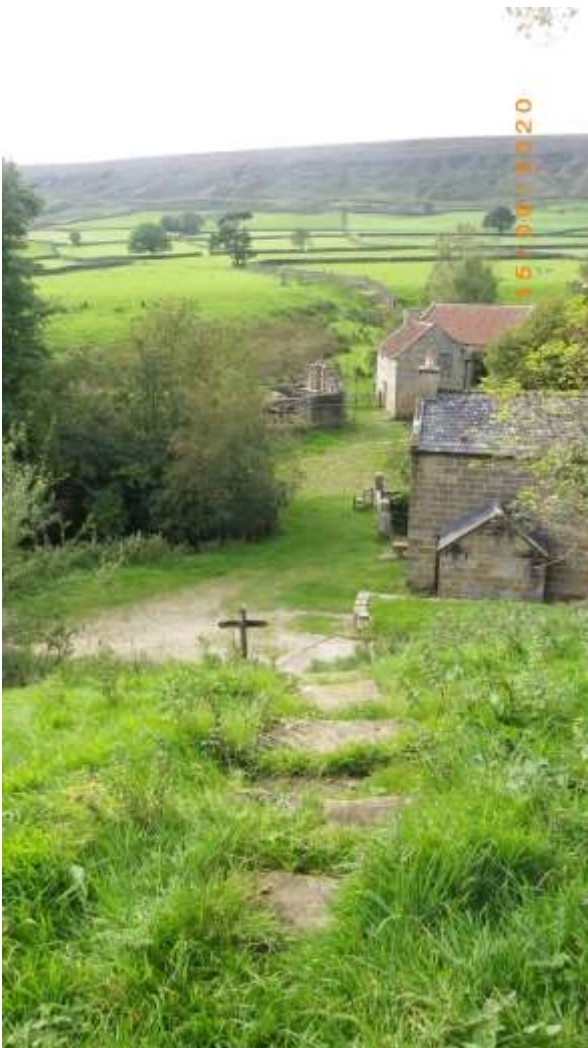
Photo 139 Bransdale Mill buildings and note PROW sign for footpaths and bridleways.

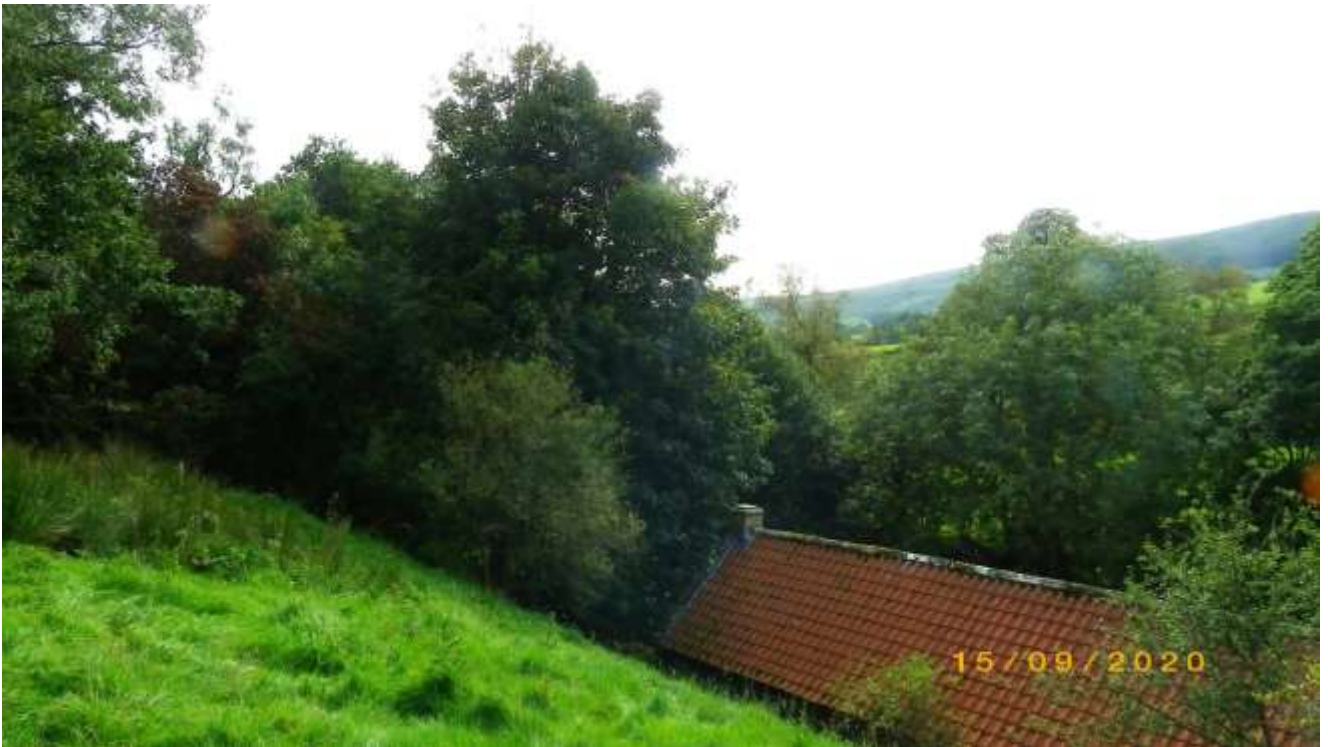
Photo 140 Cpt9a on a west facing slope down to Hodge Beck

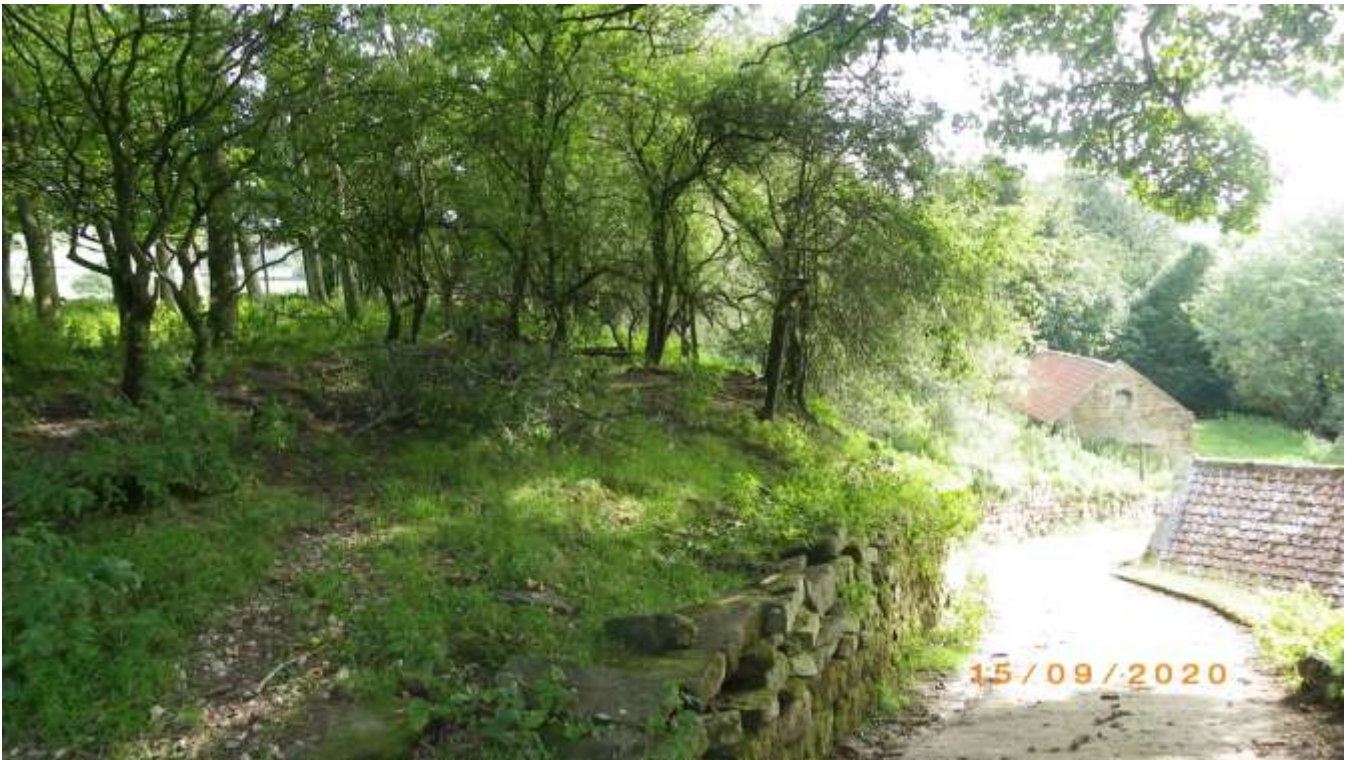
Photo 149 Cpt9b to the north of 9a and to the east of the track to Bransdale Mill

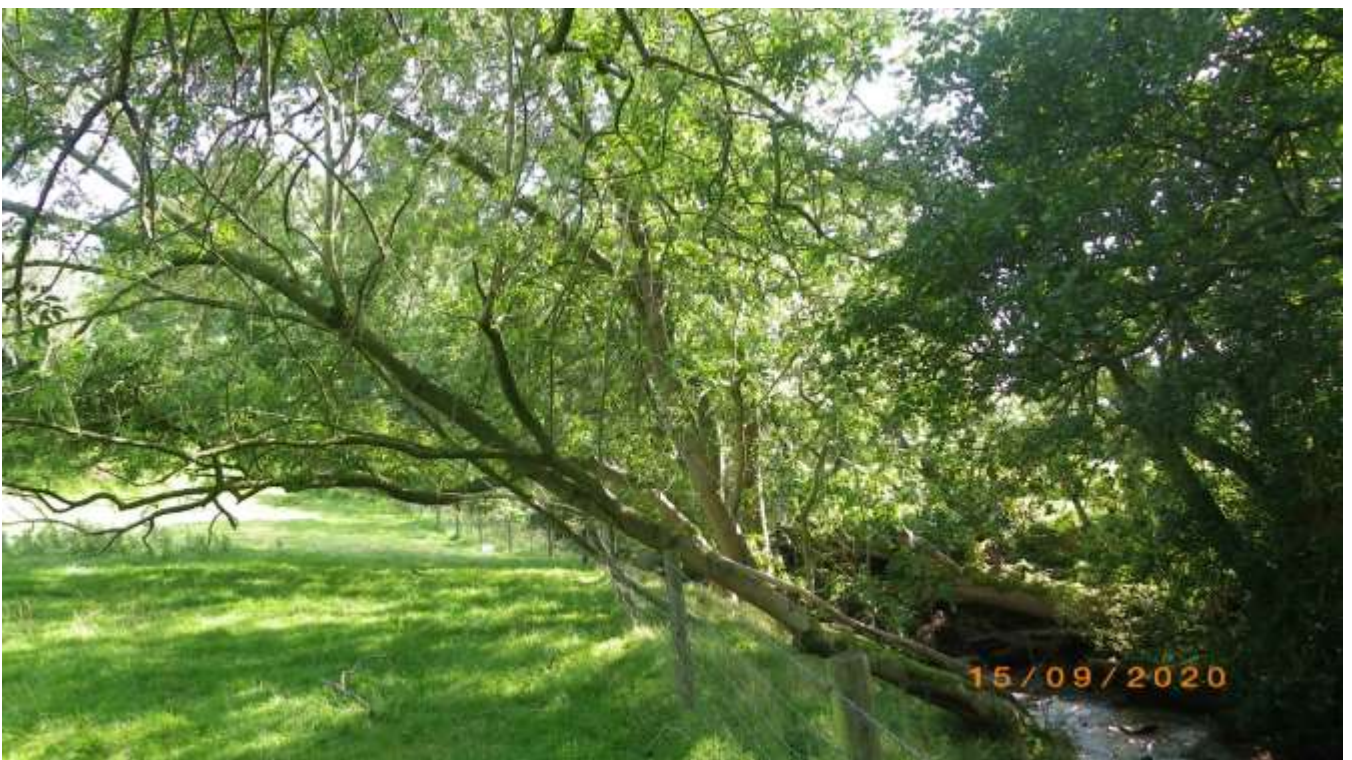
Photo 165 Cpt10b ash with dieback symptoms down on fence; see map 14 for location

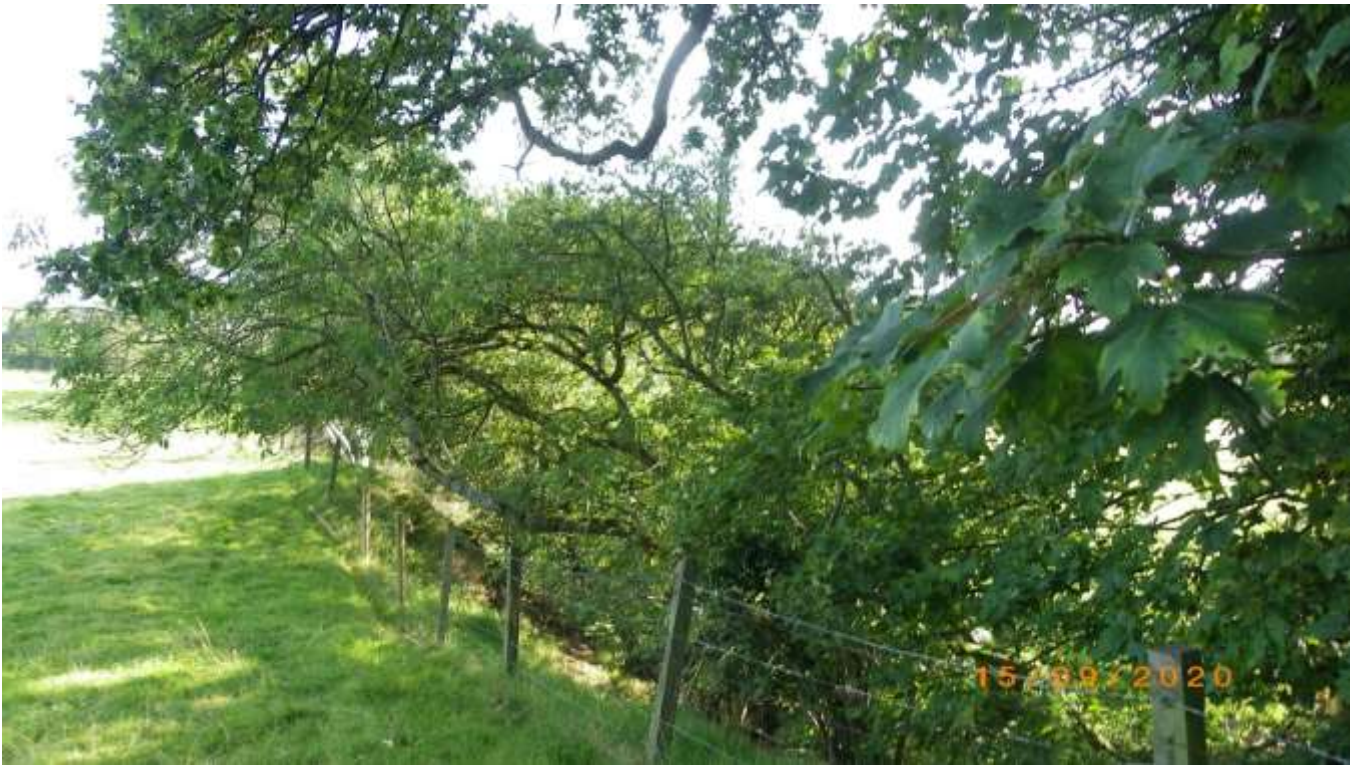
Photo 174 & 175 fencing to Hodge Beck just south of the footbridge between cpt10a & cpt11

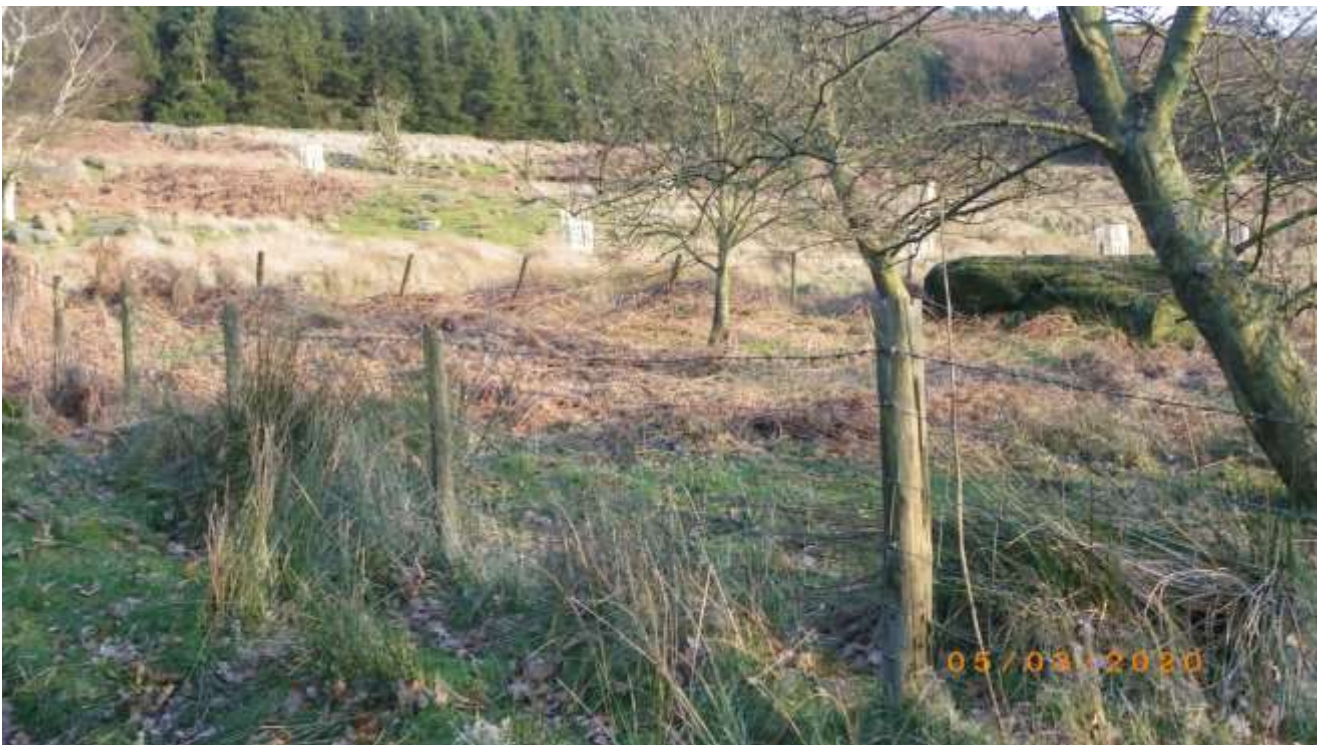
Photo 202 Cpt 13a southern section of planting is a little sparser than the rest of the wood

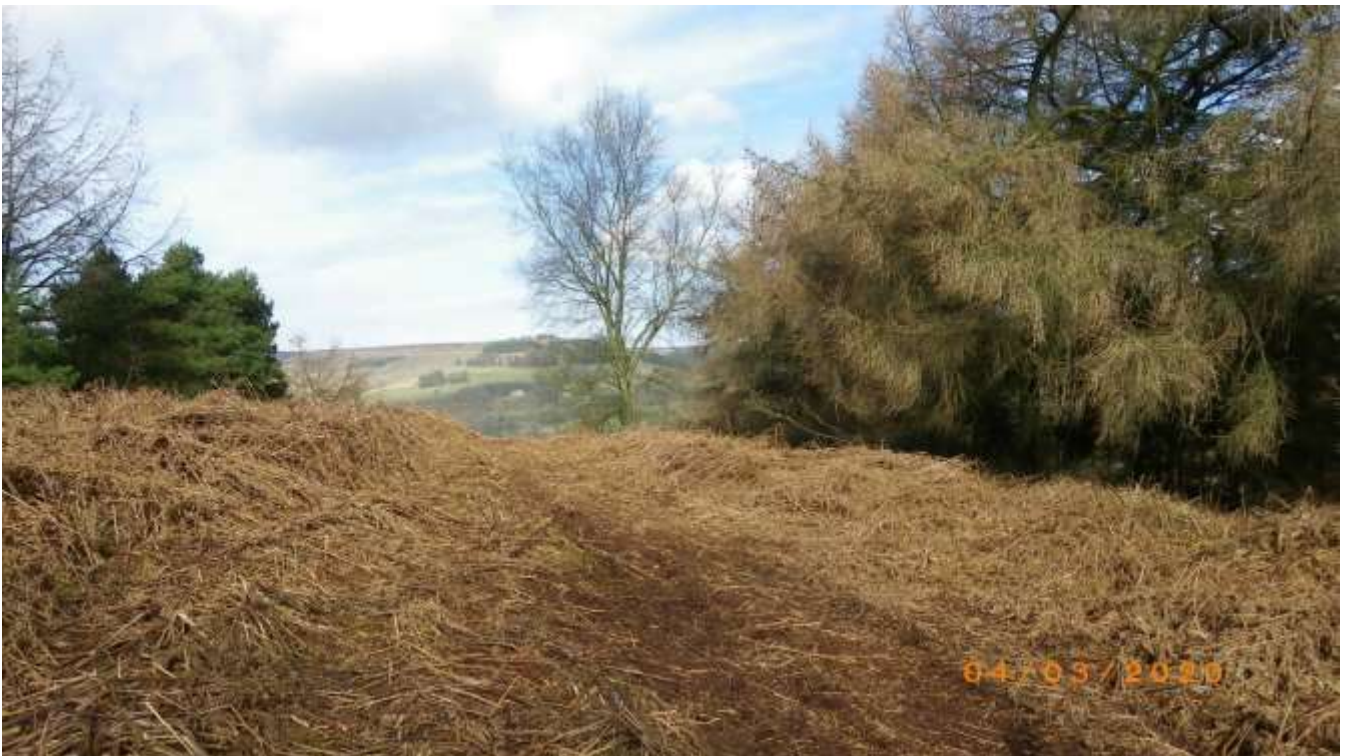
Photo 208 Cpt 14a Barker Plantation view point from the northern tip of the wood across the valley; note bracken dense in the open area

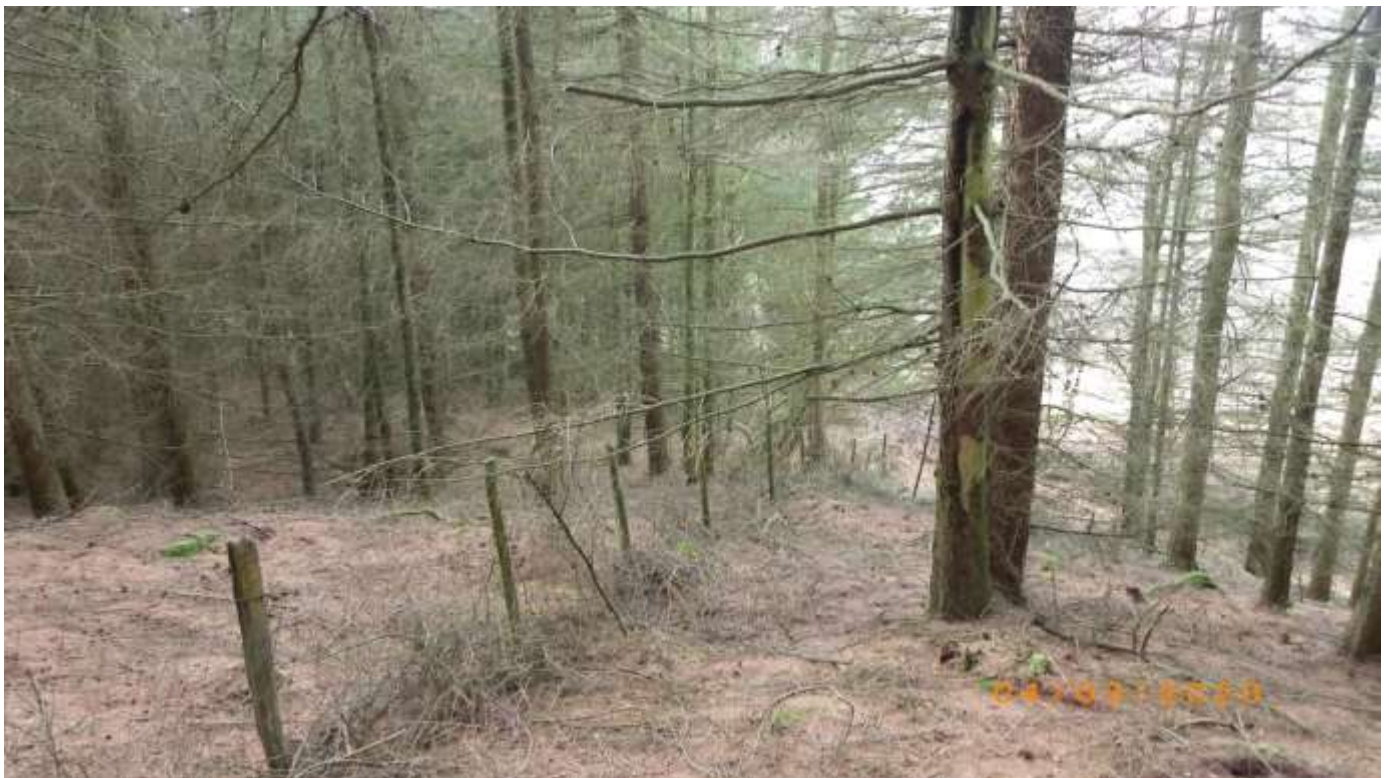
Photo 218 Barker Plantation old rabbit fence between cpt14a the larch to cpt14b pine on a west facing slope

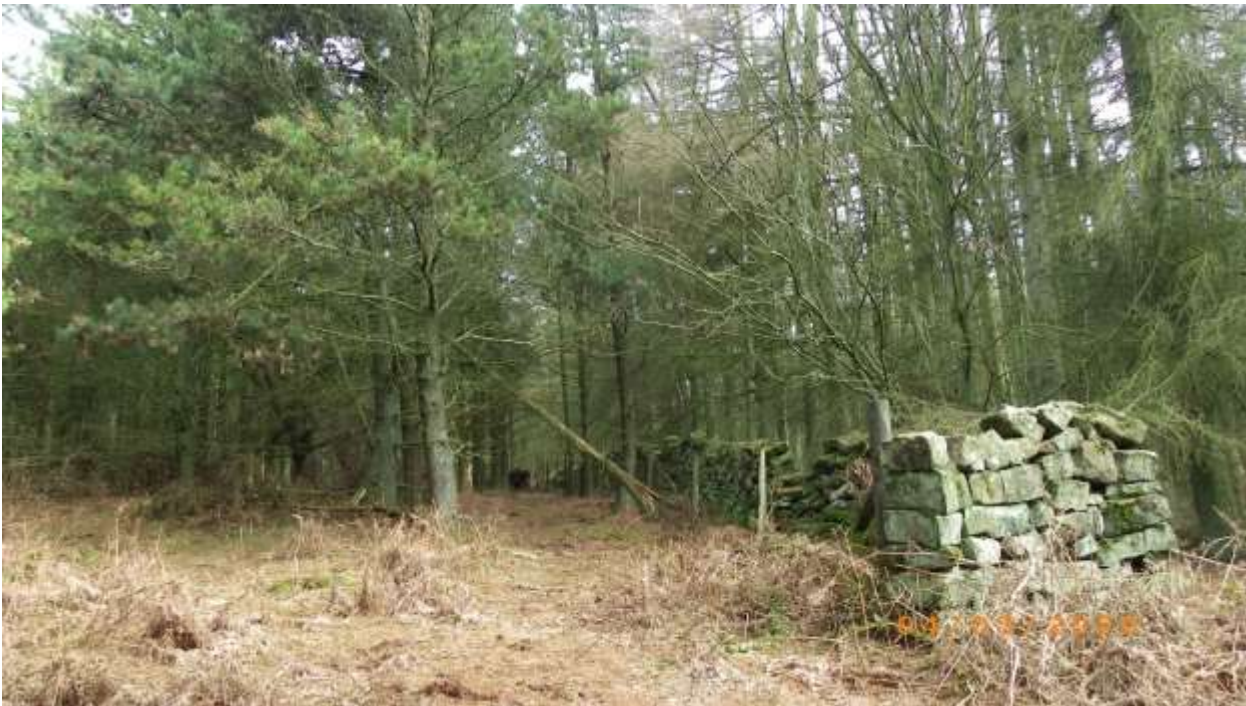
Photo 228 Barker Plantation boundary wall between NT property & Forest England property showing there is no windbreak between the two crops so once FE clear fell cpt14b is likely to suffer significant windblow

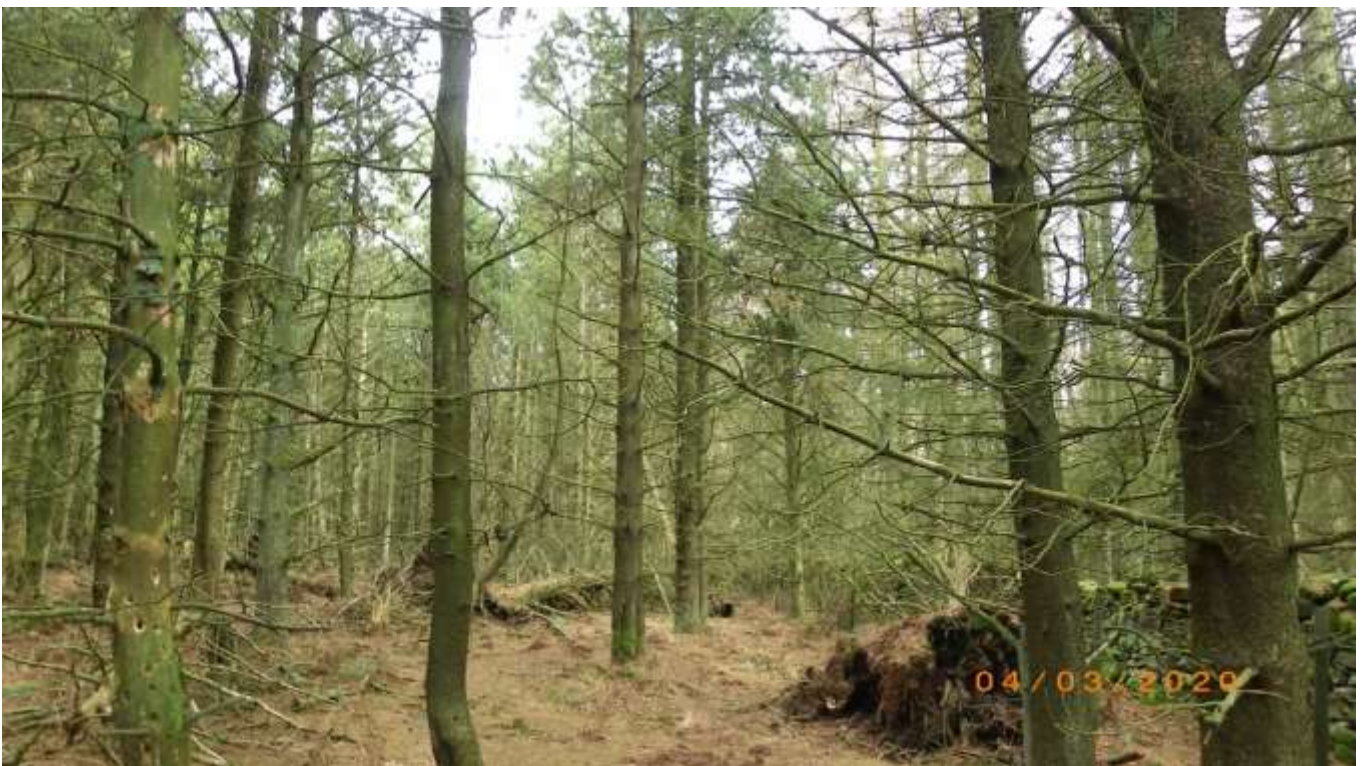
Photo 231 Barker Plantation cpt14b wind blow occurring off the ride at the top of the wood

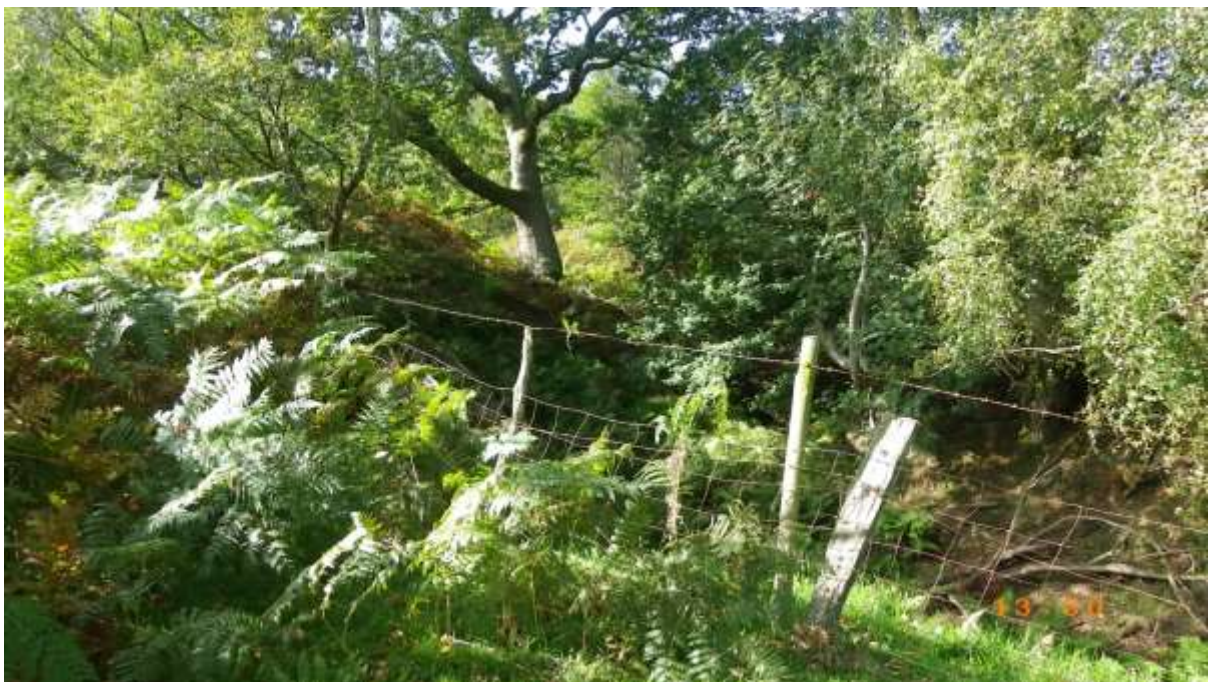
Photo 261 Cpt17c poor fence along the southern boundary.

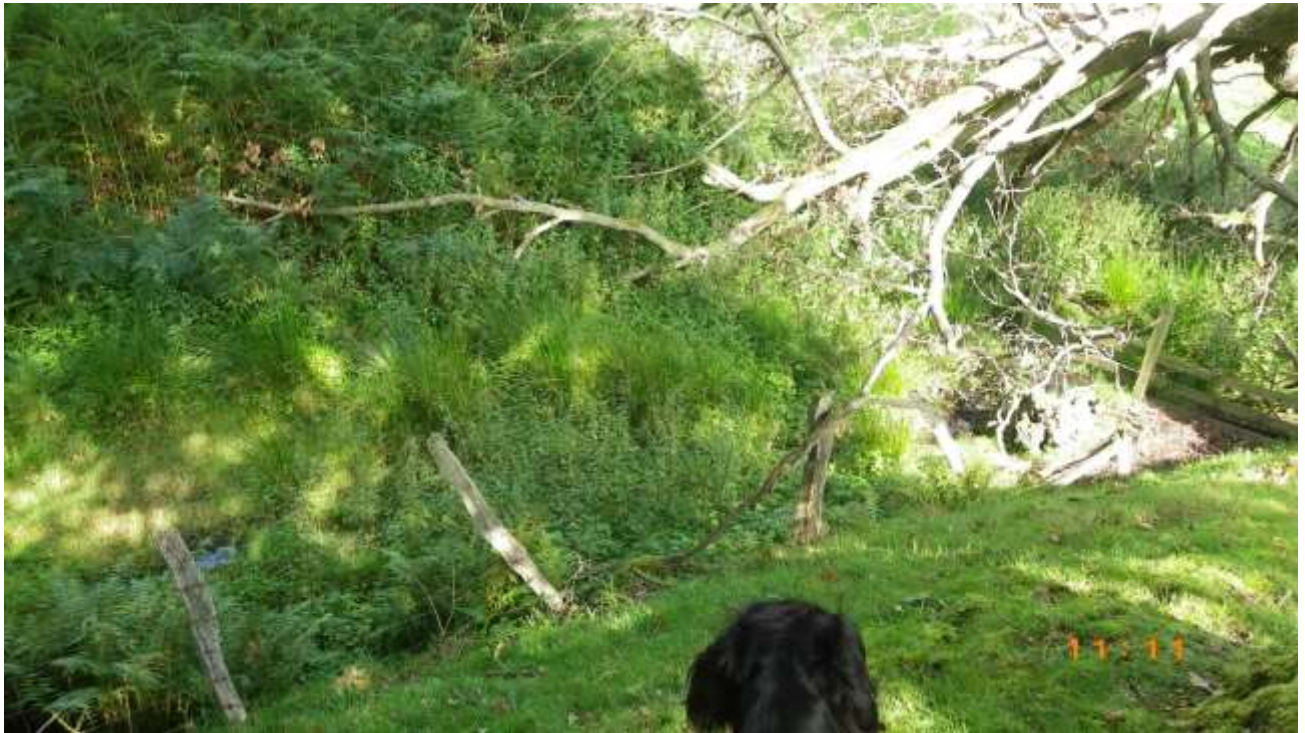
Photo 269 & Cpt19a fence to the south no longer stock proof

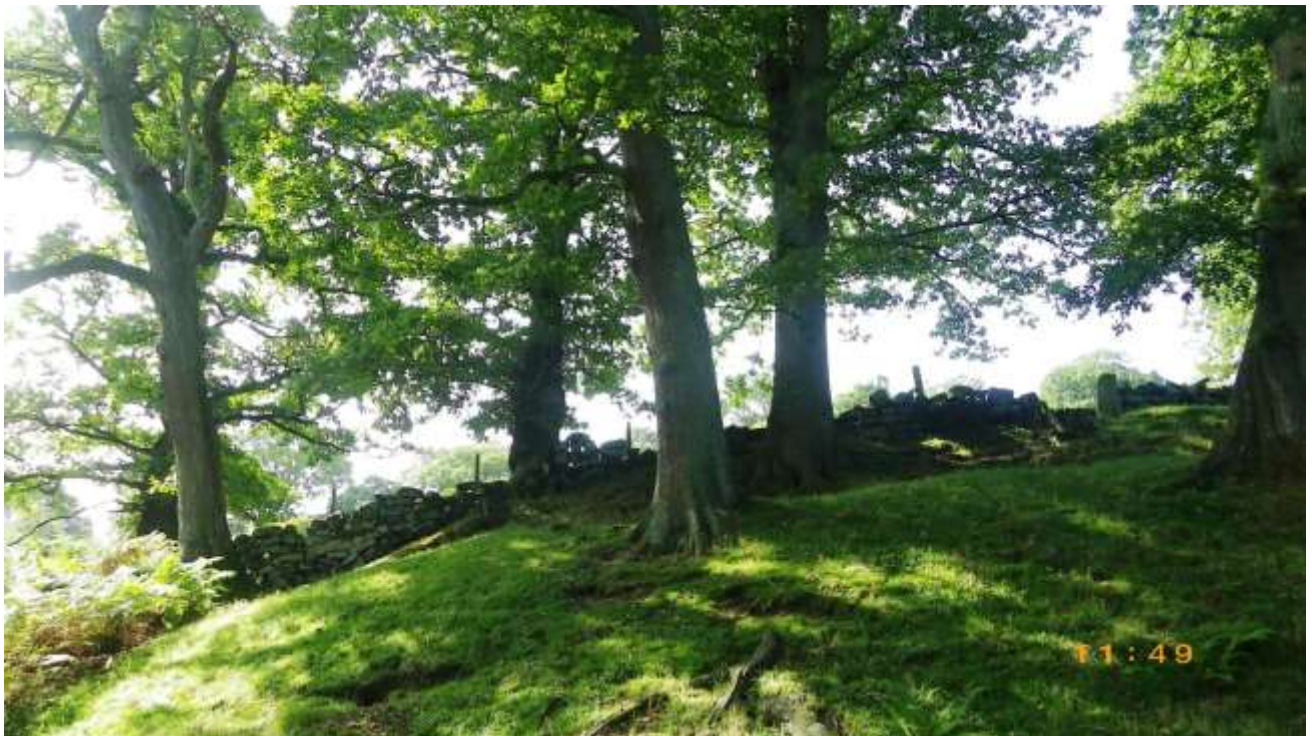
Photo 274 Cpt20a boundary wall with fencing to the s/w boundary; not secure

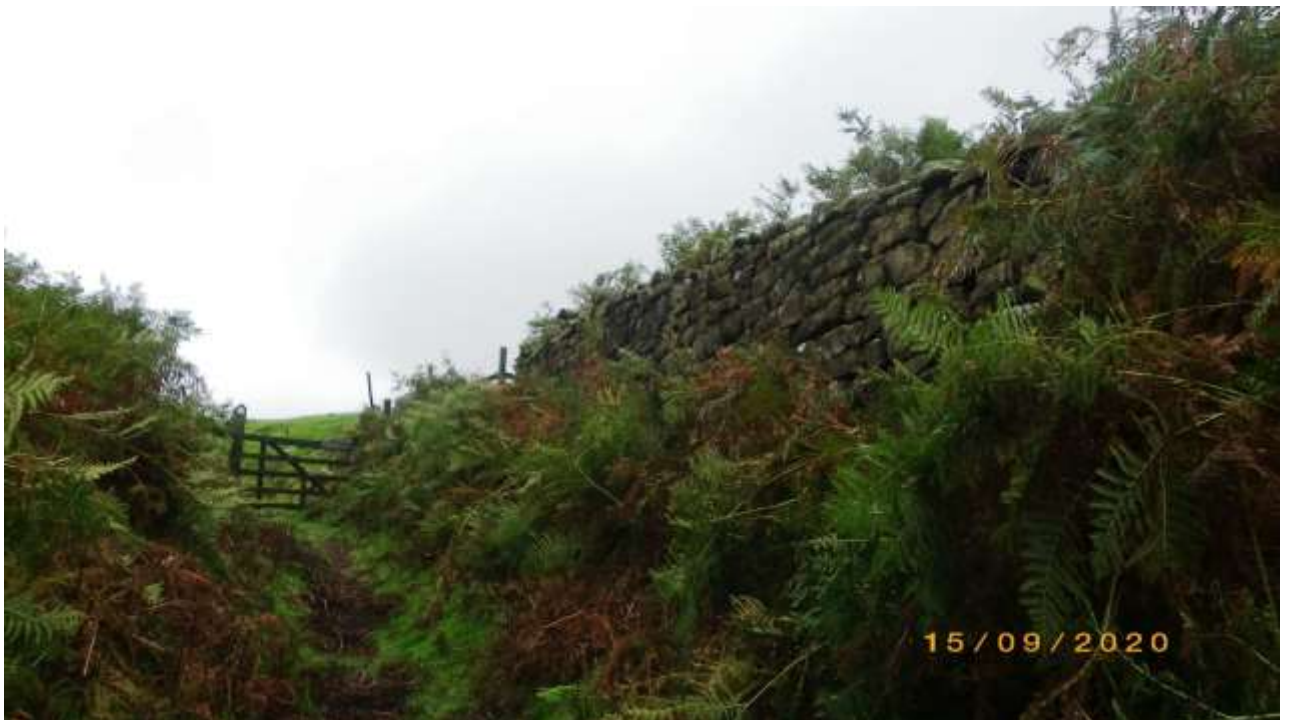
Photo 304 boundary wall to the south west towards Stork House

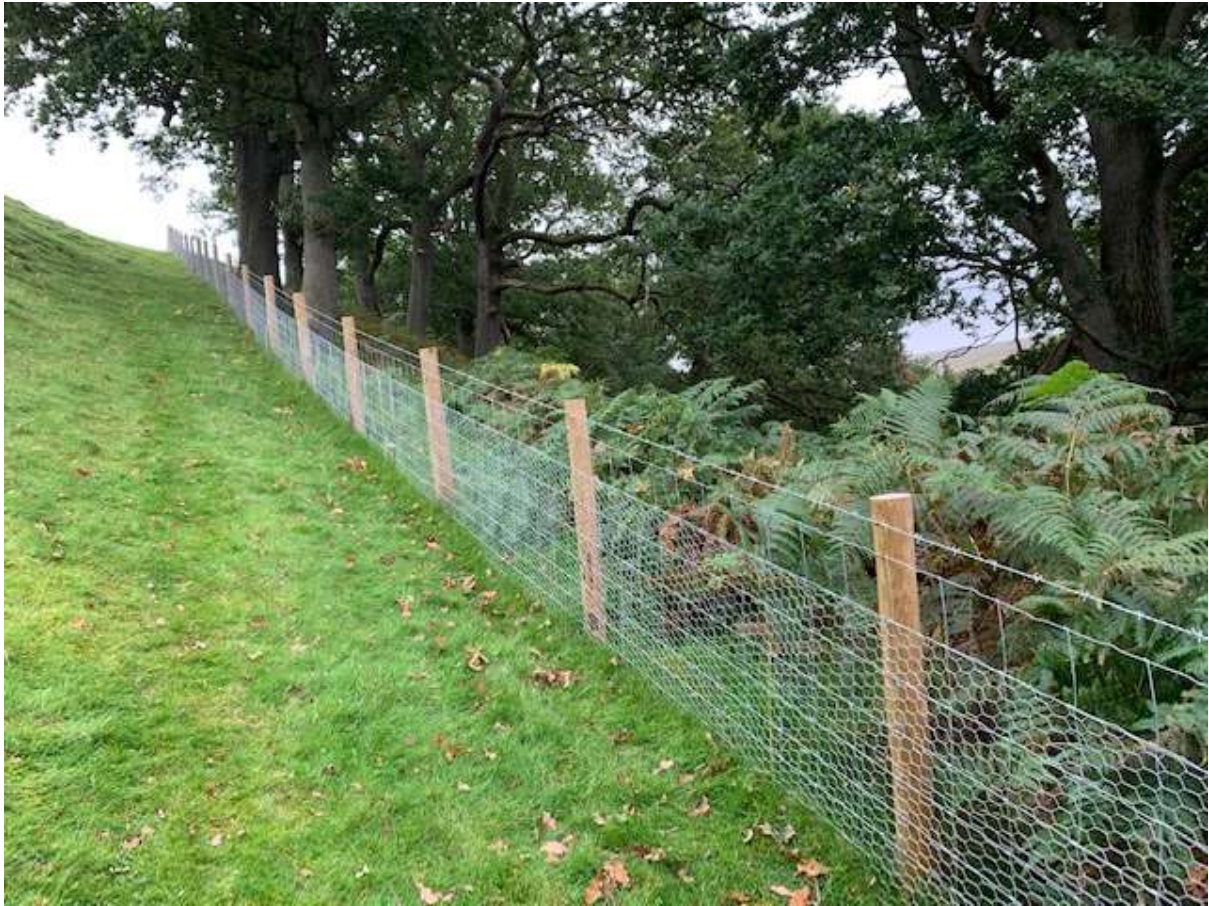
Photo 317 & 318 Cpt22a New stock fencing to the very east of Low Wood
