National Trust Bransdale & Farndale Woodland Management Plan
Photo and Images Gallery 2021

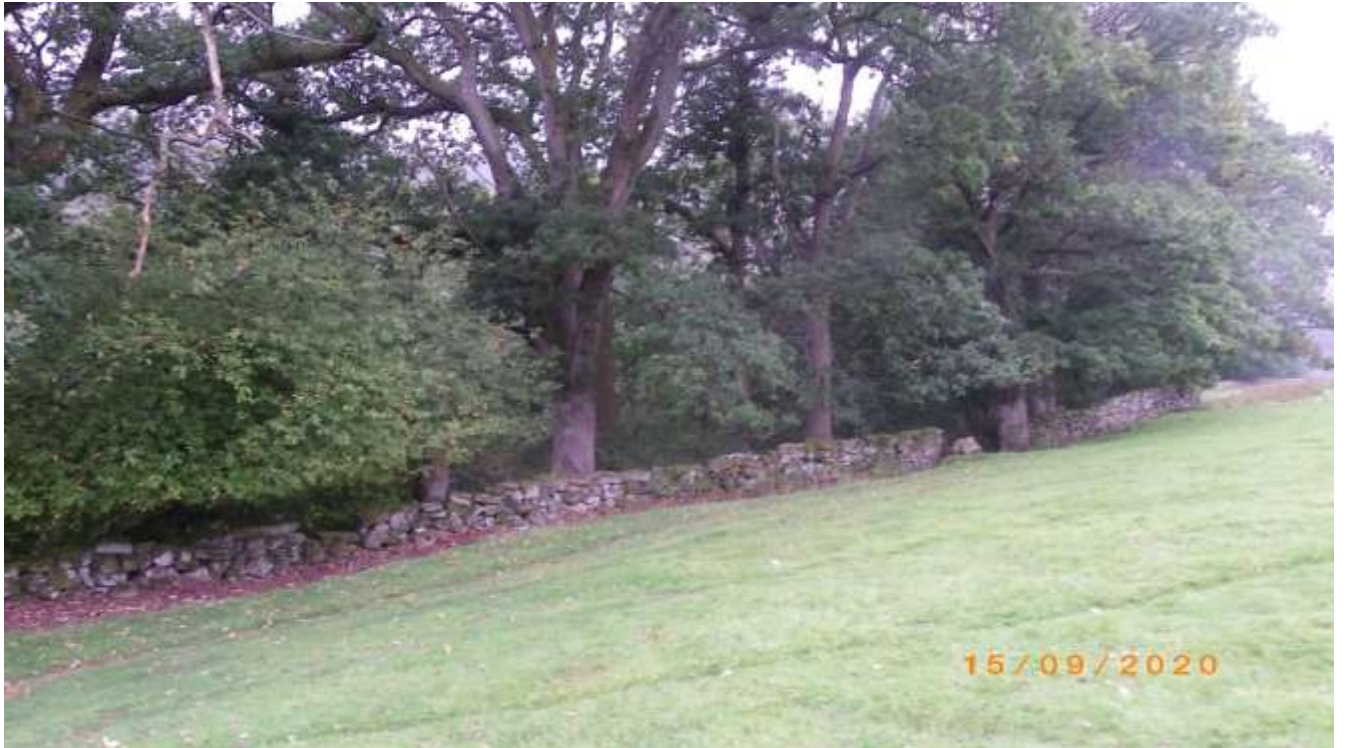
Photo 402 & 403 Cpt22a Low Wood boundary wall collapsed in several places to the north west and the wood is grazed in parts

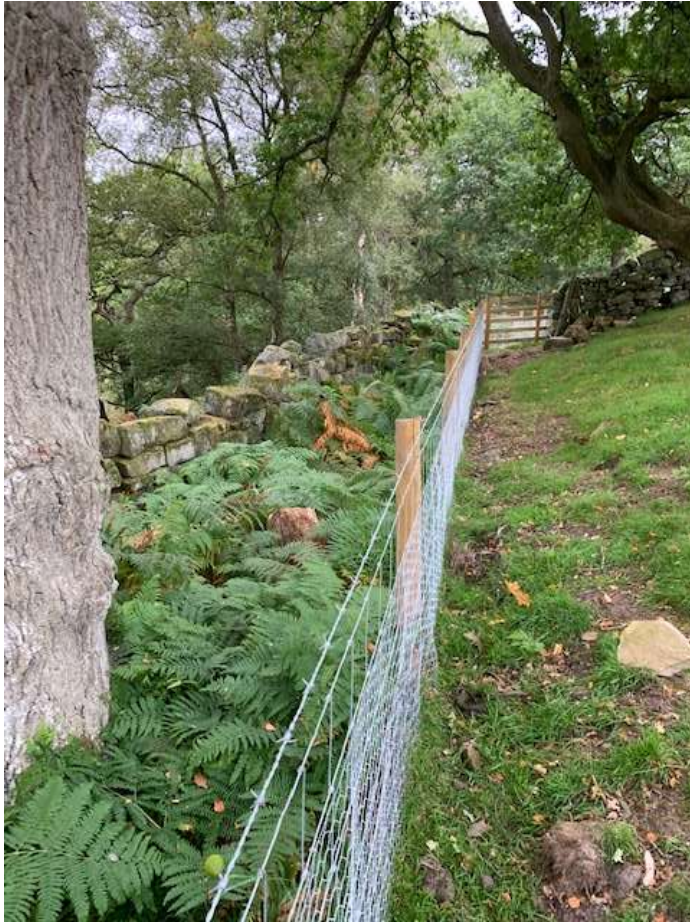
Photo 404 Cpt22a Low Wood new fencing to the eastern boundary on the section of Low Wood flanking Shaw Beck

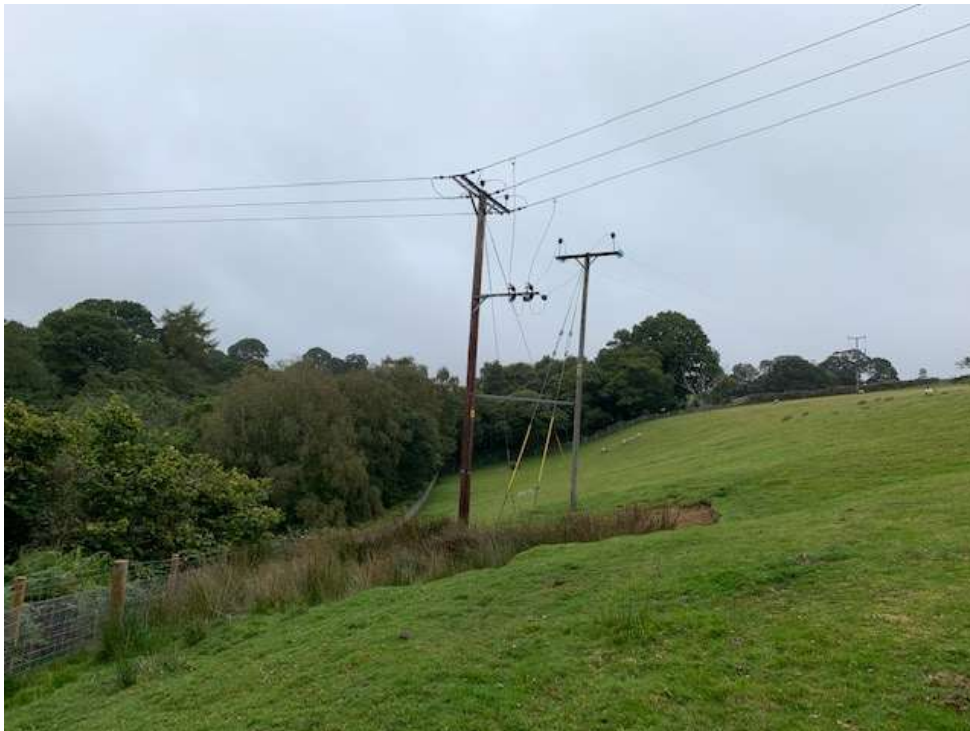
Photo 405 Cpt22a Overhead electric crossing Low Wood

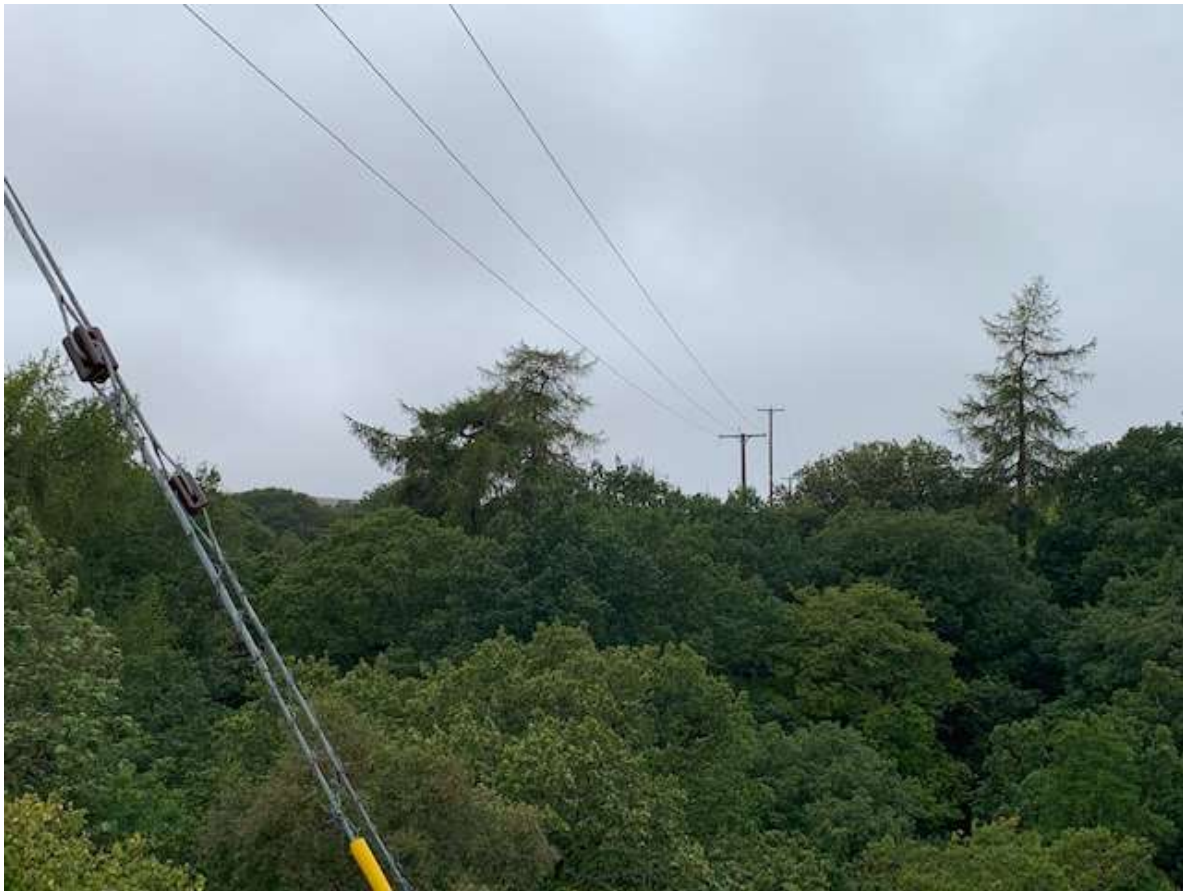
Photo 406 Cpt22a Overhead electric crossing Low Wood; larch in the canopy (minor species)

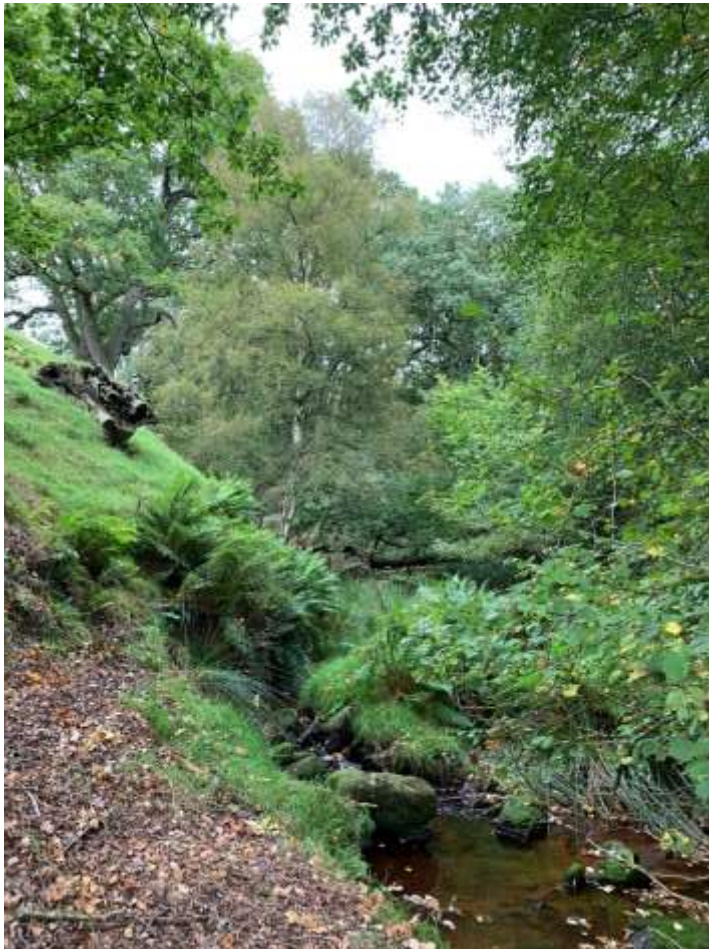
Photo 422 & 423 Cpt24a Shawbeck Wood no fence to the s/w boundary field

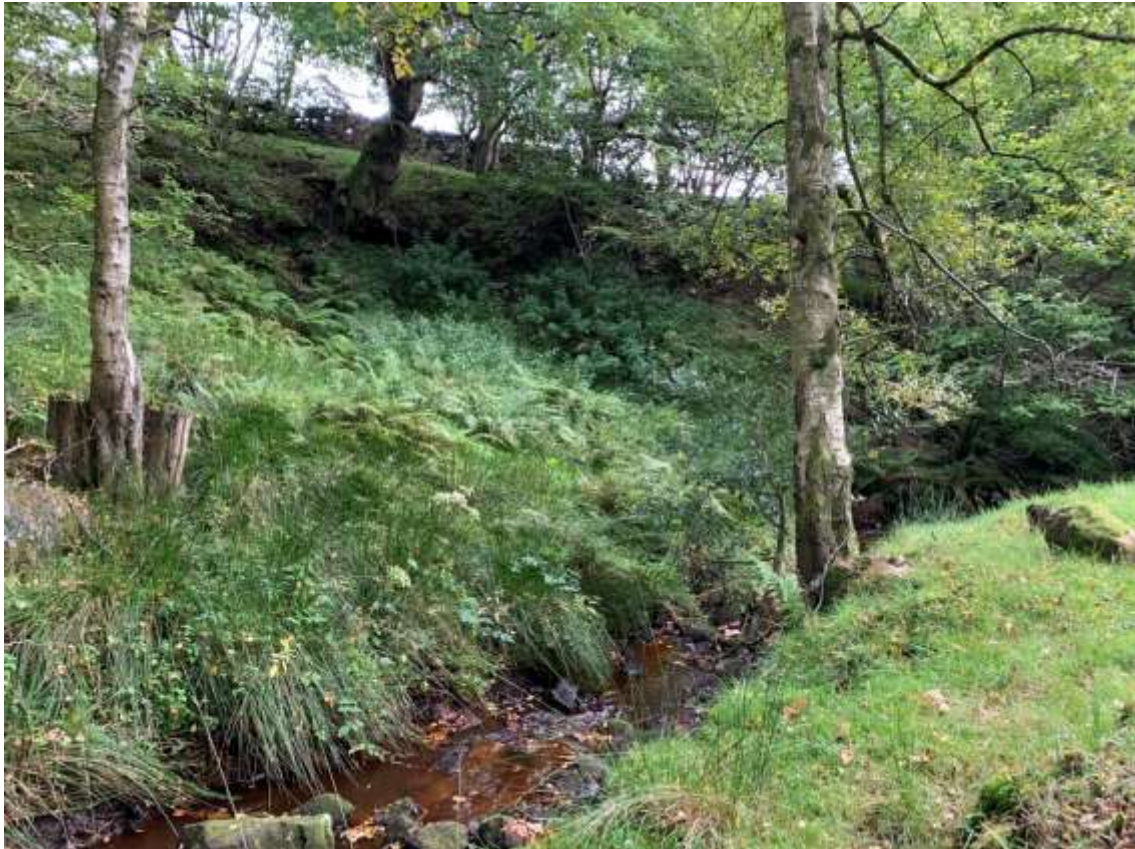
Photo 424 Cpt24a Shawbeck Wood wall boundary to s/e

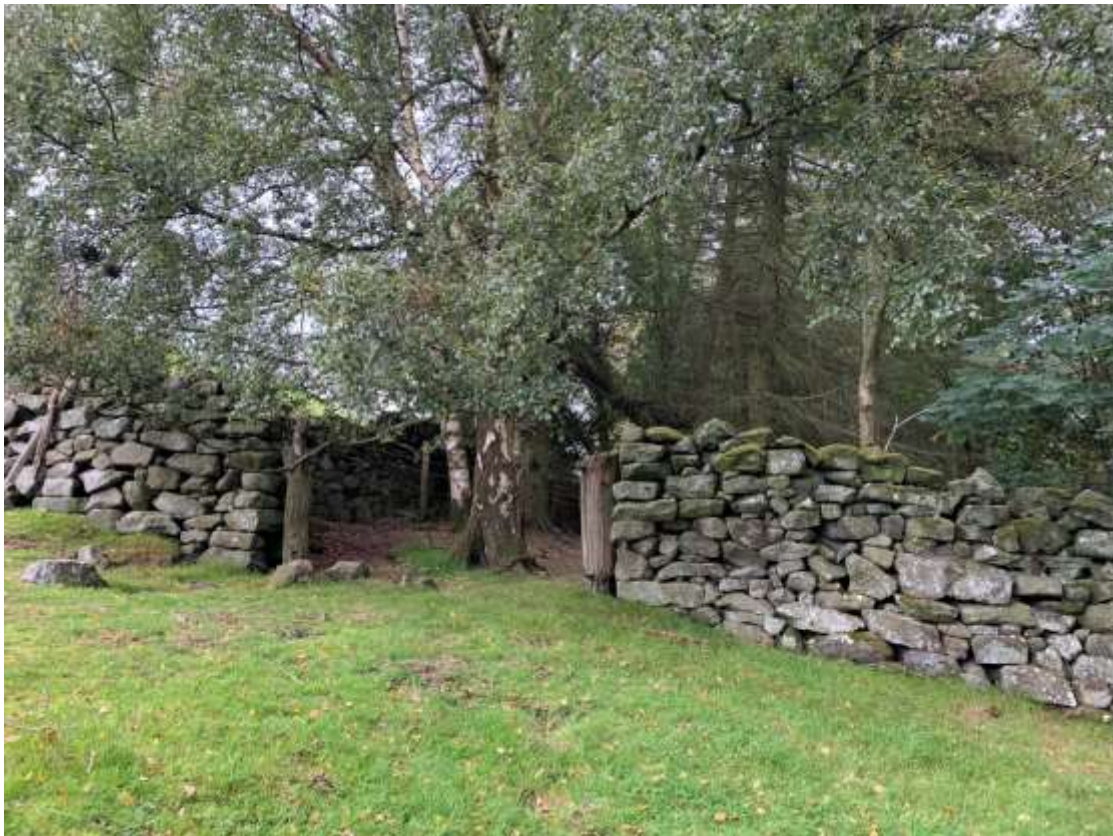
Photo 425 Cpt24a Shawbeck Wood boundary wall on east of wood not stock proof

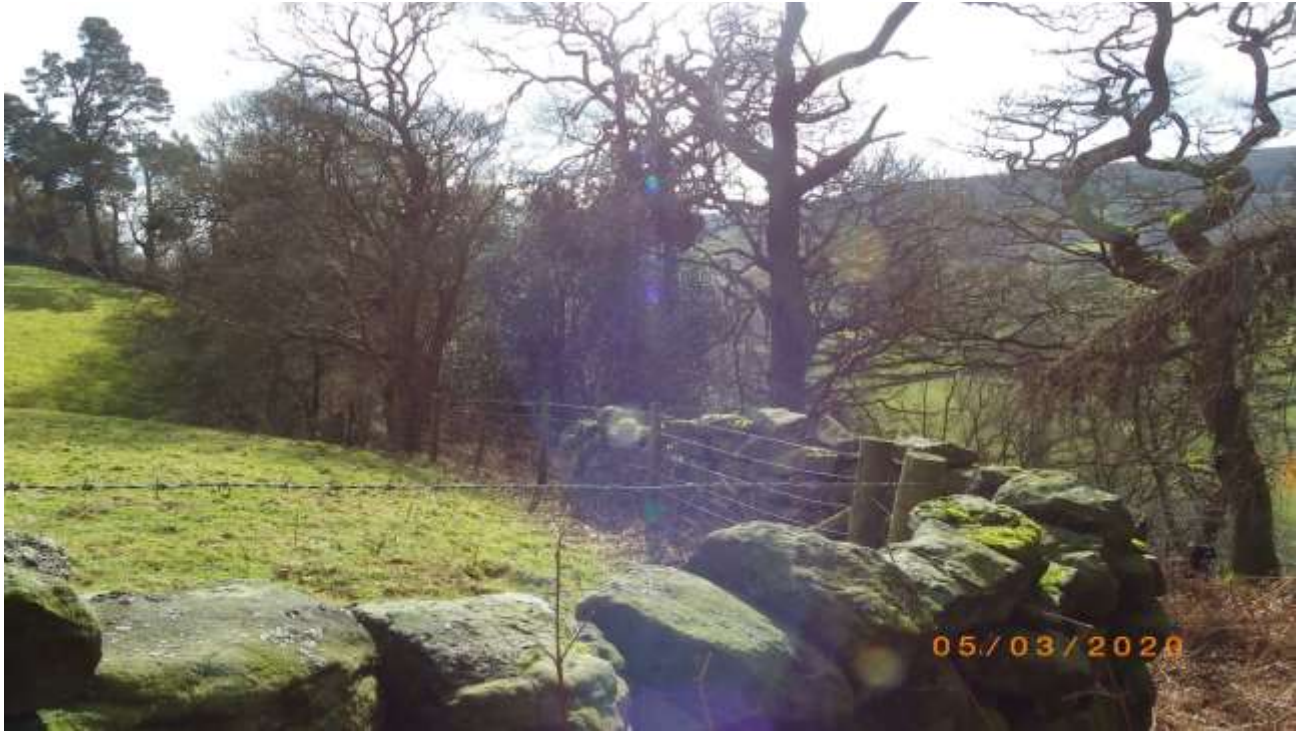
Photo 436 & 437 Cpt26 Sonley Woodland old wall boundaries mostly fenced to the field side or with top wires.

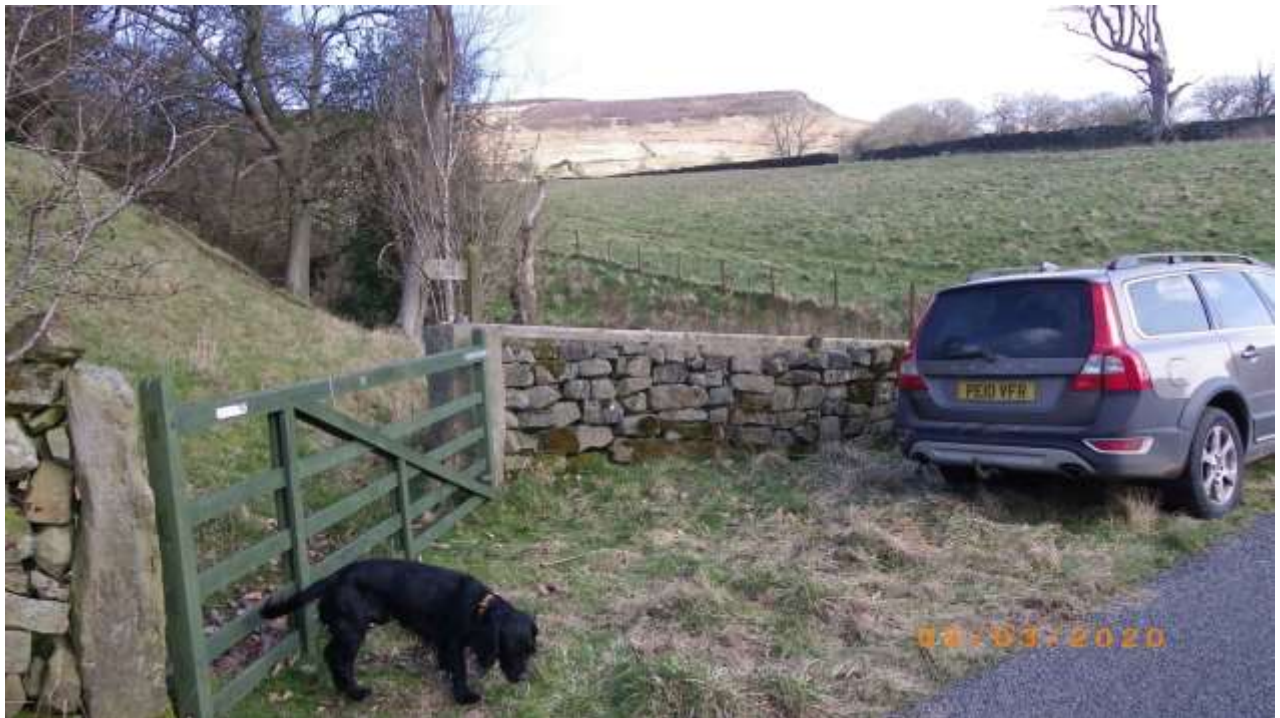
Photo 440 Cpt27 Sike Wood entrance area to the wood and adjacent public footpath route

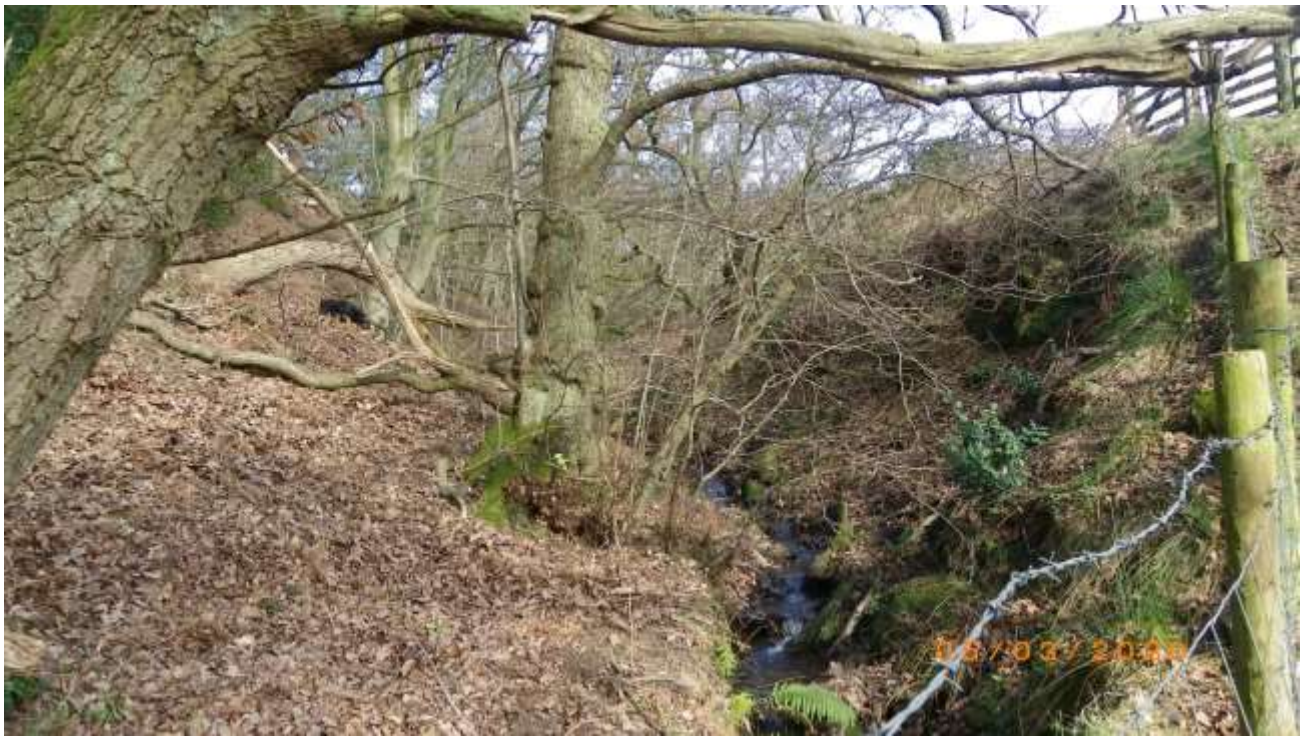
Photo 443 & 444 Cpt27 Sike Wood mature woodland along a narrow watercourse

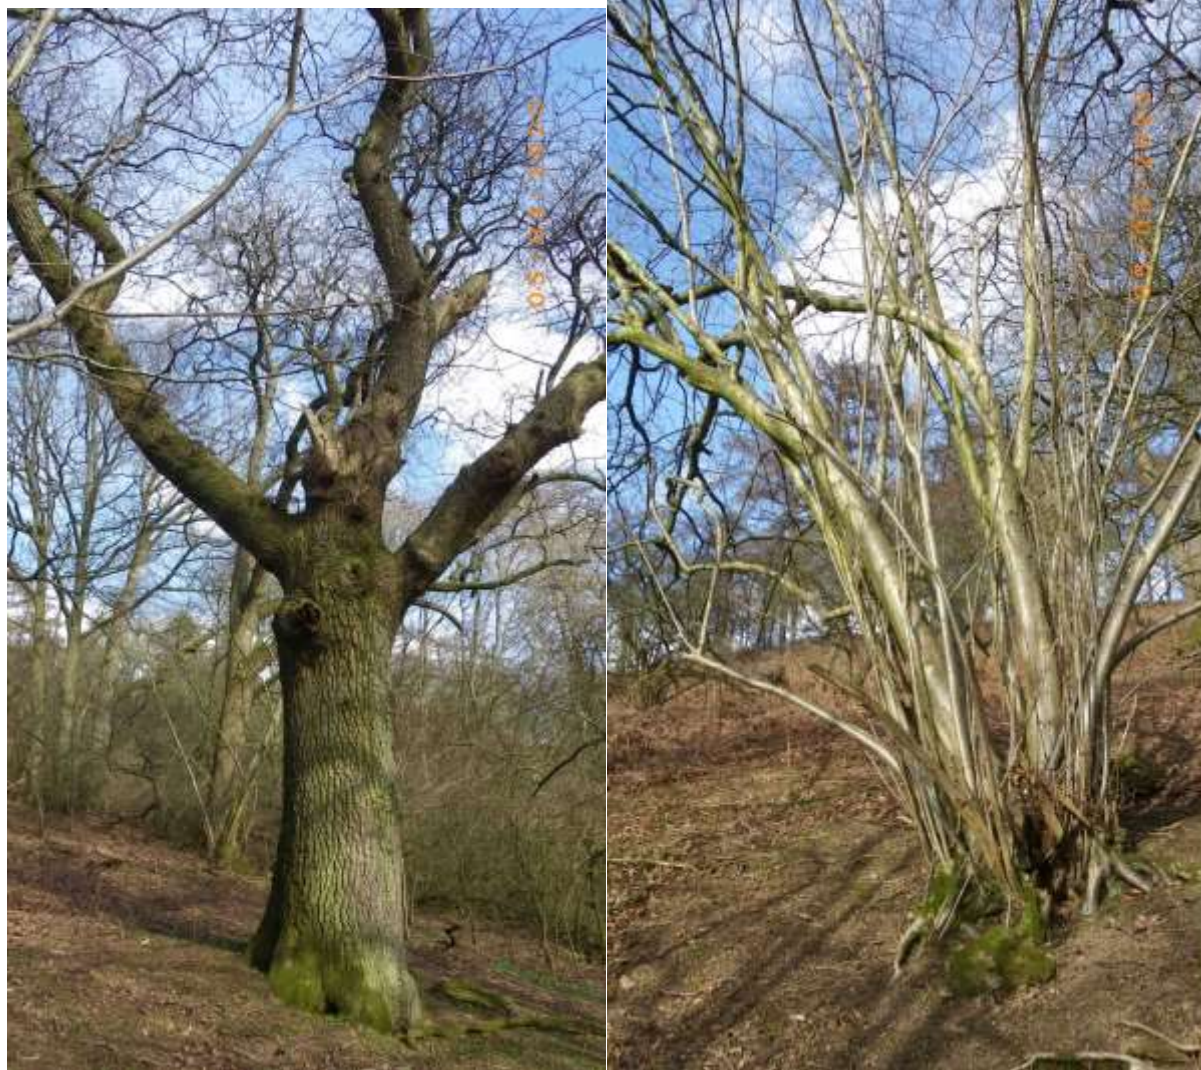
Photo 452 & 453 Cpt28 Hall Wood mature oaks with hazel within the woodland

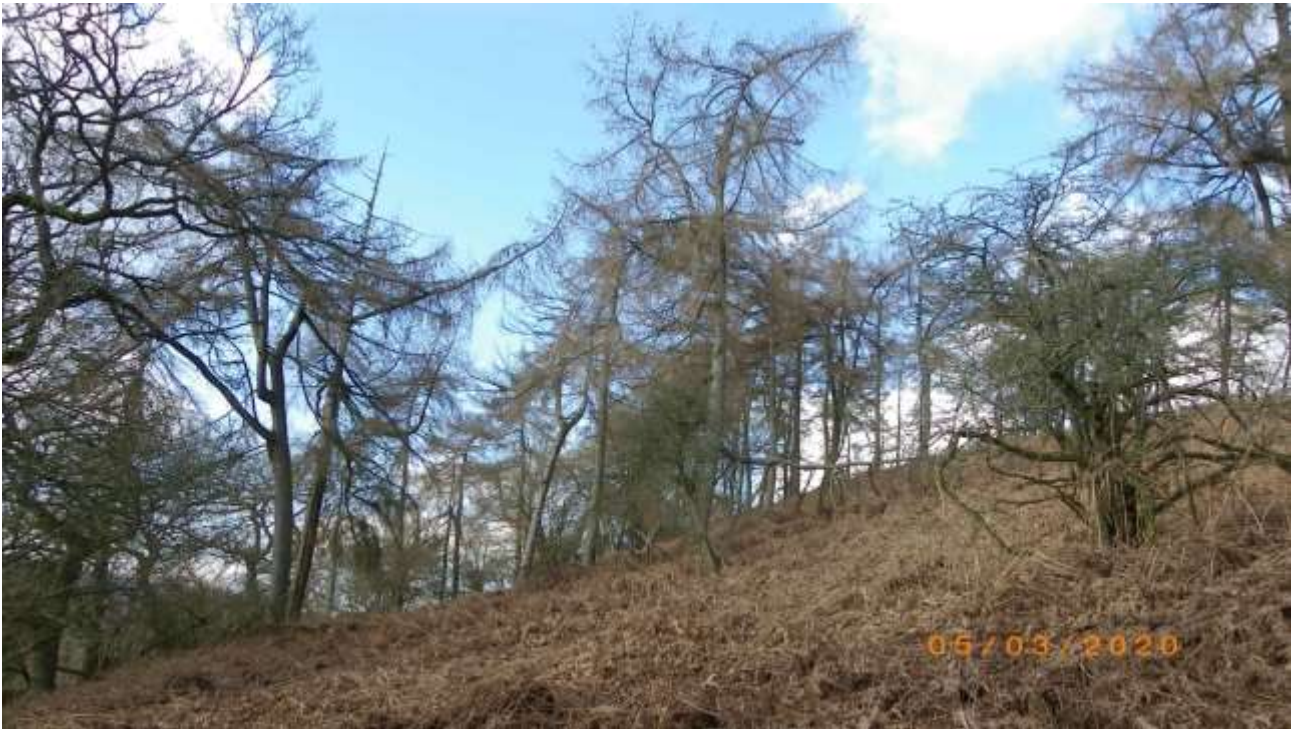
Photo 454 & 455 Cpt28 Hall Wood mature large with bracken dominant in more open areas

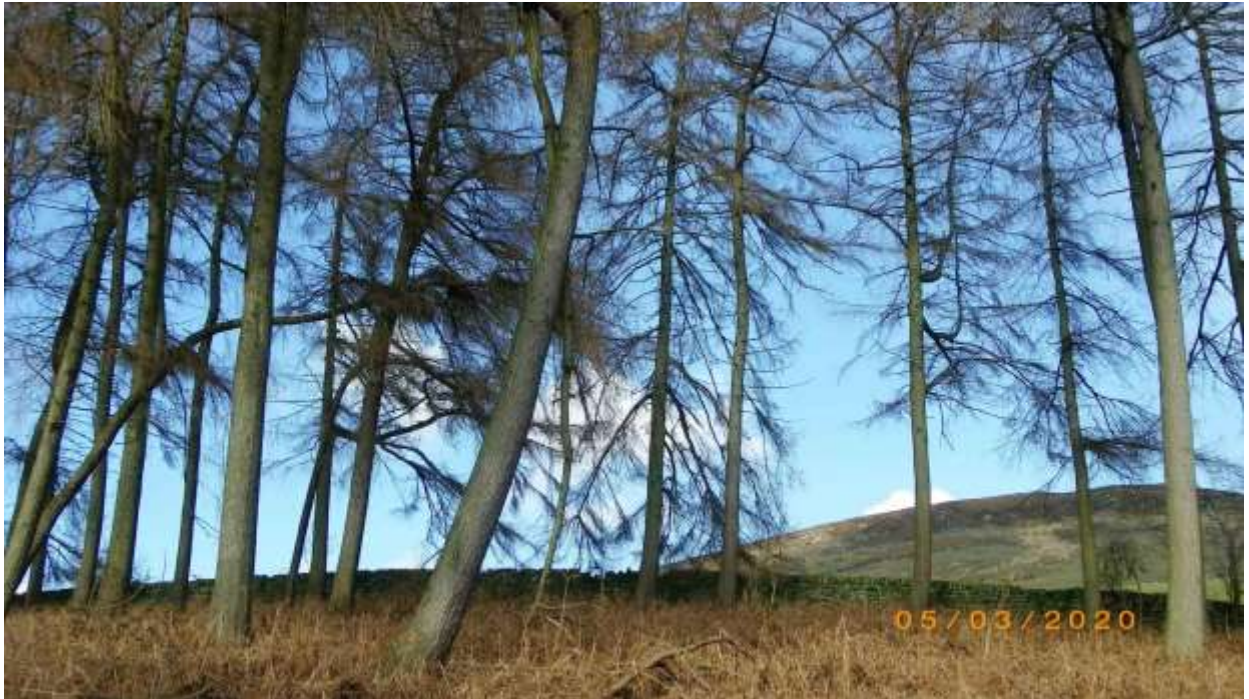
Photo 456 Cpt28 Hall Wood wall boundaries to the north and north east of the wood

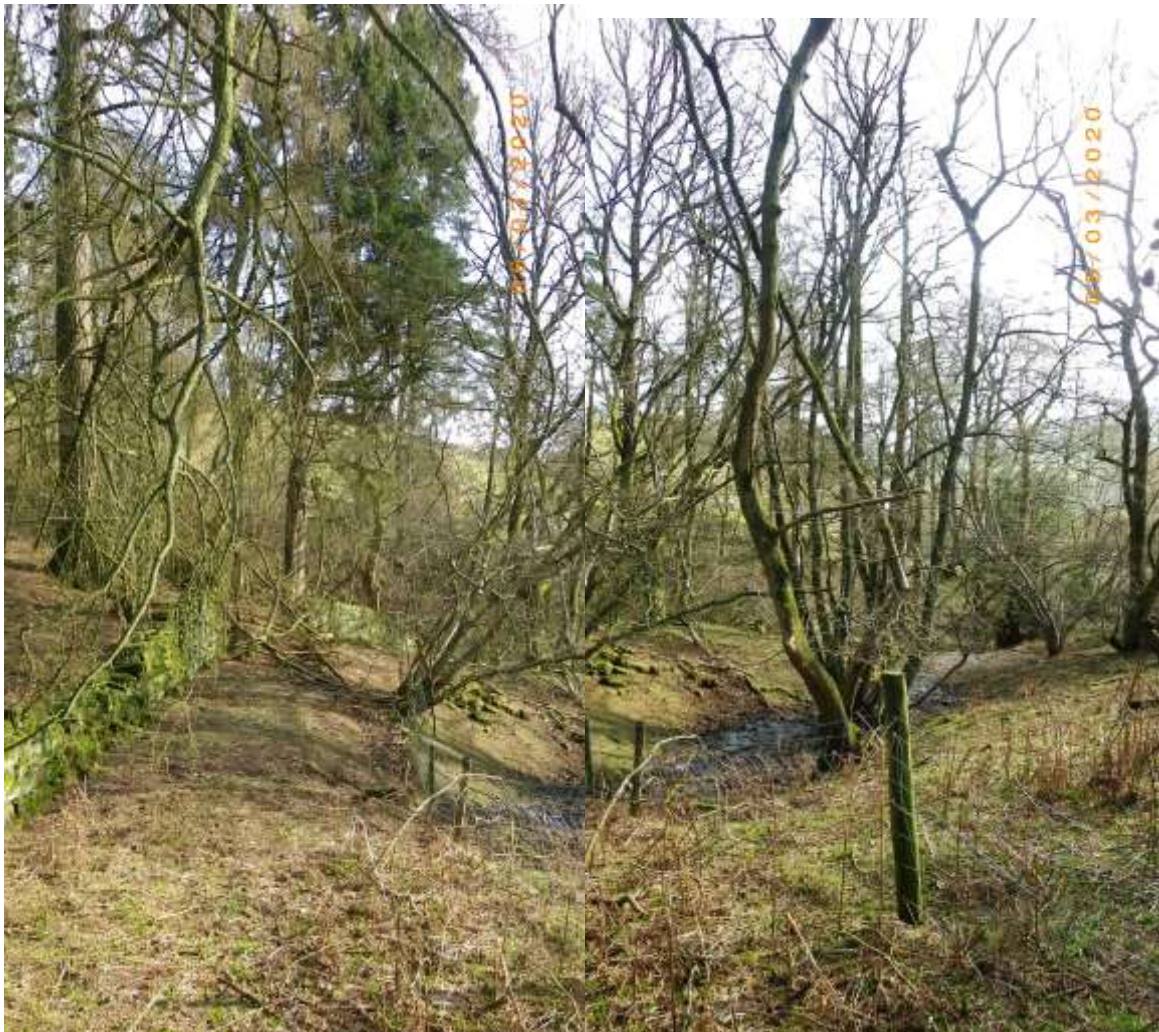
Photo 457 & 458 Hall Wood third party access across the wood with stock net to south

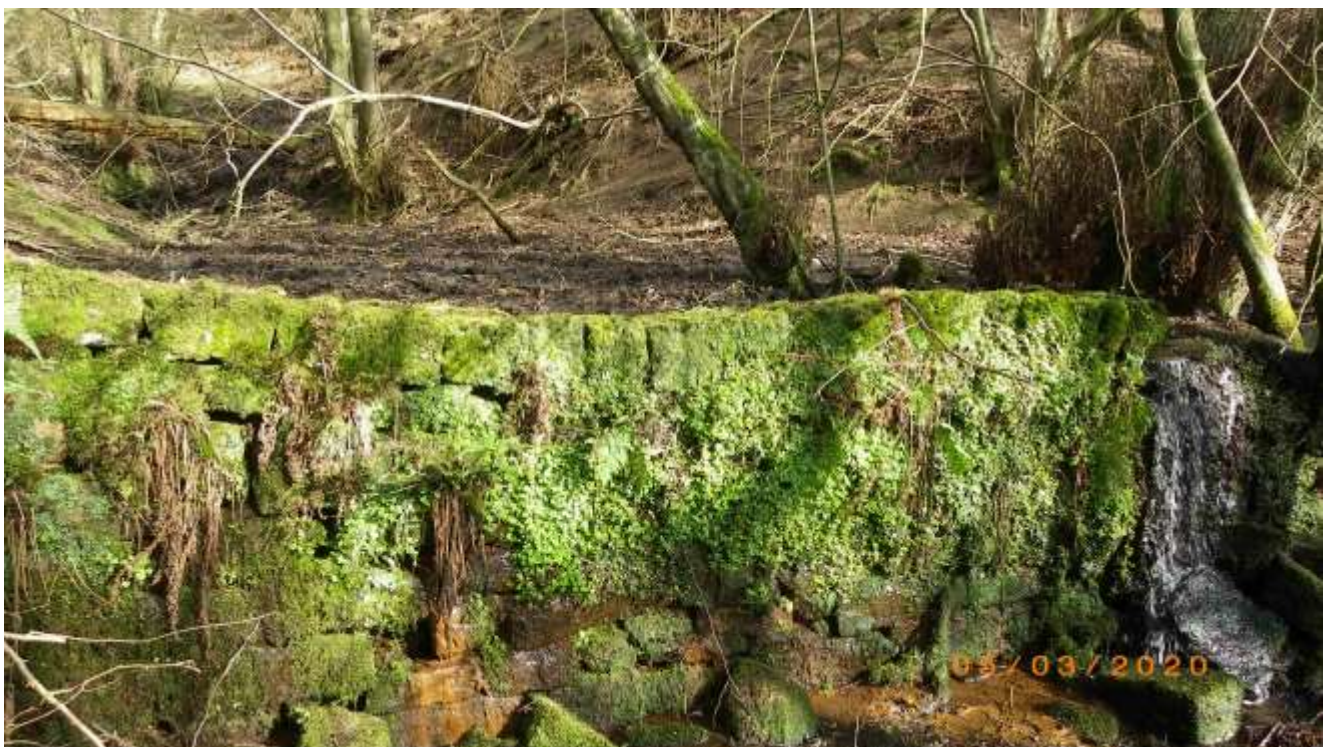
Photo 460 Cpt28 Hall Wood watercourse going over the top rather than using culvert
