National Trust Bransdale & Farndale Woodland Management Plan
Photo and Images Gallery 2021

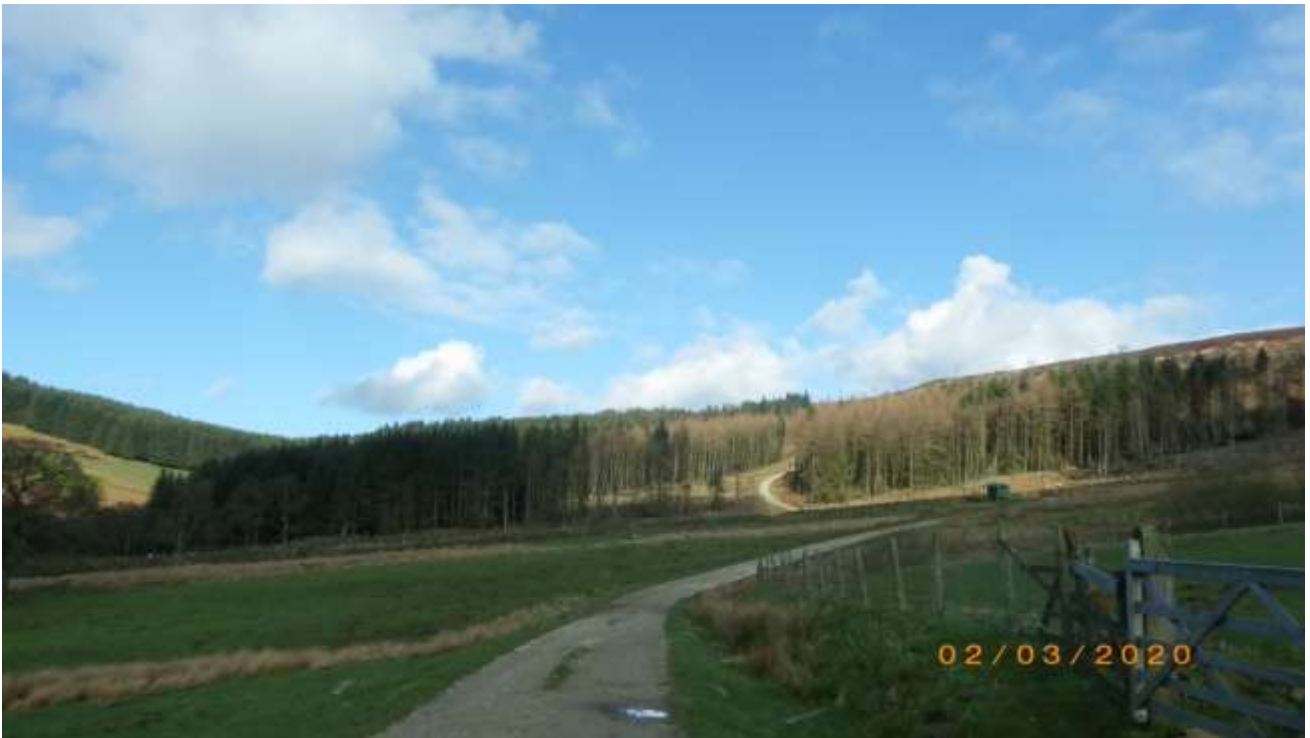
Photo 1 View of the southern edge of cpt1a & 1b; access road good.

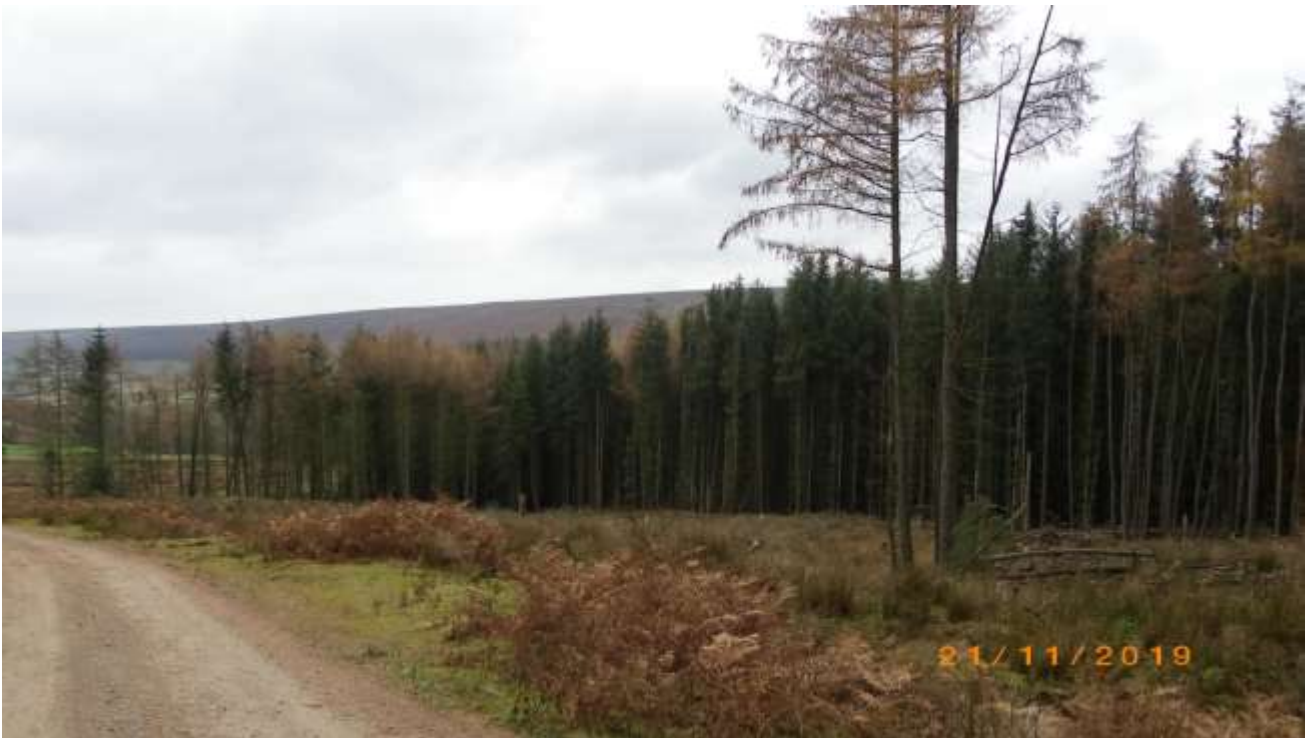
Photo 2 Cpt1a open ground felled by FE in error

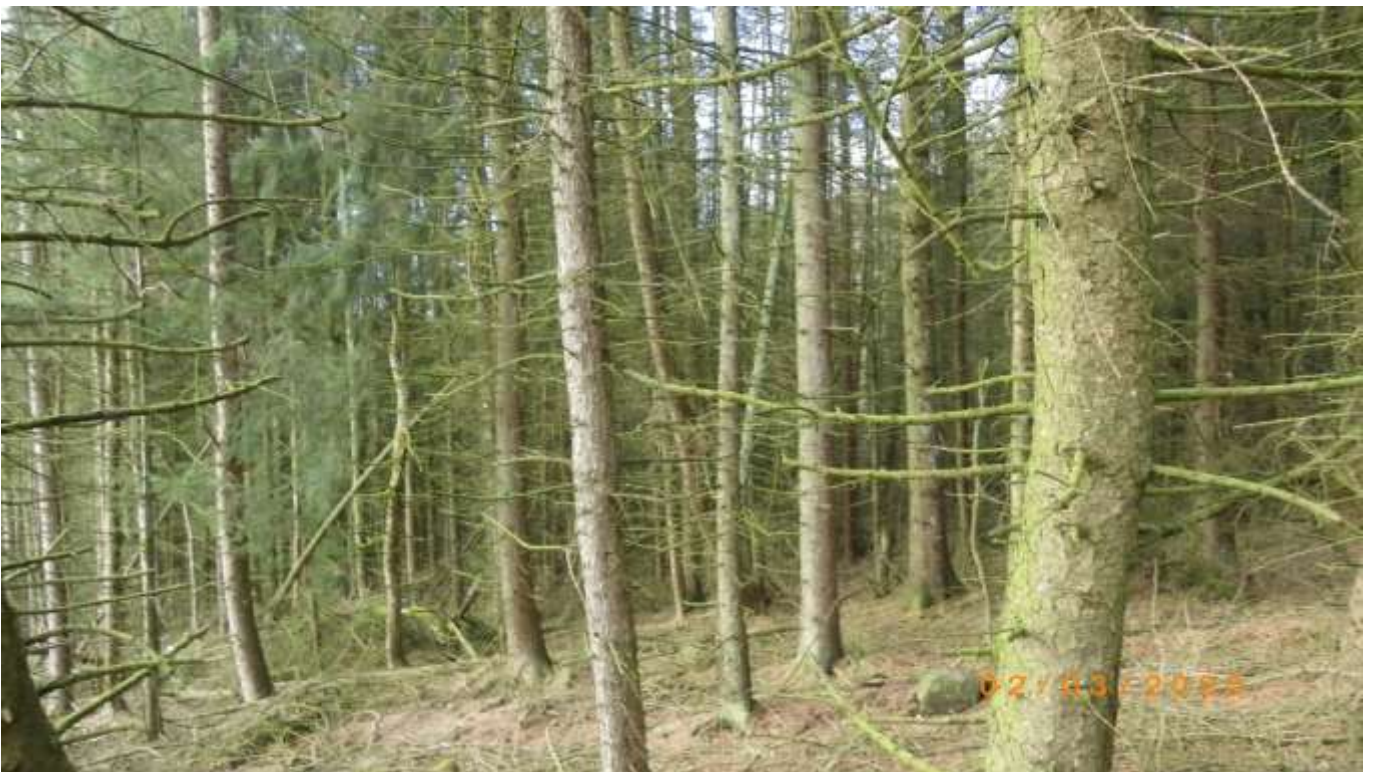
Photo 4 Cpt1a unthinned spruce and larch with pockets of windblow

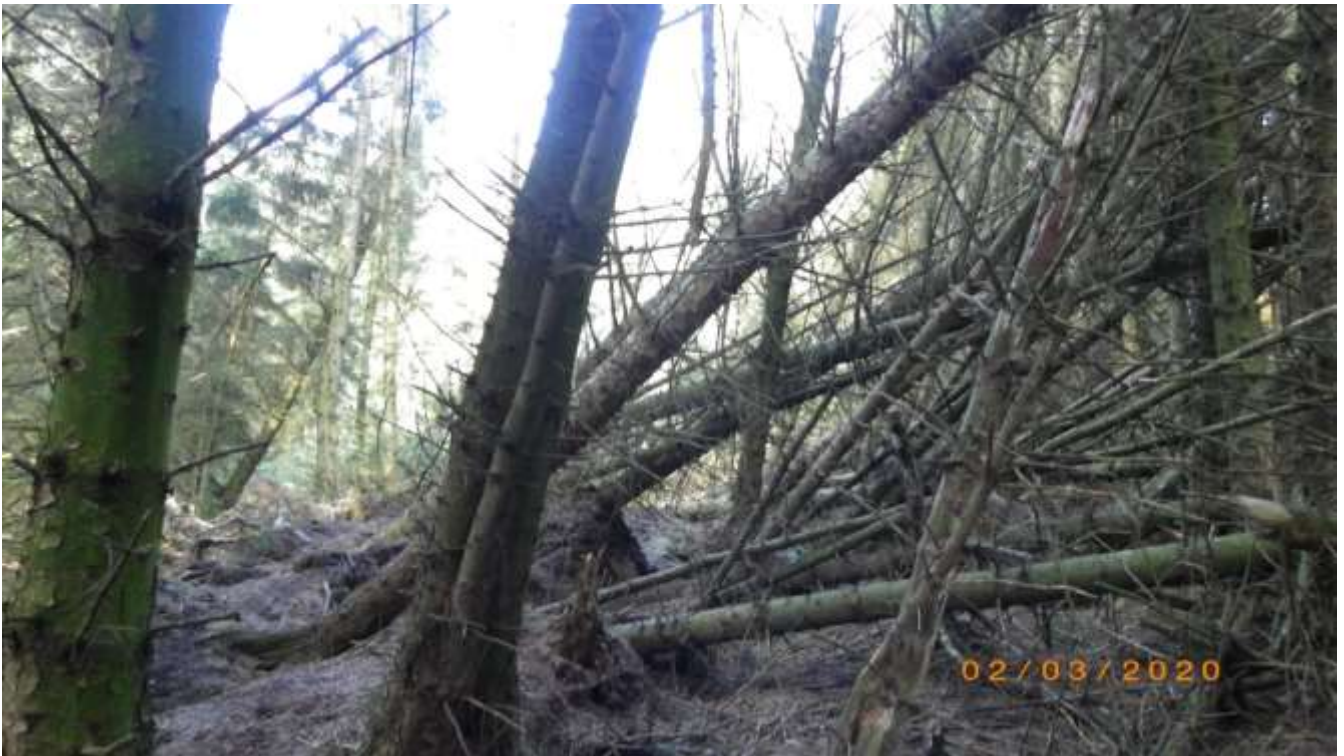
Photo 5 Windblow within the unthinned stand cpt1a

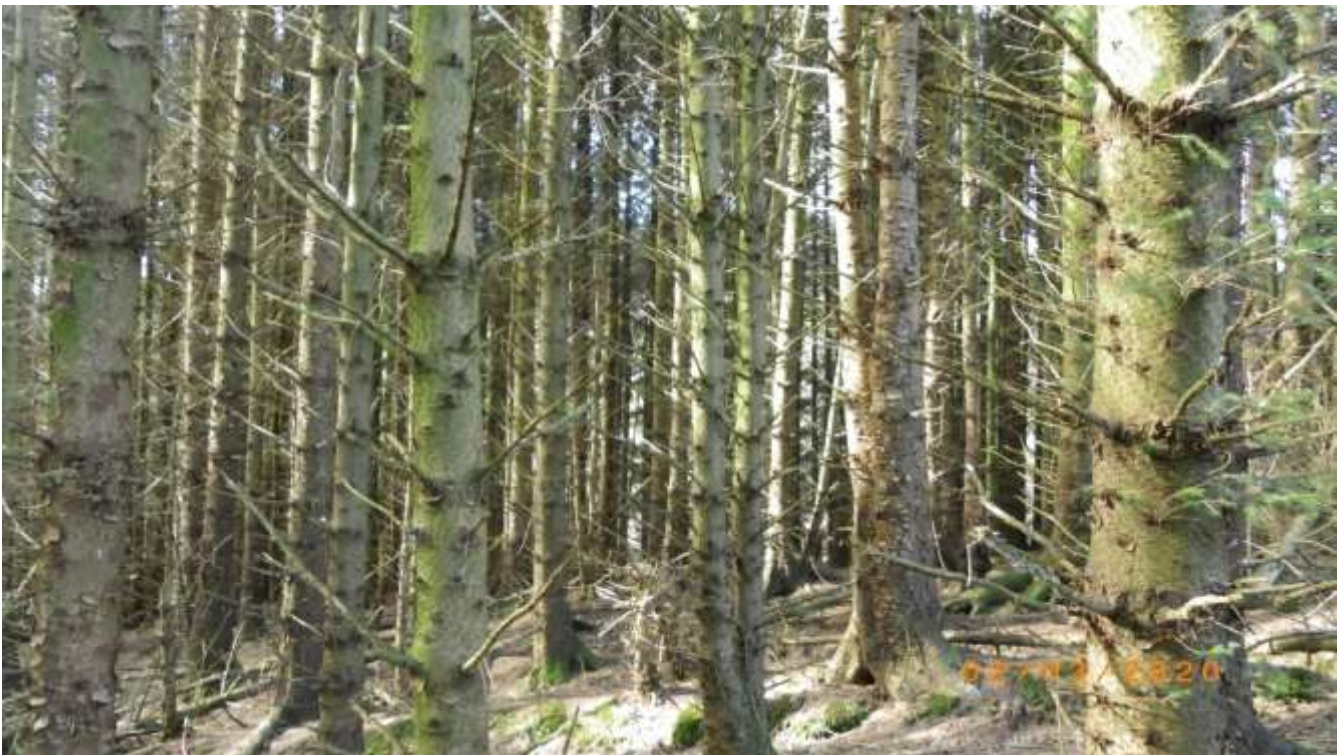
Photo 6 cpt1a little light filtering so minimal ground flora within the stand

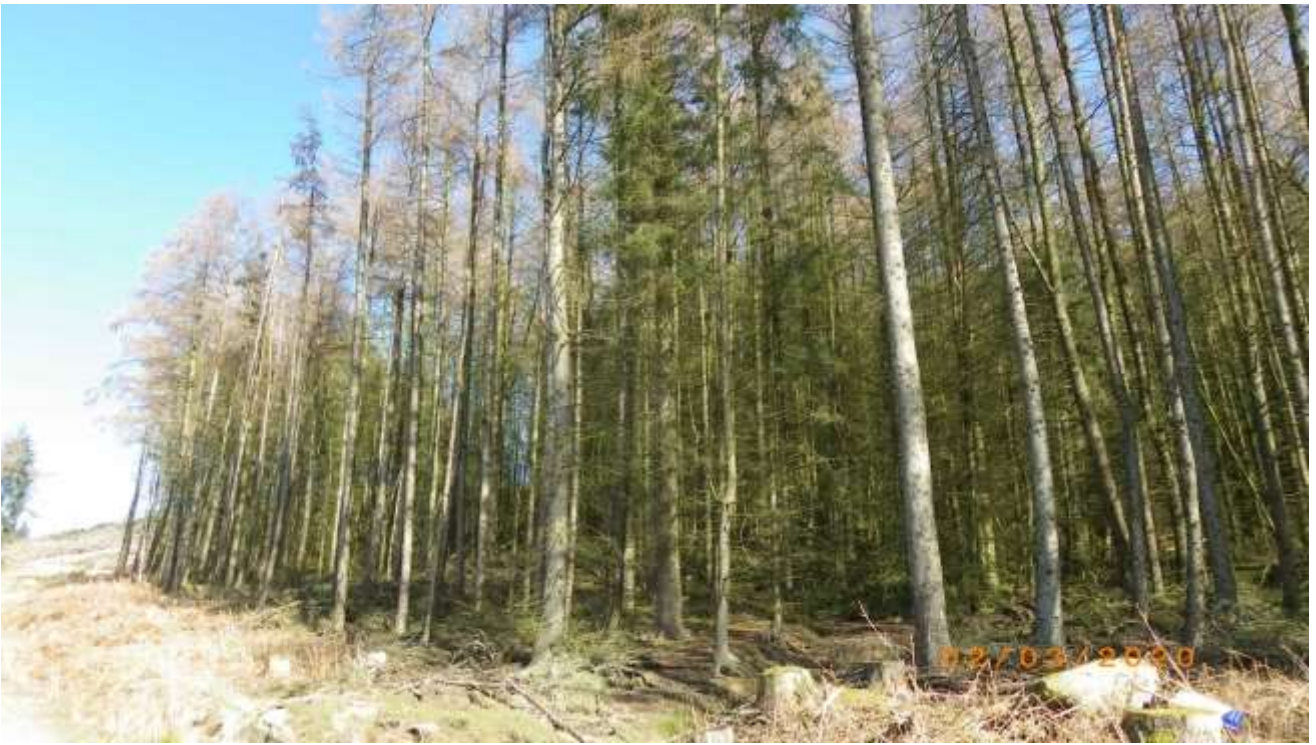
Photo 9 Cpt 1b unthinned larch and spruce

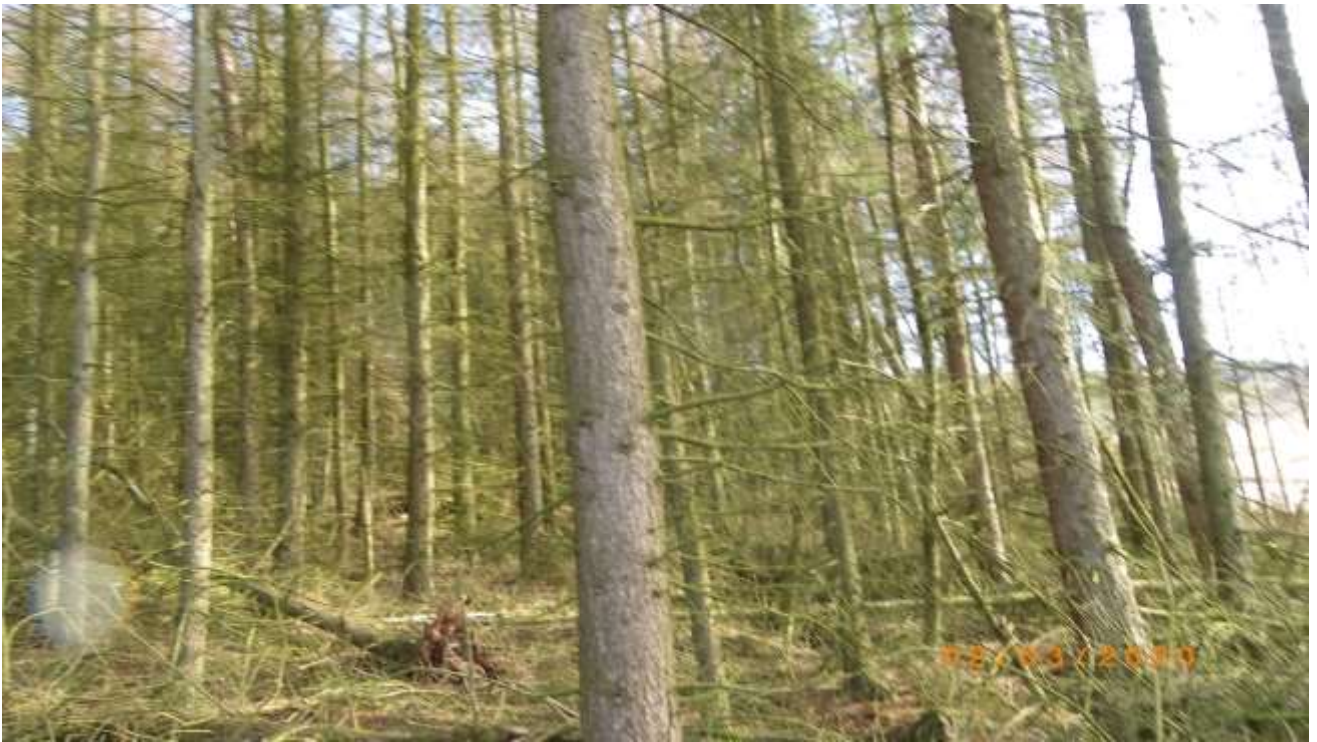
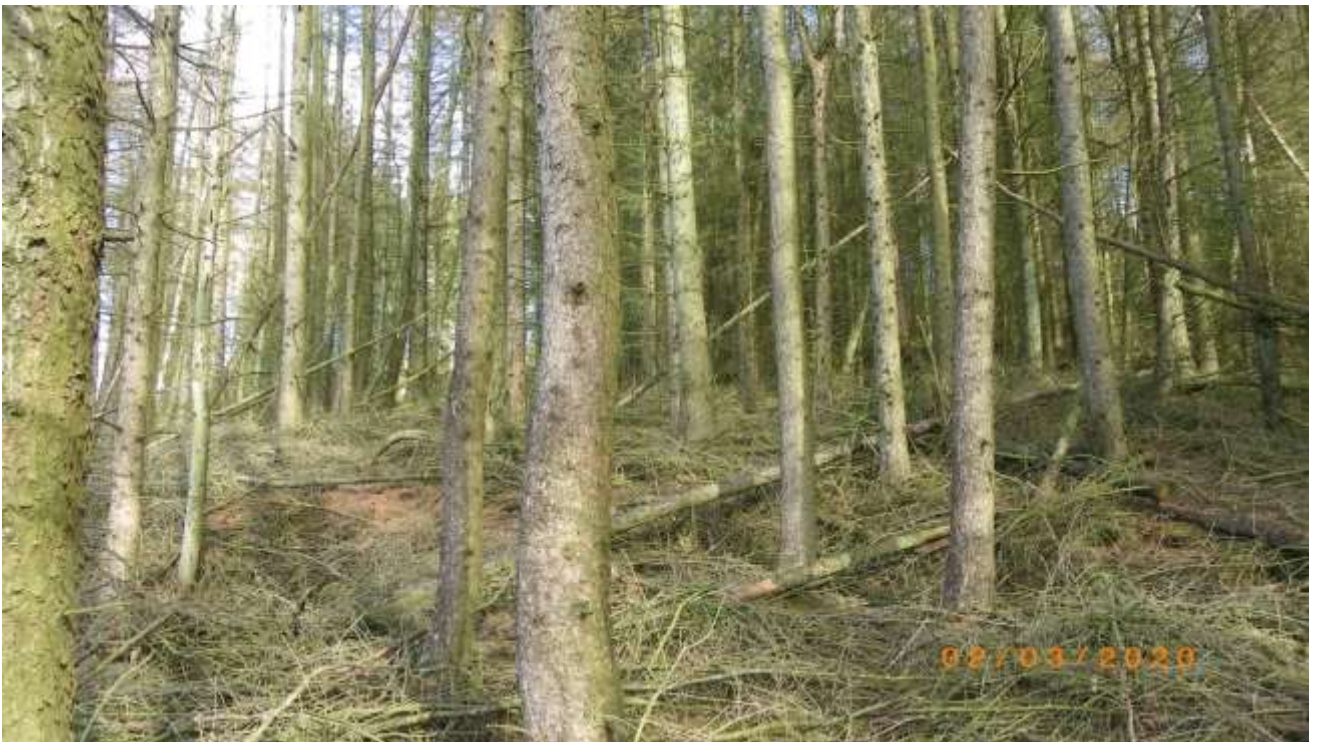
Photo 11 & 12 Cpt 1b little vegetation within the stand & windblow occurring

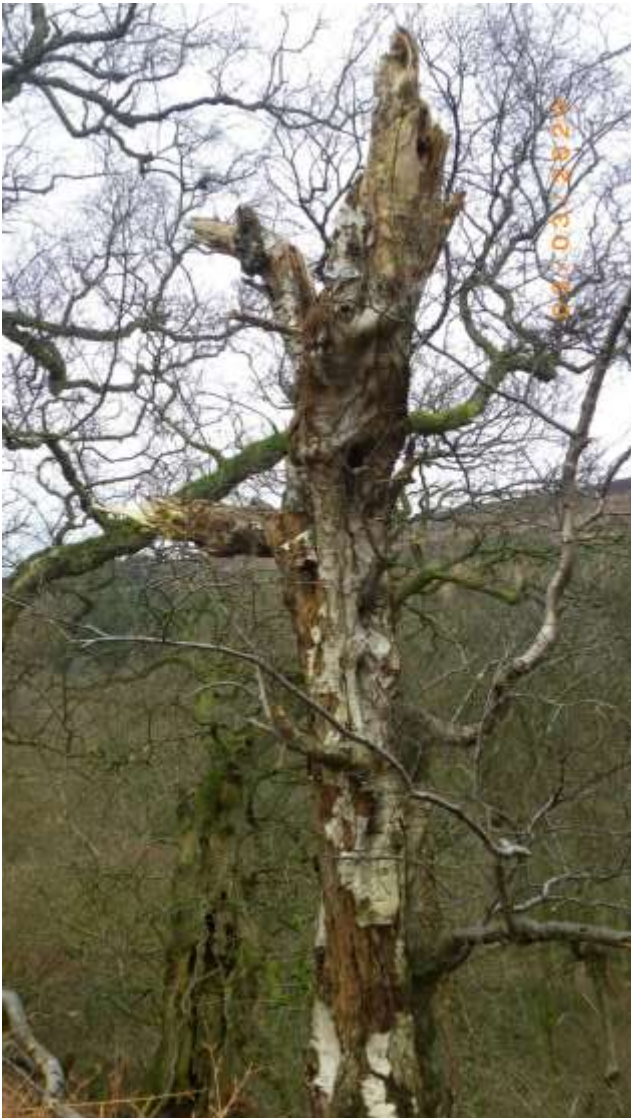
Photo 20 standing and fallen deadwood through cpt1c

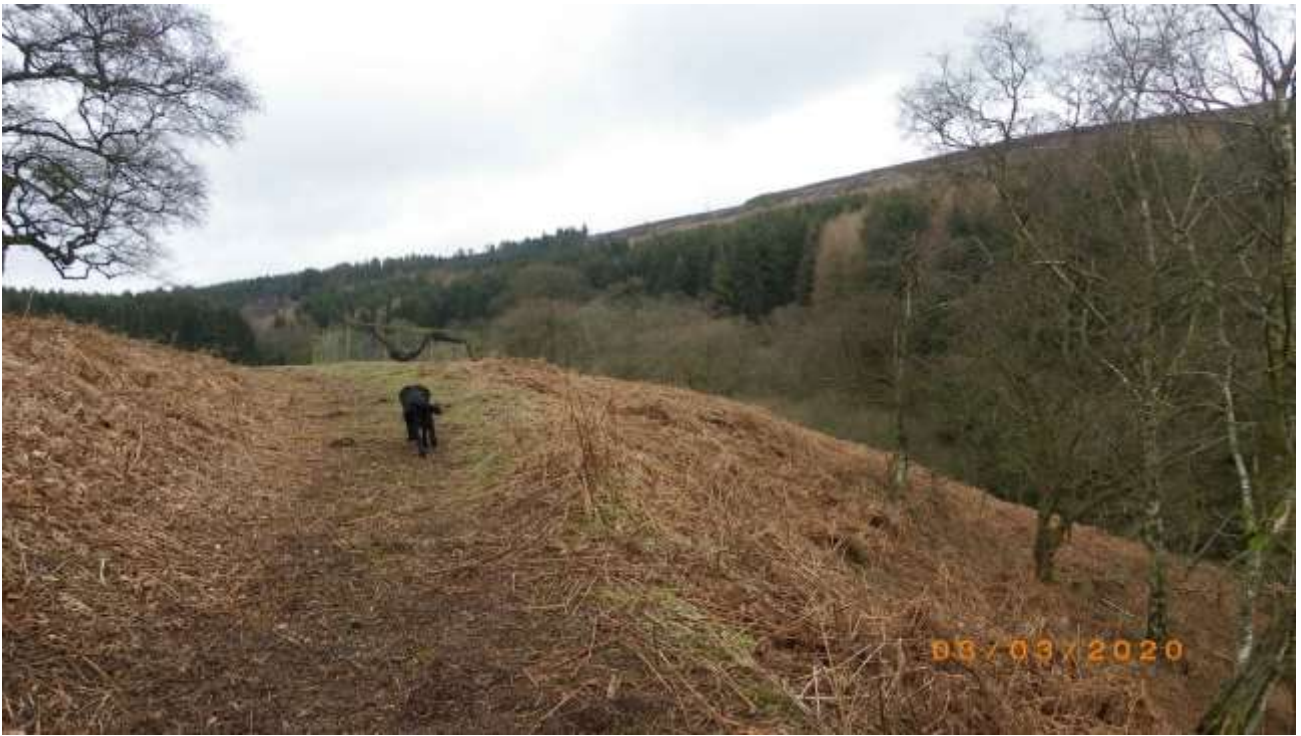
Photo 22 Cpt1c boundary not secure from grazing stock

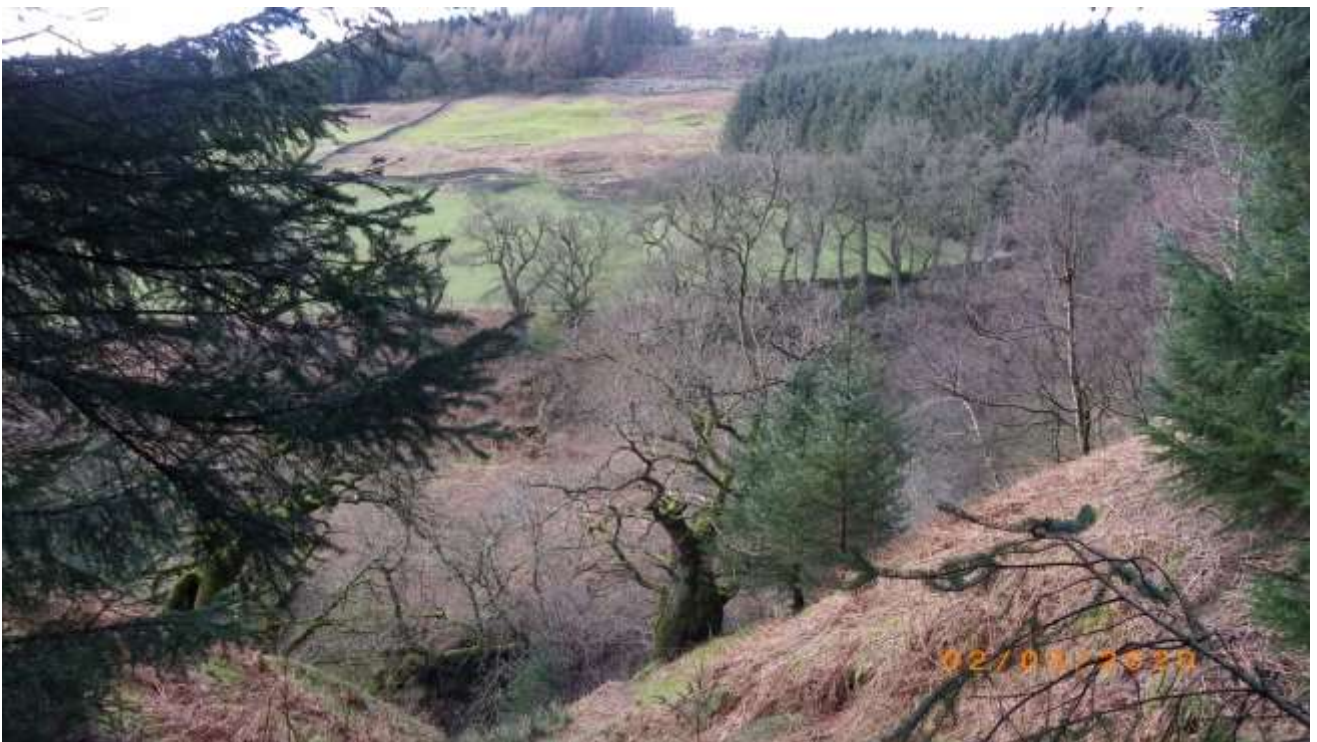
Photo 23 looking down into cpt1c from 1a; some natural regeneration of spruce

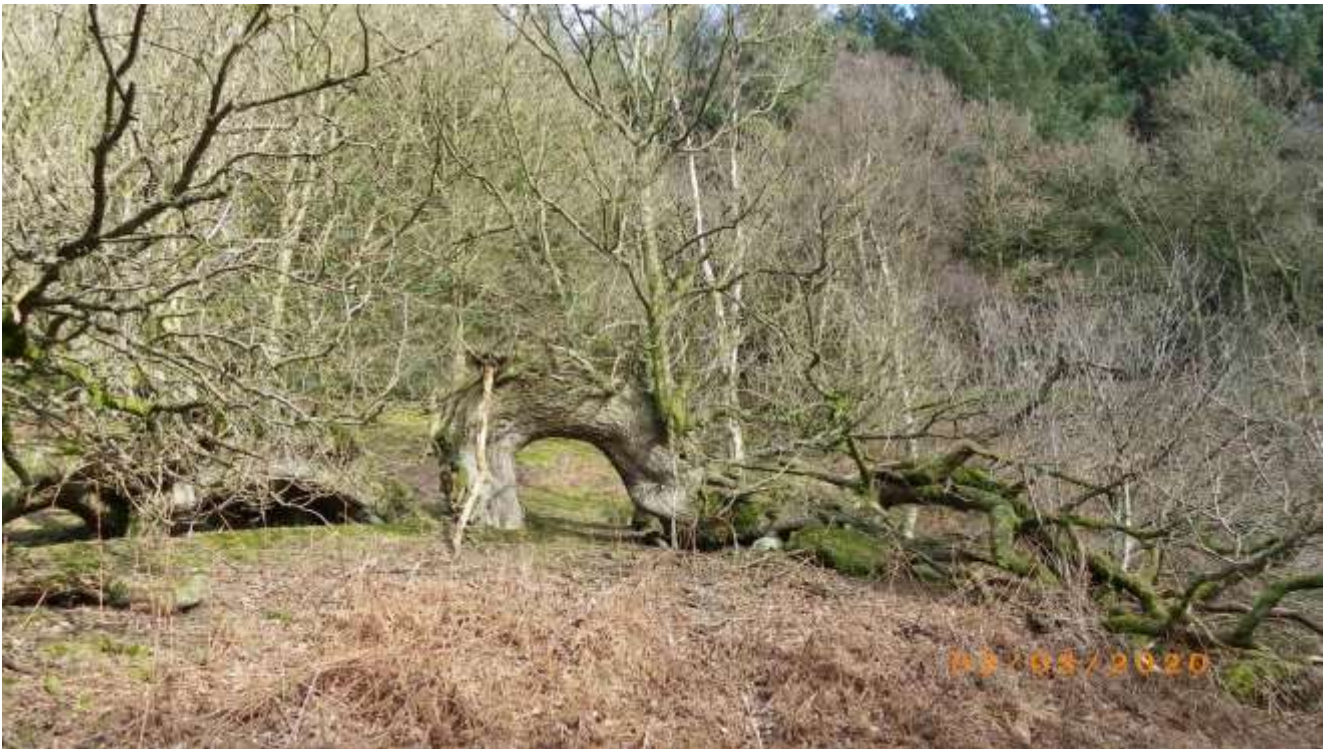
Photo 24 fallen deadwood in cpt1c

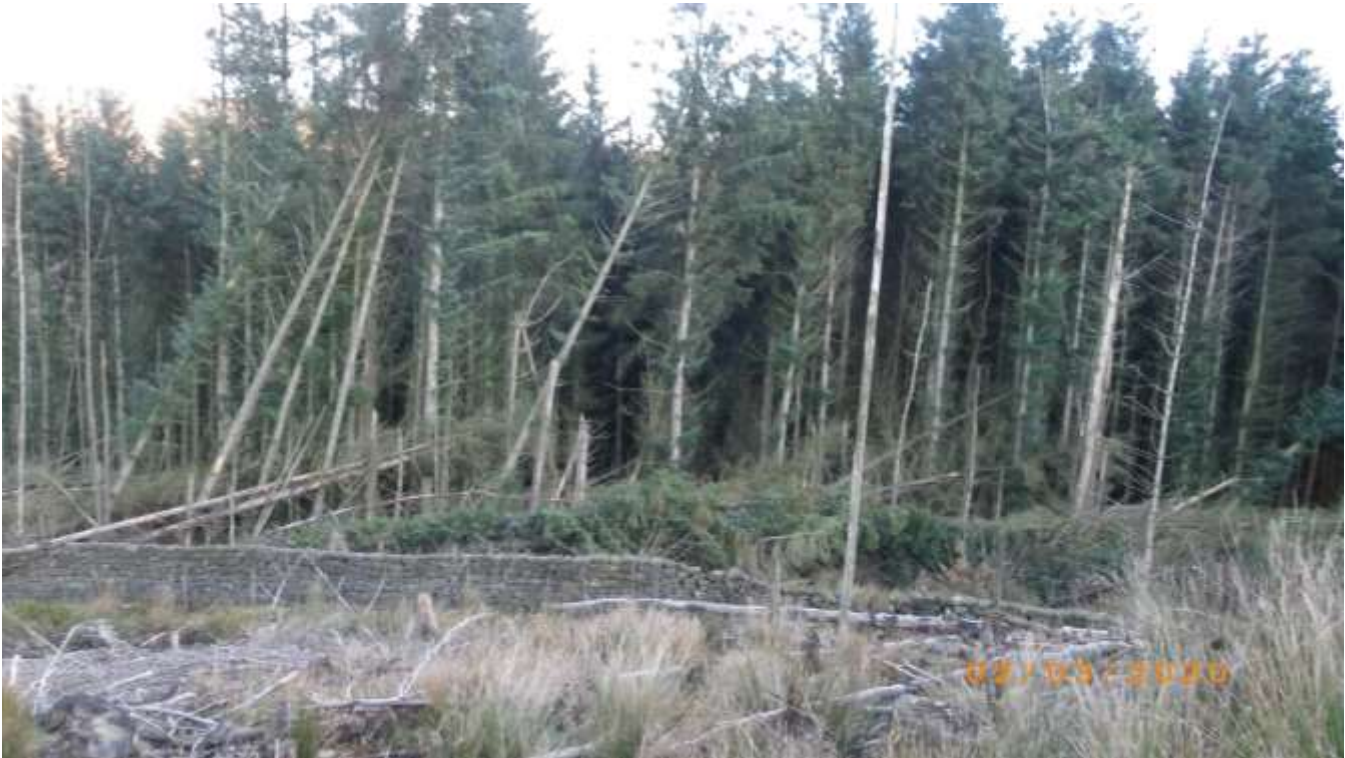
Photo 28 & 29 cpt1c windblow to the west and north boundary where FE have clear felled their stands

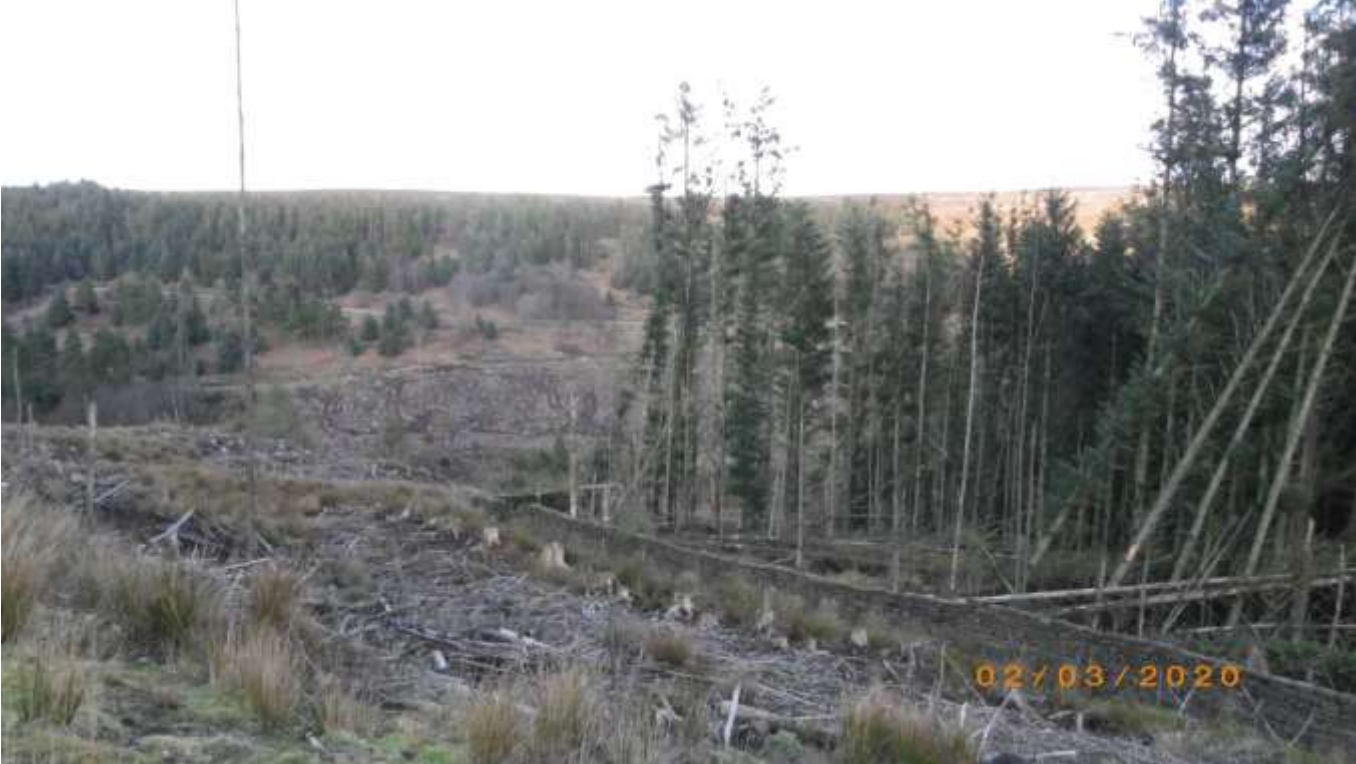
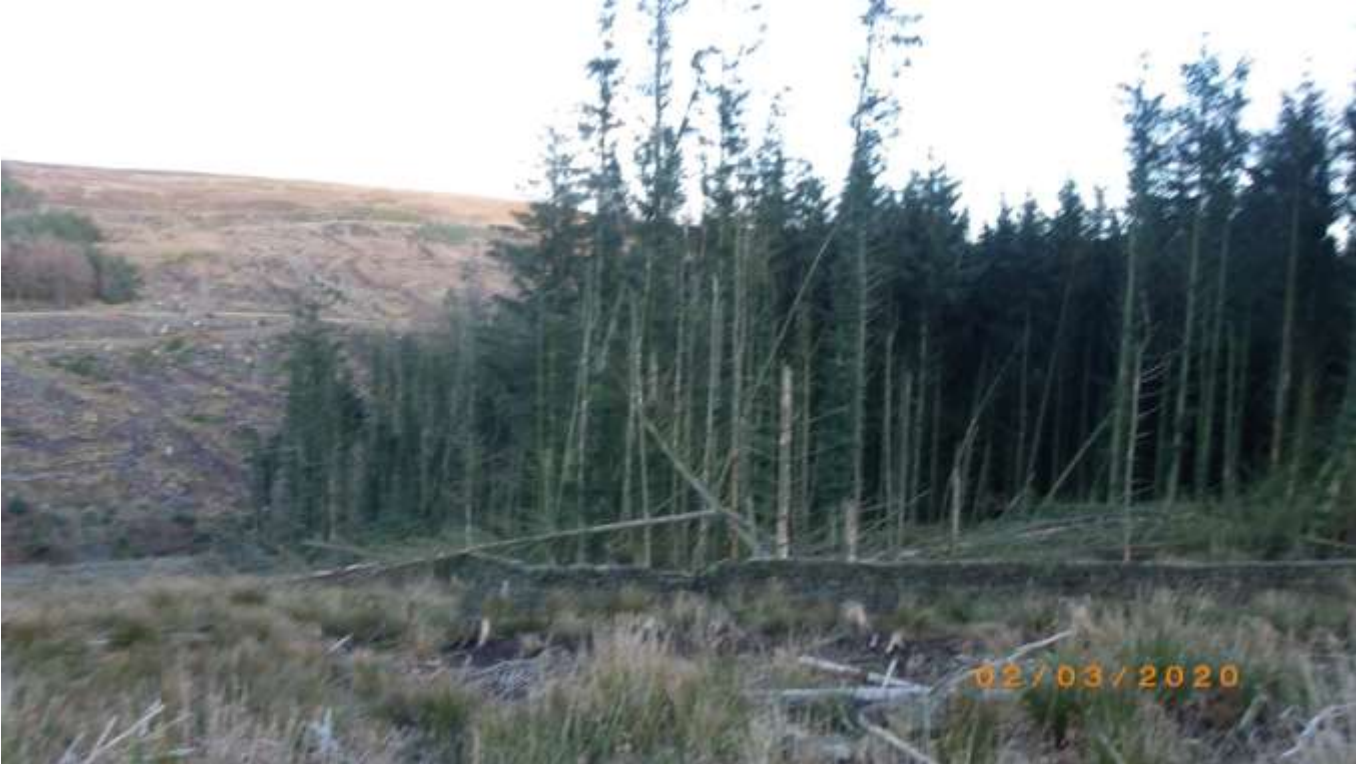
Photo 30 & 31 Cpt 1d old boundary walls visible

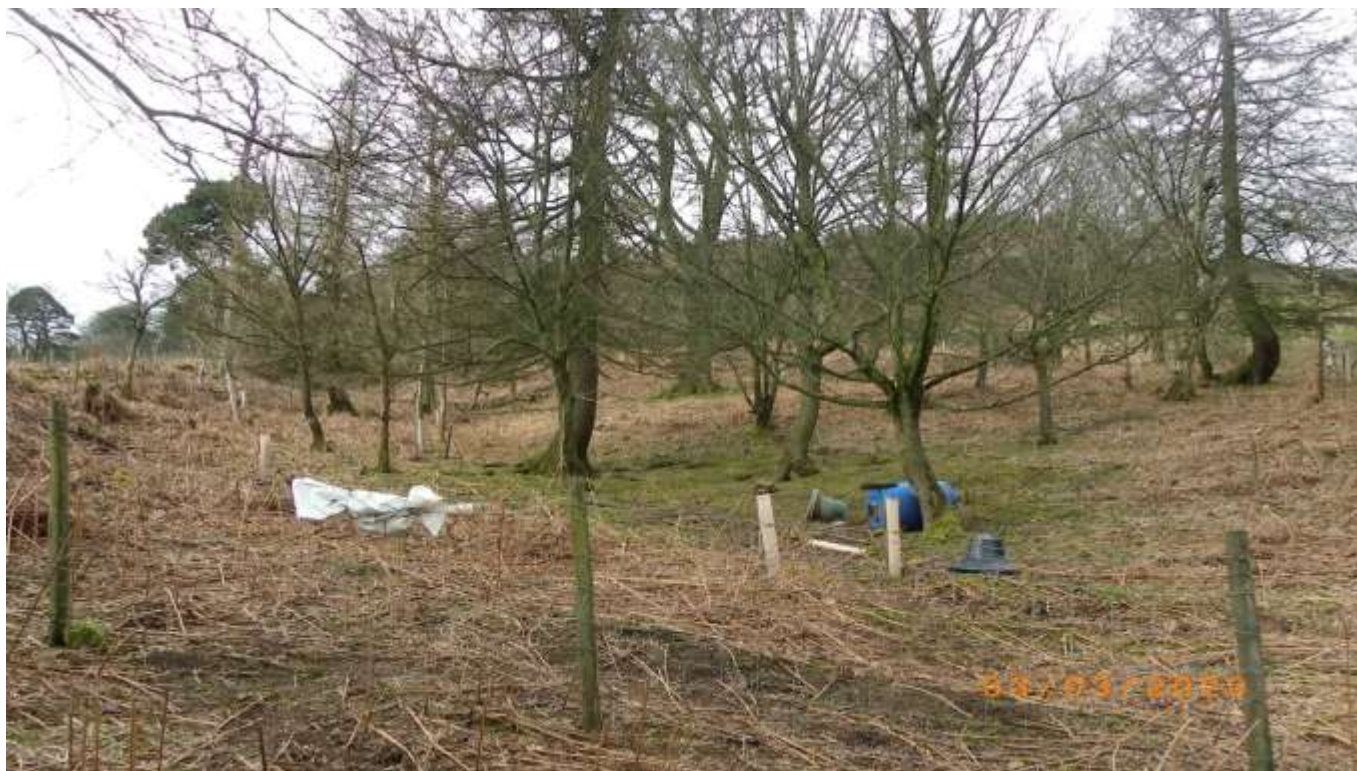
Photo 35 Cpt 2a stock fence inside the wall, bracken abundant

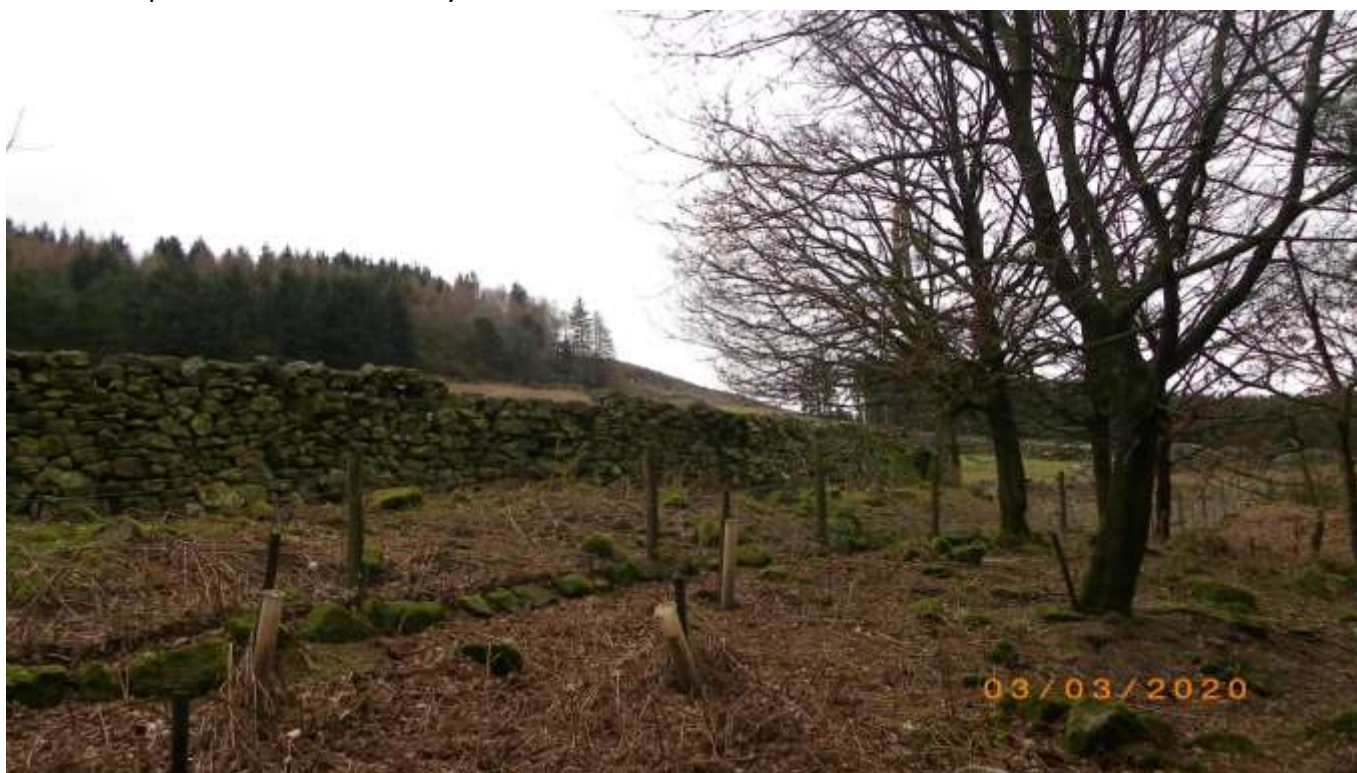
Photo 36 Cpt 2a western boundary wall and fence

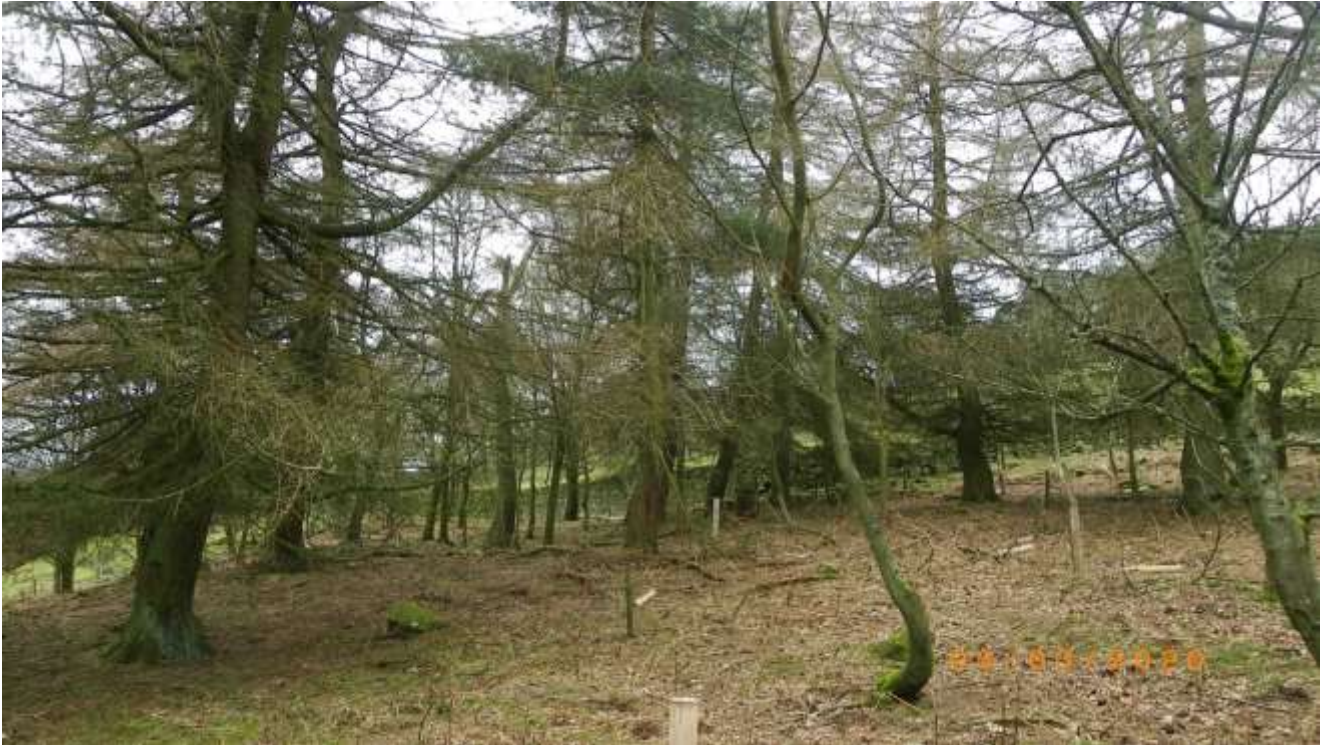
Photo 38 Cpt 2a semi mature larch of poor form

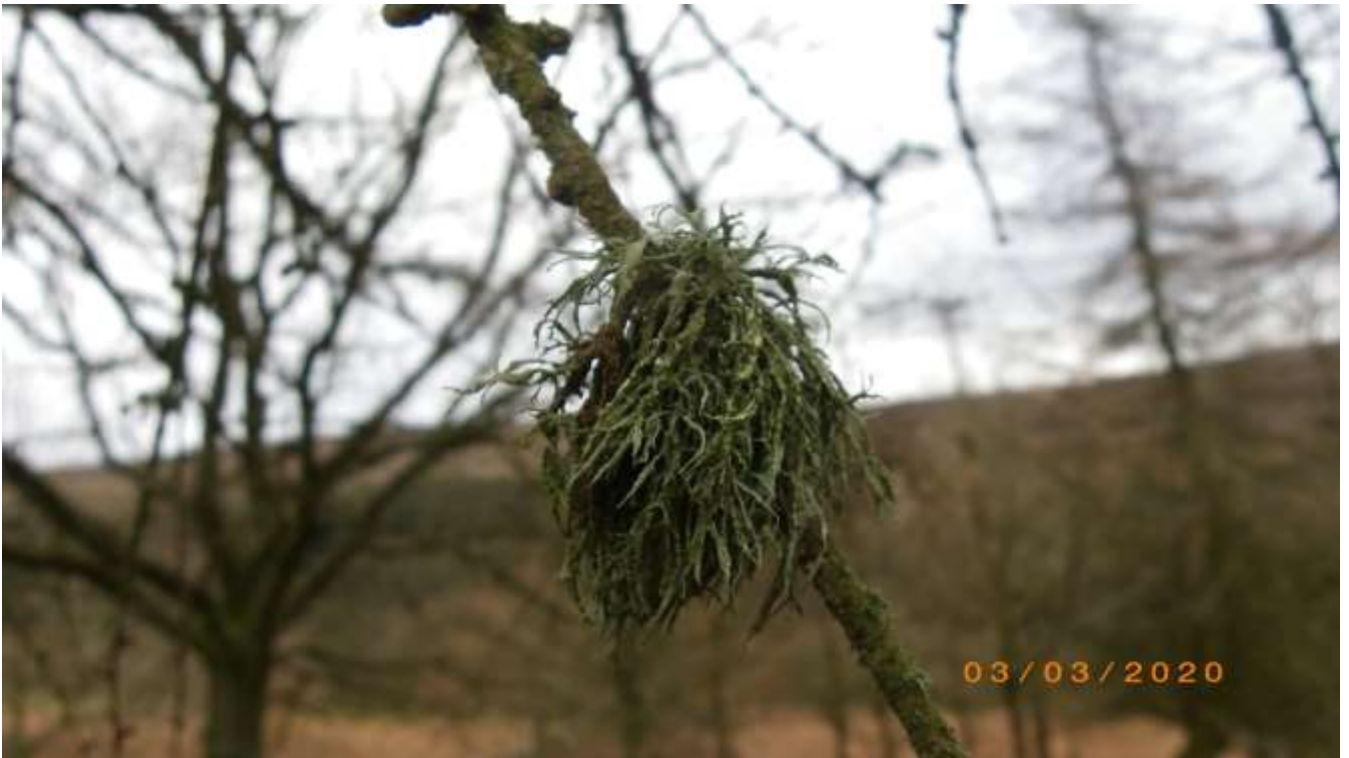
Photo 41 Cpt 2a lichen on a larch branch

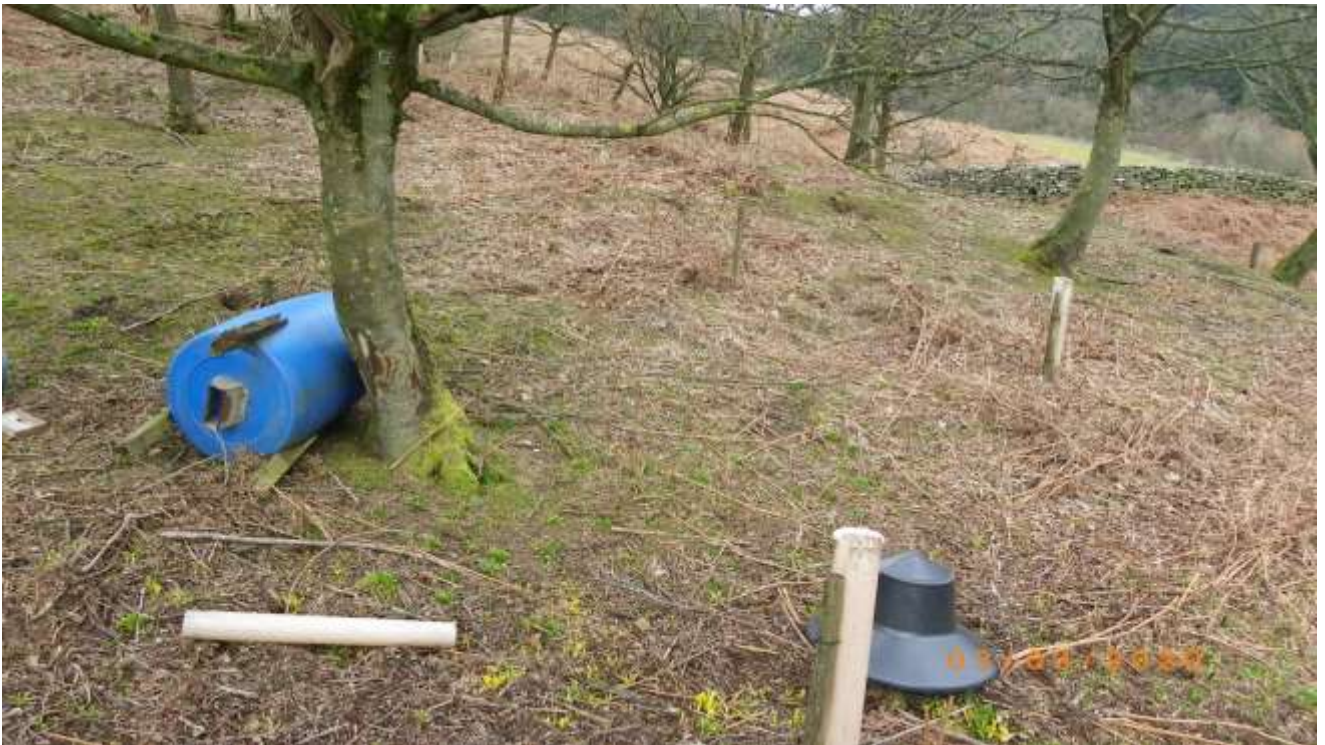
Photo 43 Cpt 2a elements of pheasant feeding on site

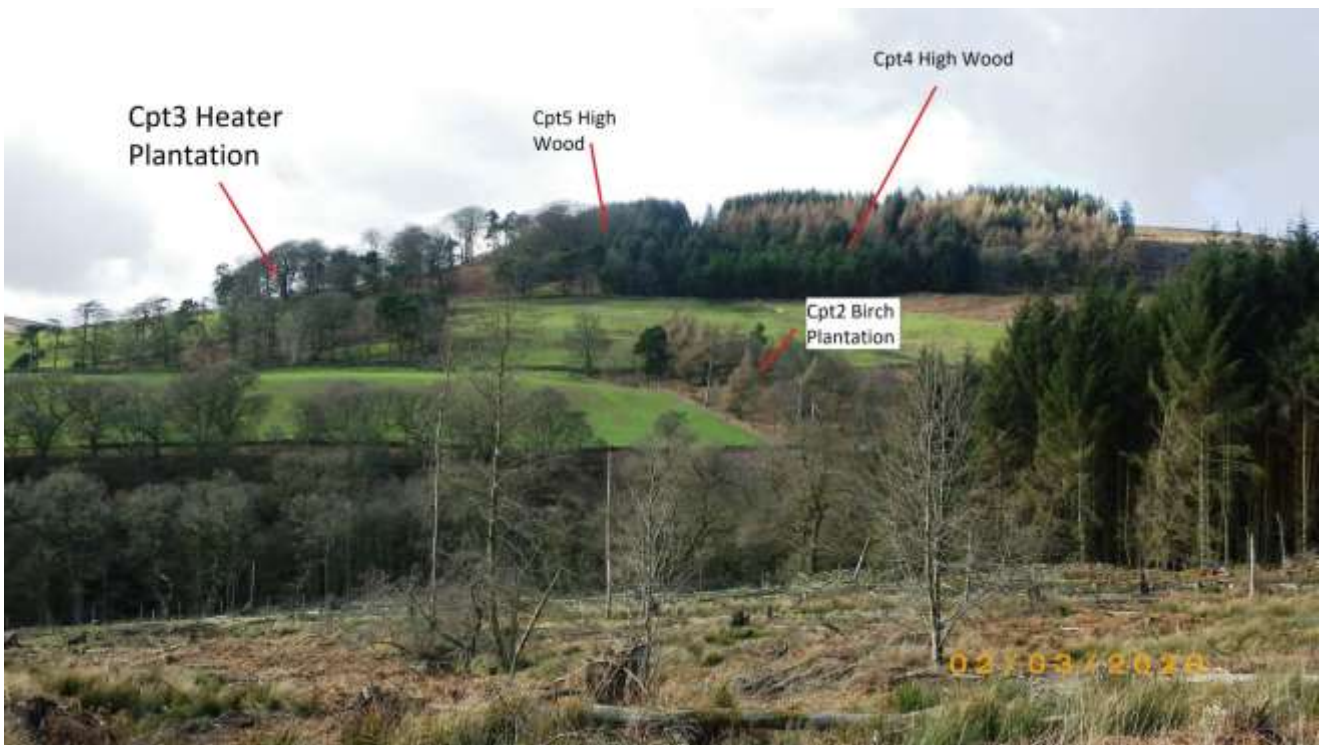
Photo 44 Cpt 3a Heater Plantation

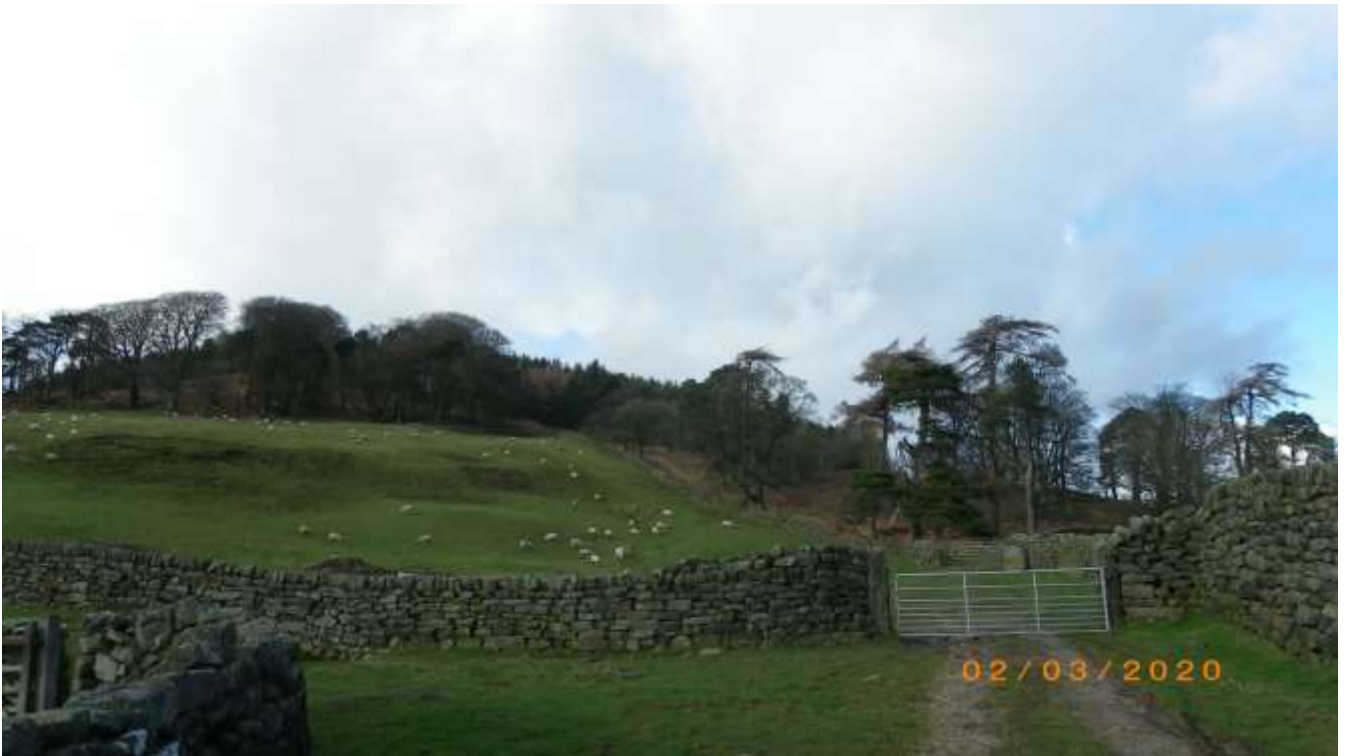
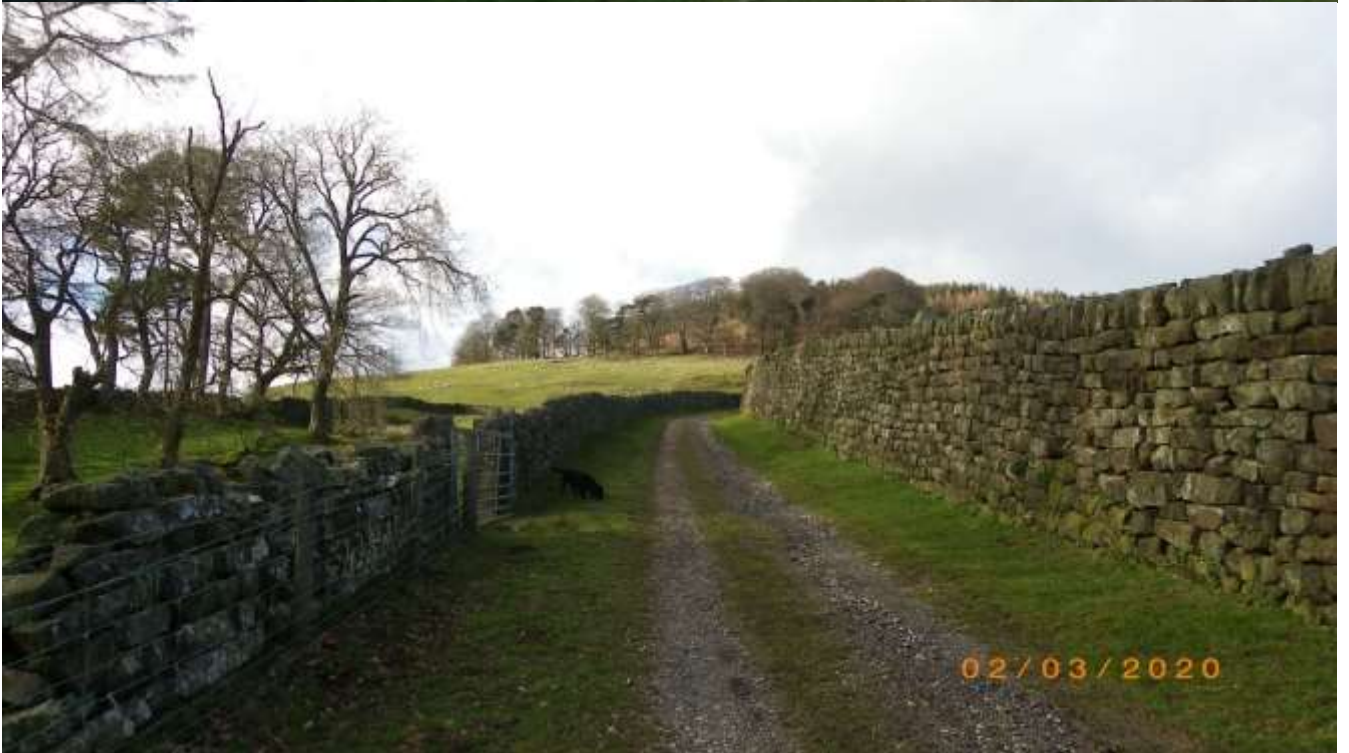
Photo 45 & 46 track from Cockayne Lodge to Heater Plantation
