National Trust Bransdale & Farndale Woodland Management Plan
Photo and Images Gallery 2021

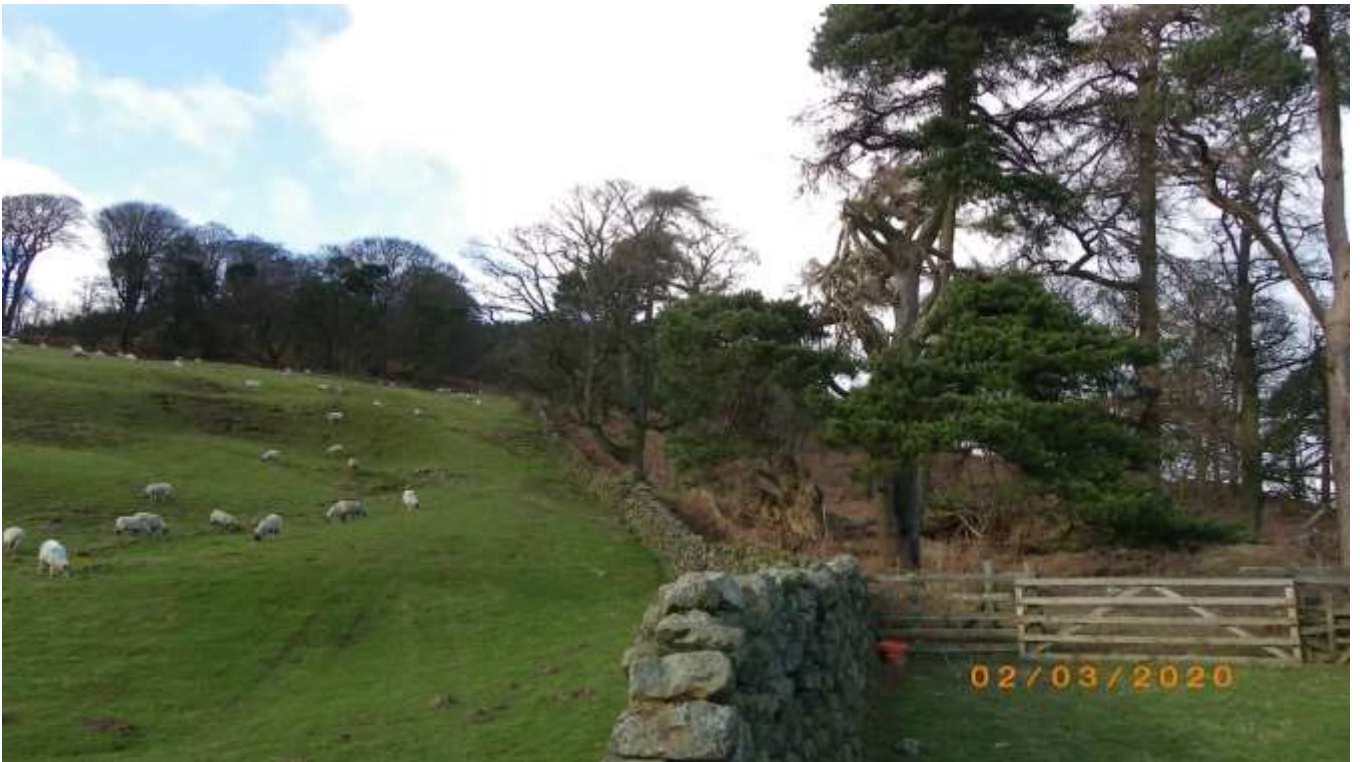
Photo 47 South west boundary of cpt3 Heater Plantation

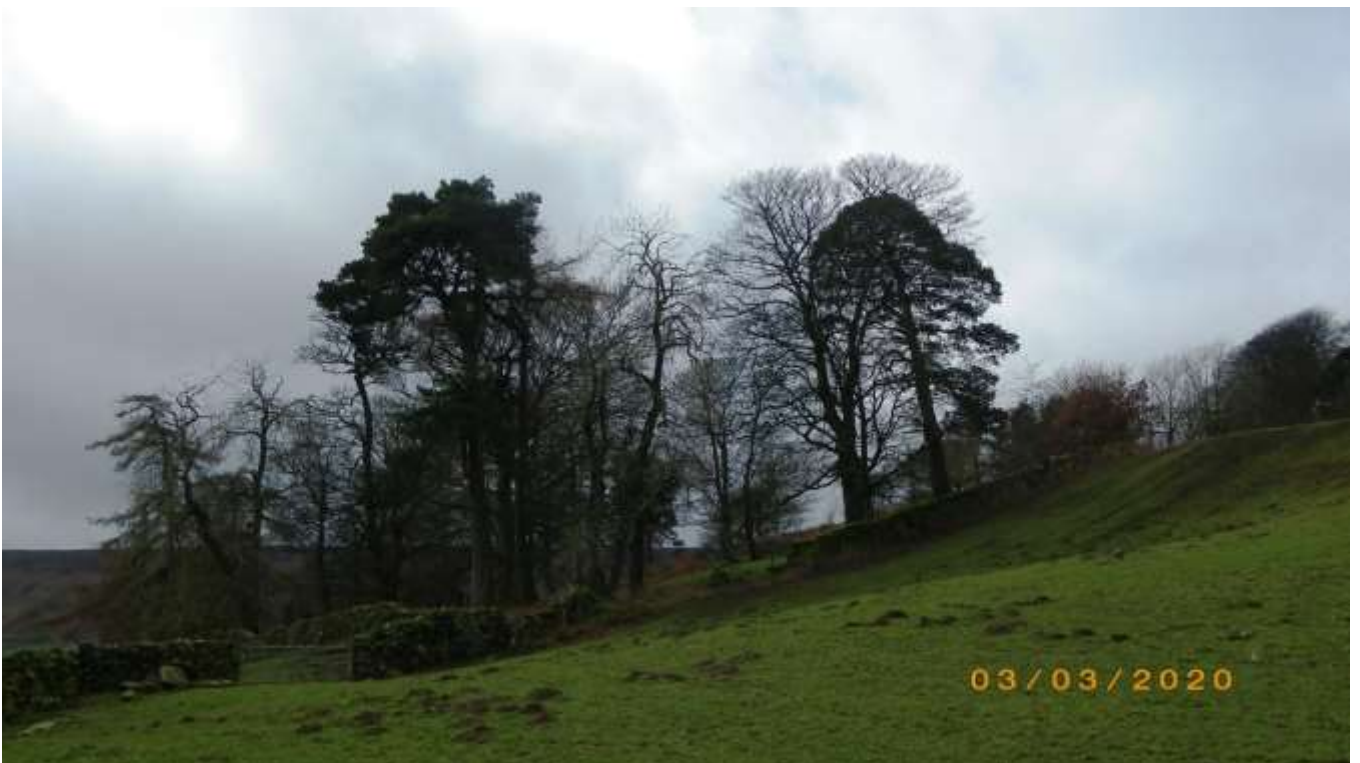
Photo 48 northern boundary of cpt3 Heater Plantation with stock fence to outside

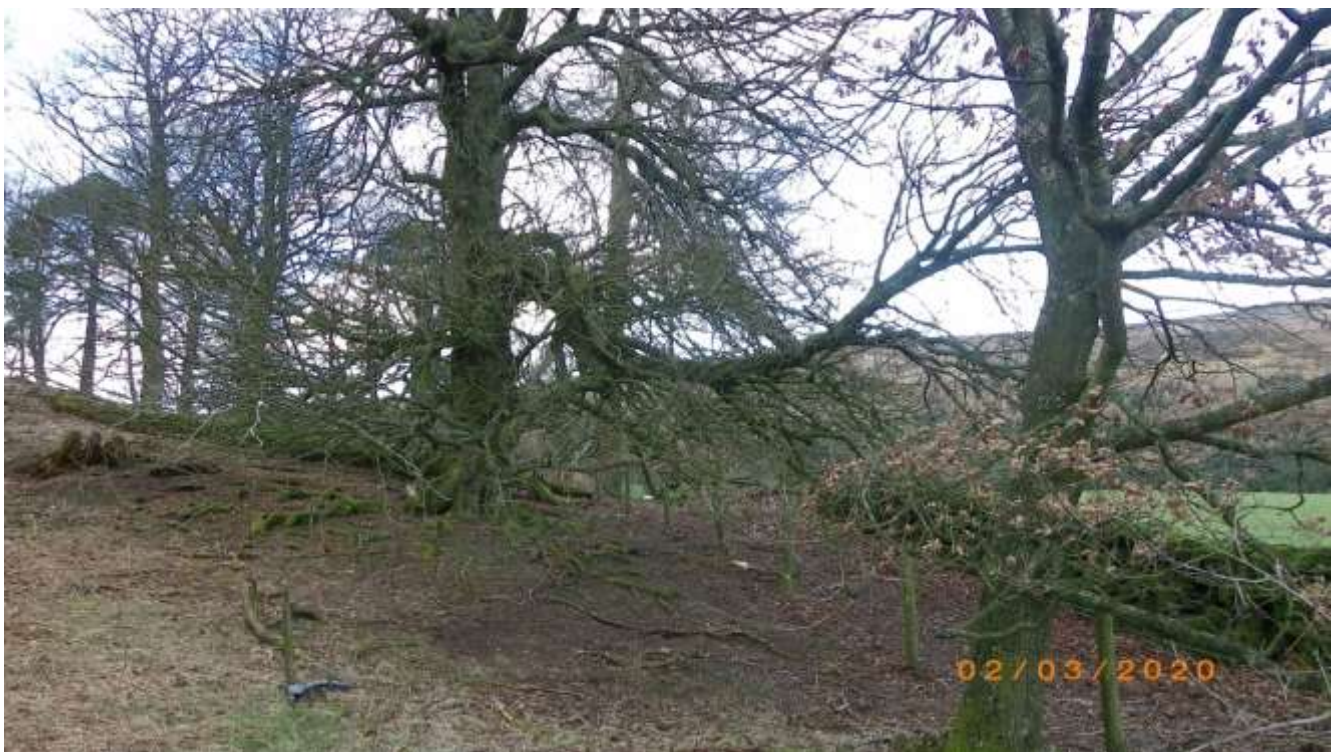
Photo 50 Cpt 3a mature horse chestnut and younger oak in Heater Plantation

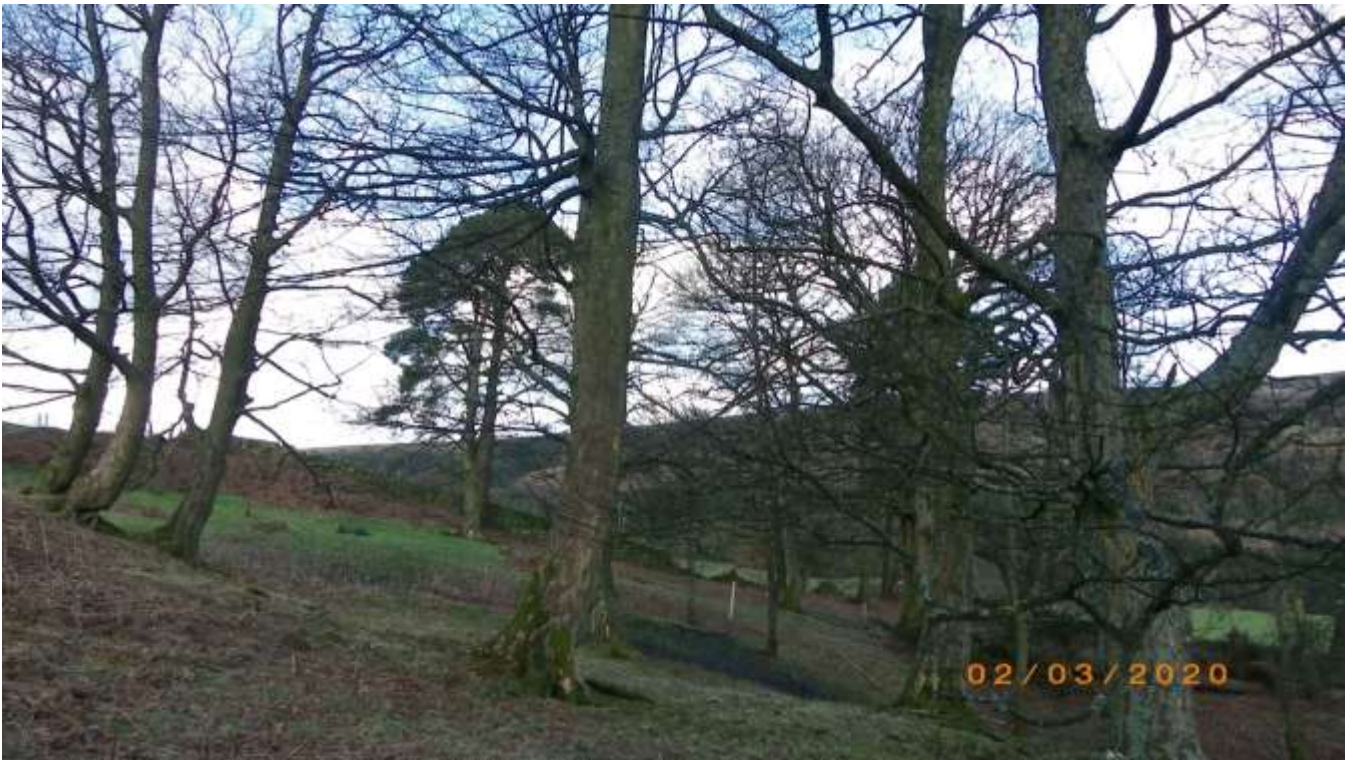
Photo 51 Cpt 3a Heater Plantation mature sycamore & pine visible here

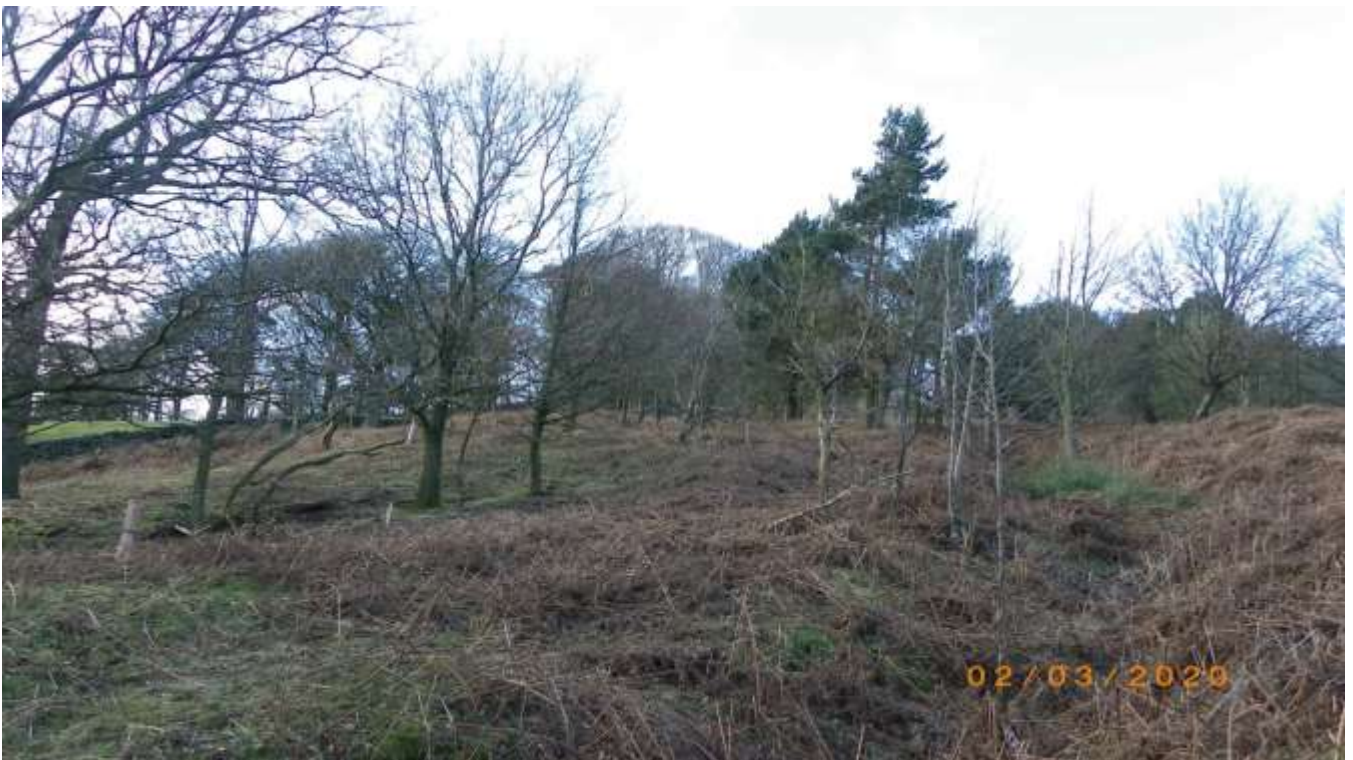
Photo 51 Cpt3a dense bracken, younger trees and empty tubes

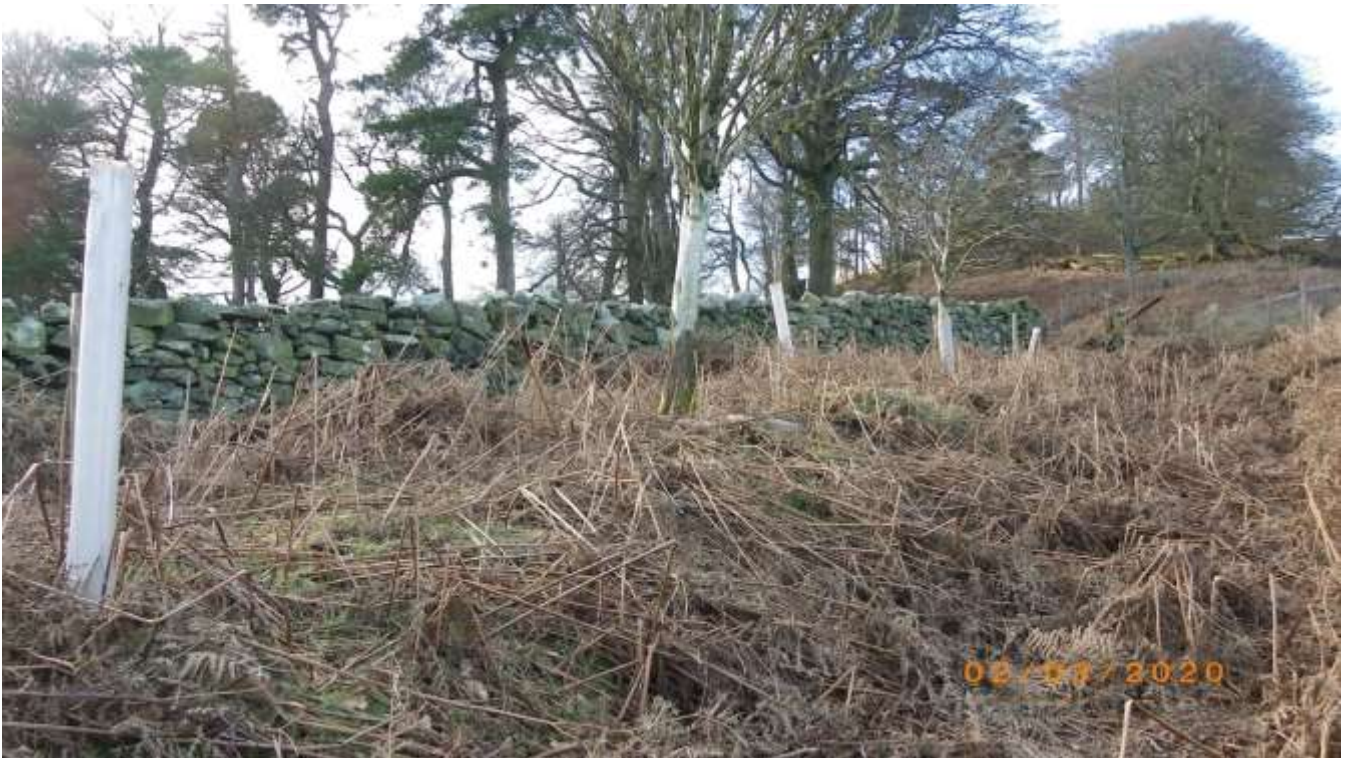
Photo 52 Cpt3a younger tree in tubes in Heater Plantation

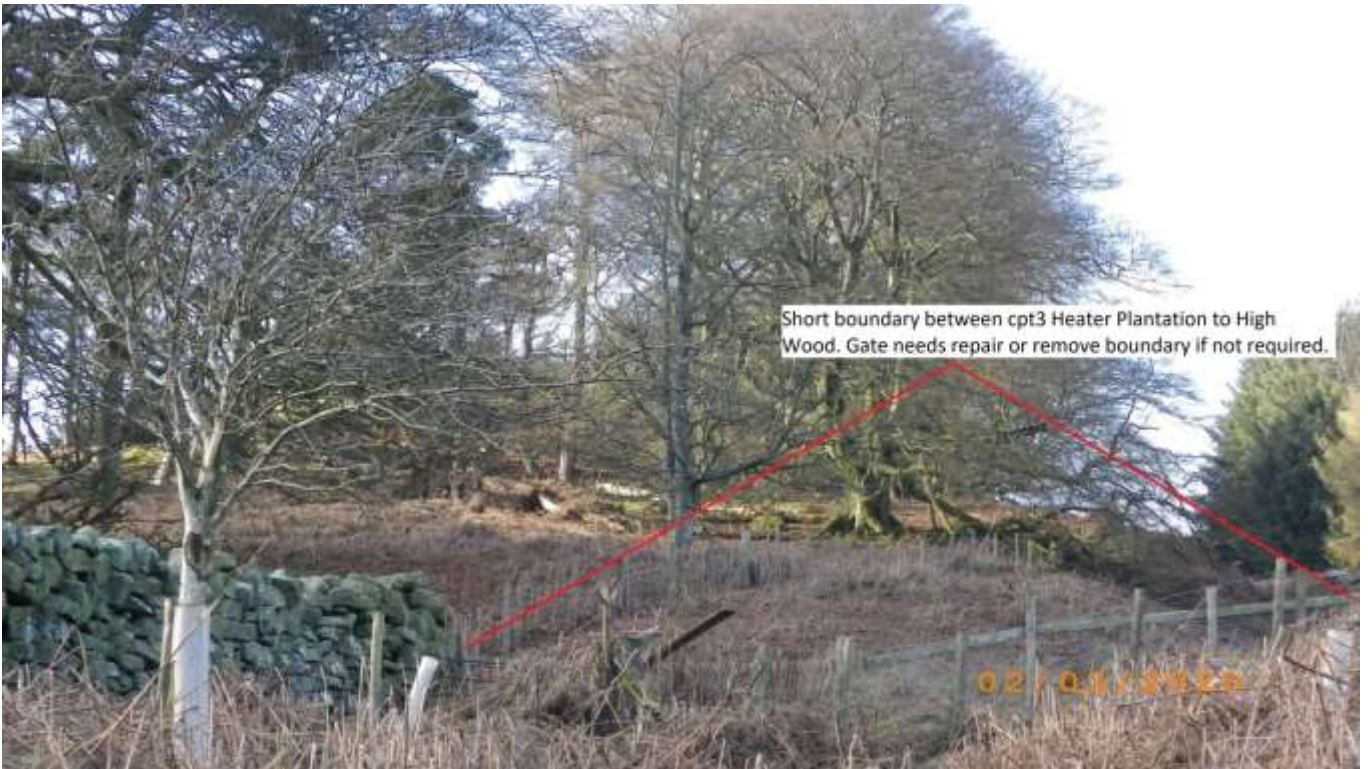
Photo 54 Cpt3a boundary between Heater and High Plantation

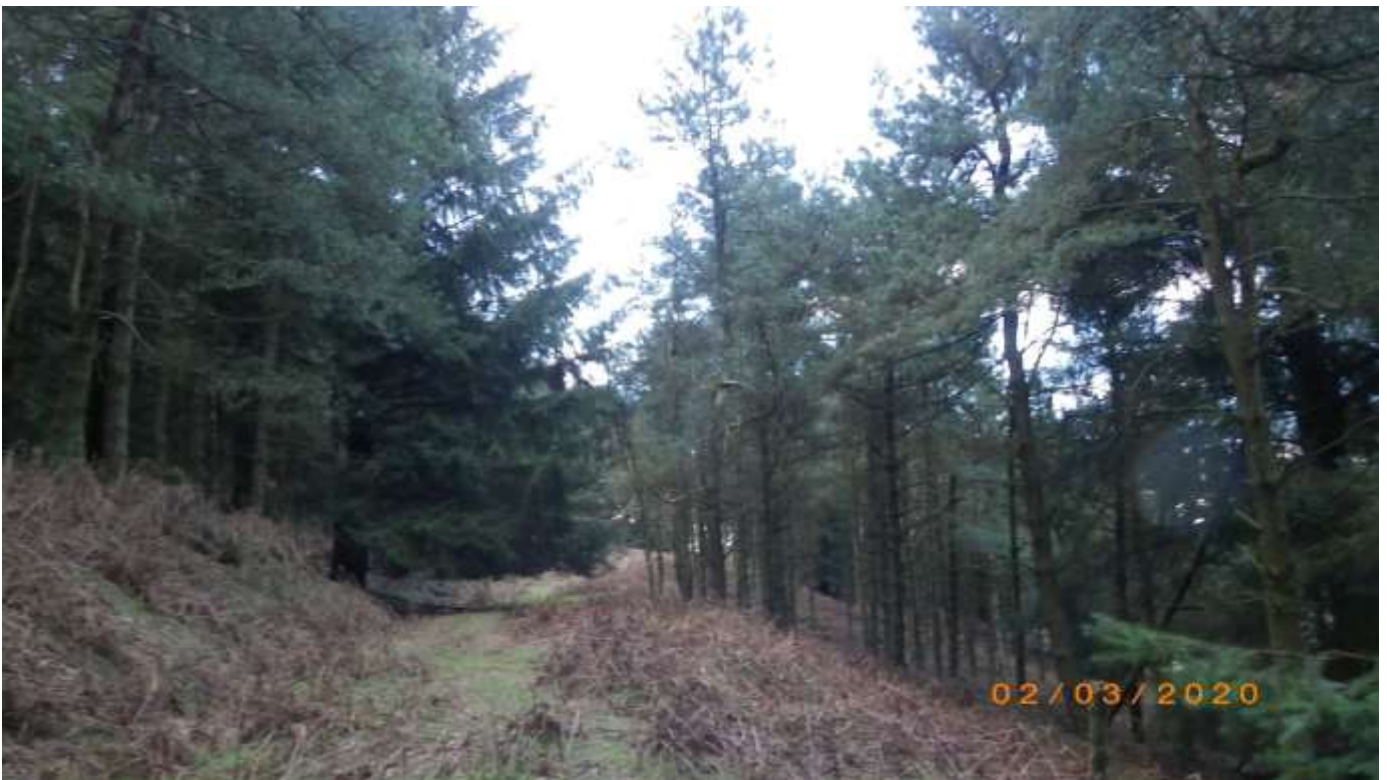
Photo 56 Cpt4a lower ride through cpt4a with bracken dense in open areas

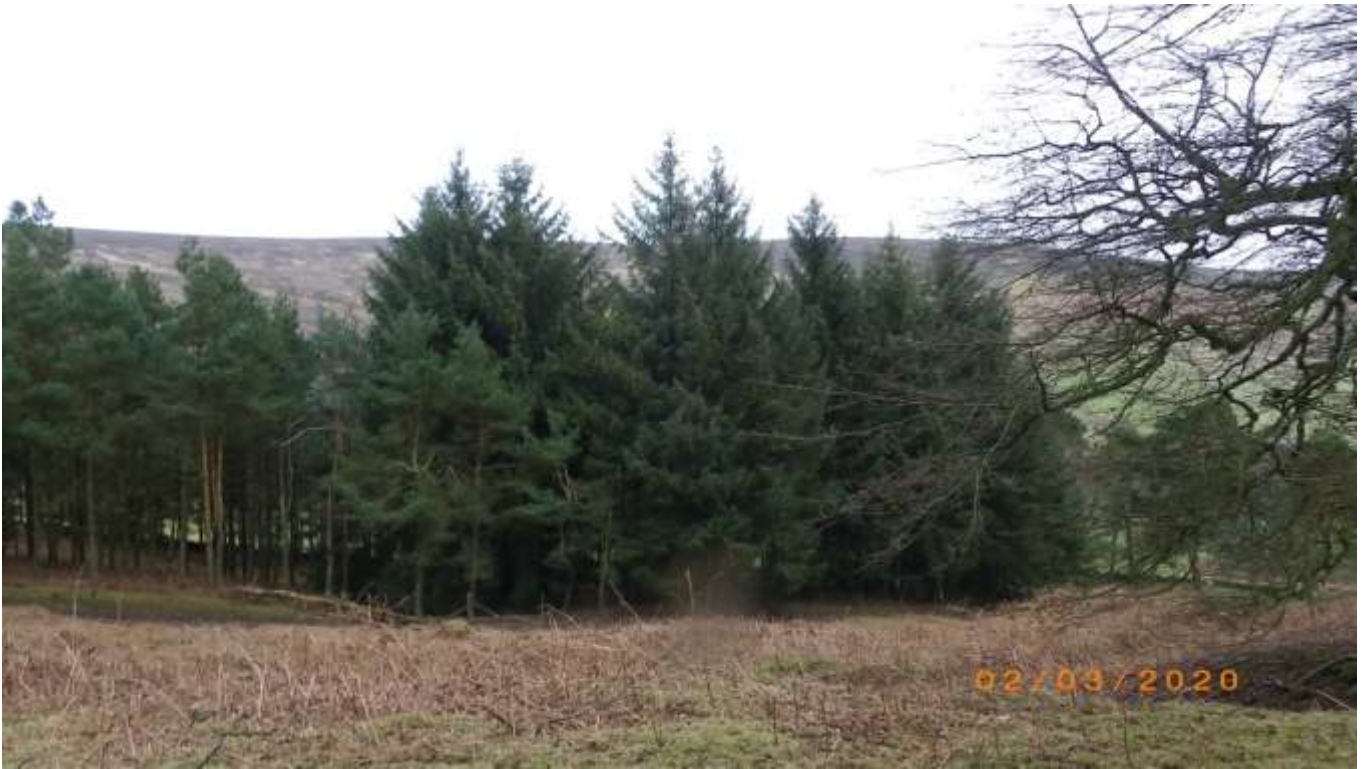
Photo 57 Looking east at cpt4a

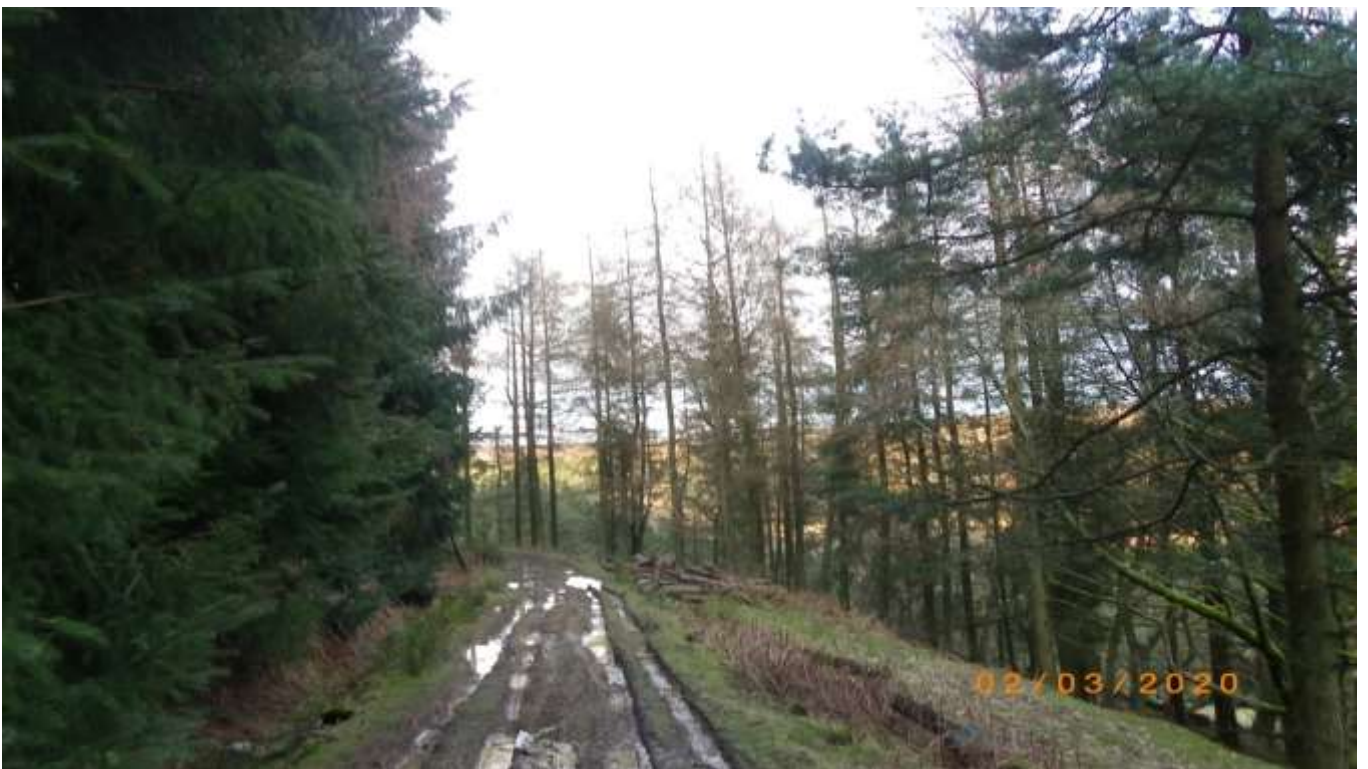
Photo 58 Cpt4a larch to the northern corner

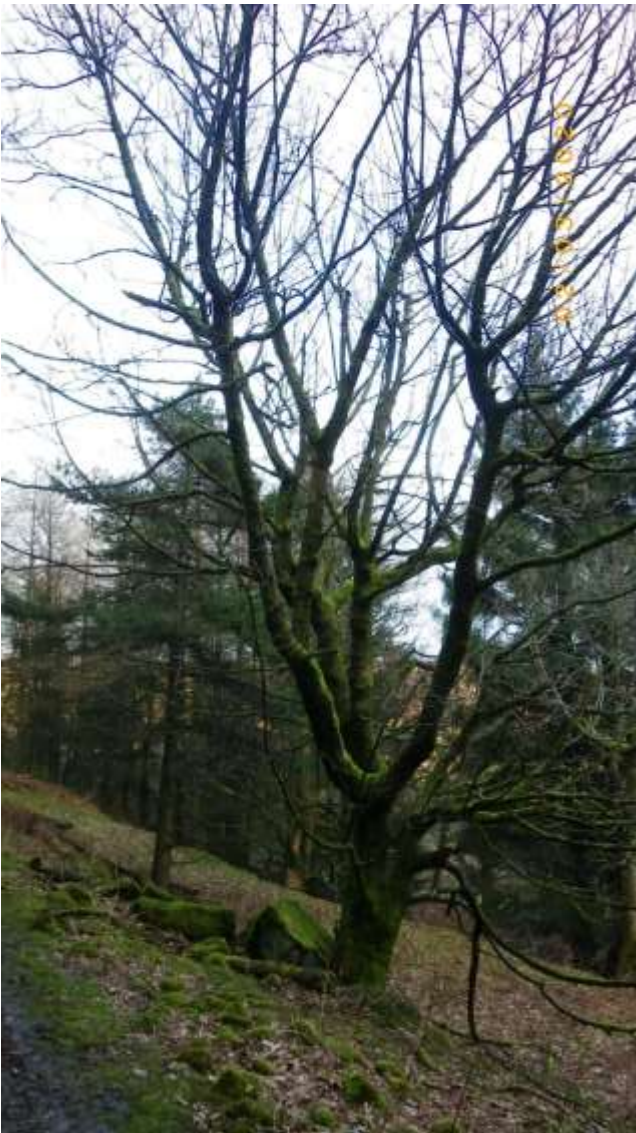
Photo 59 Three to four mature sycamore within cpt4a

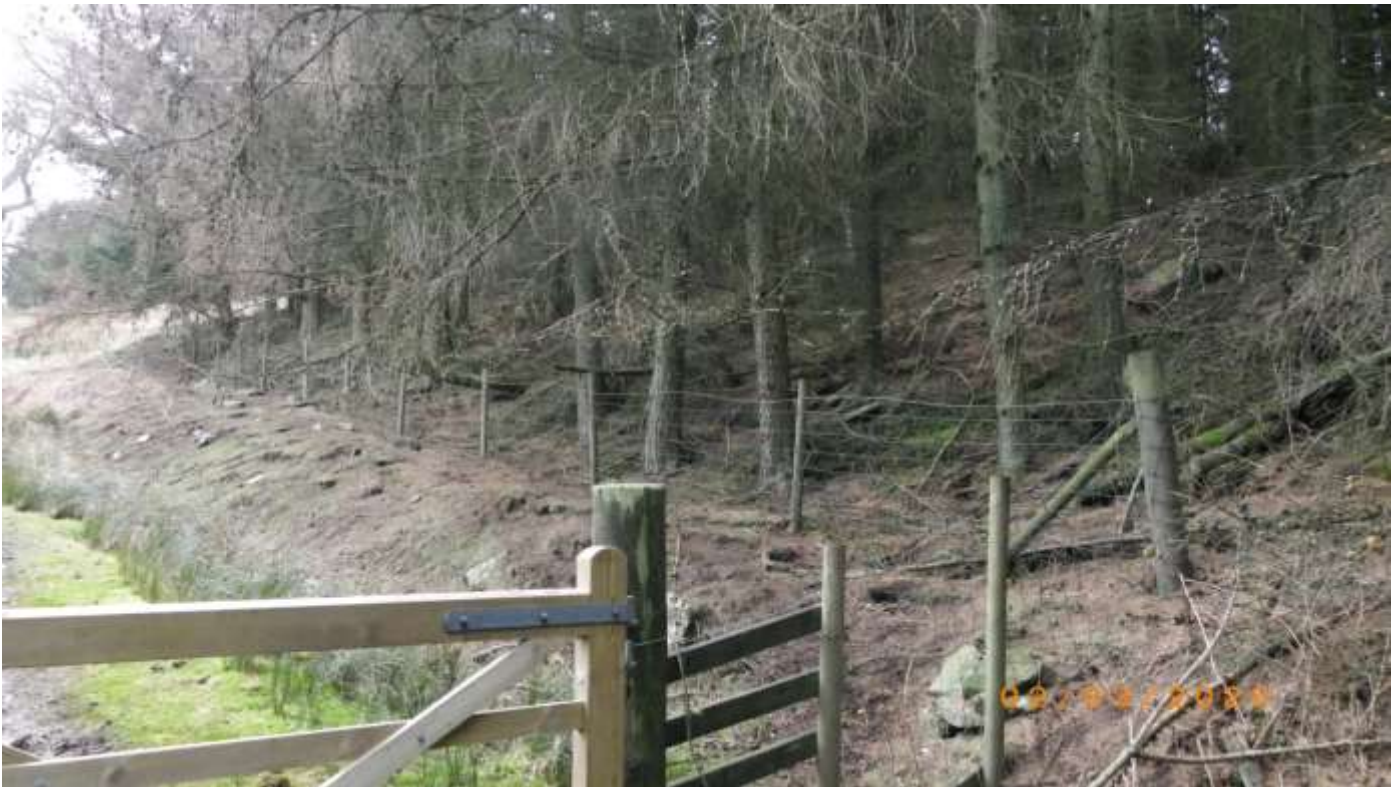
Photo 61 Cpt4b the southerly end, note old stock fence

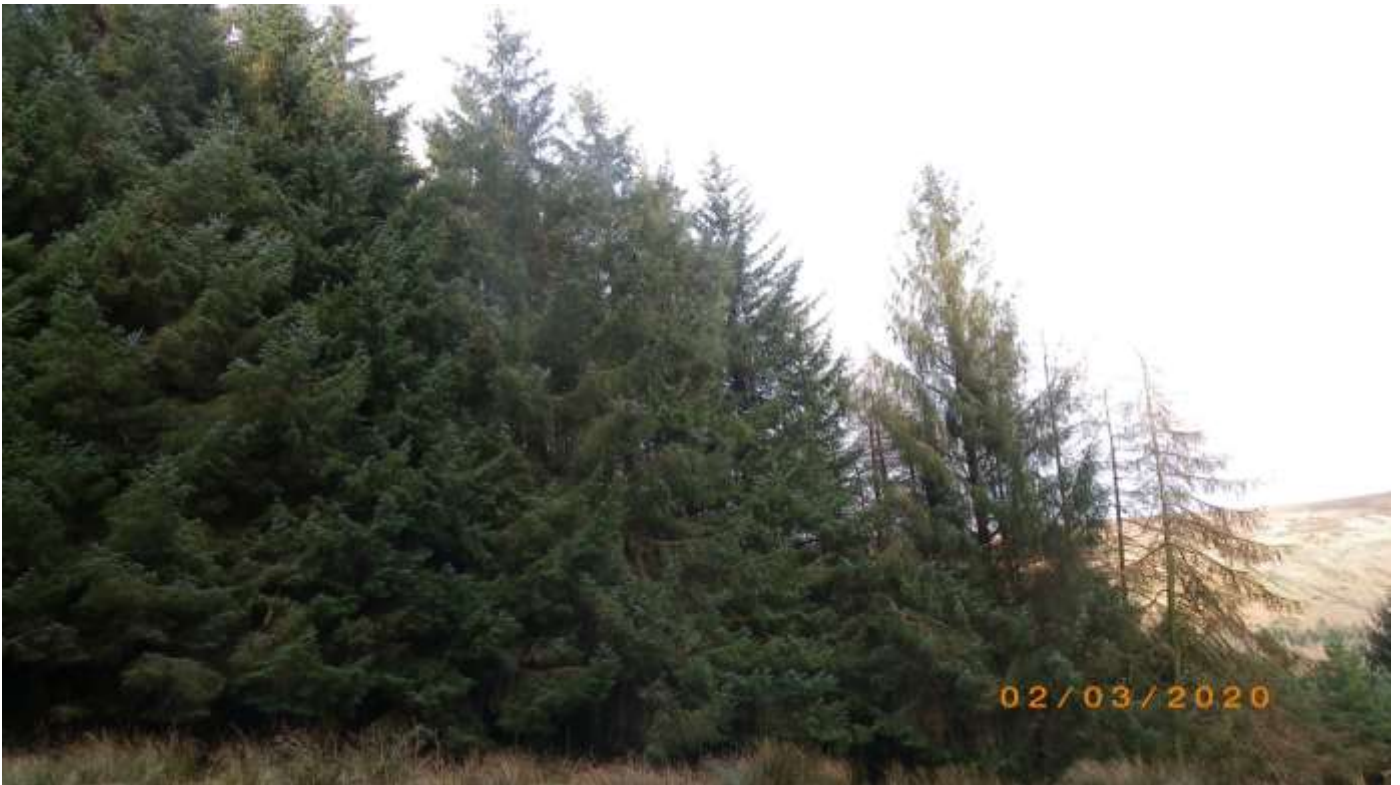
Photo 62 Cpt4b spruce in the south west of the compartment

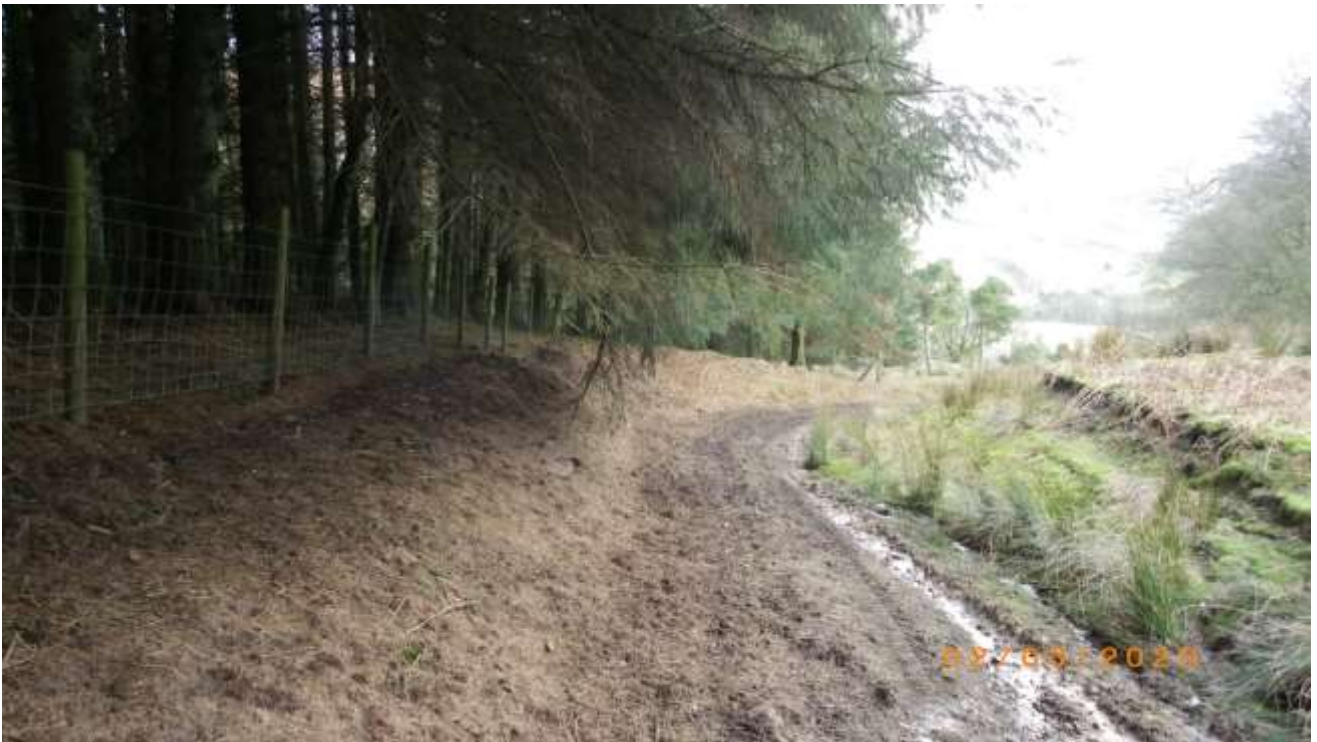
Photo 63 Cpt4b stock fence to the s/w boundary

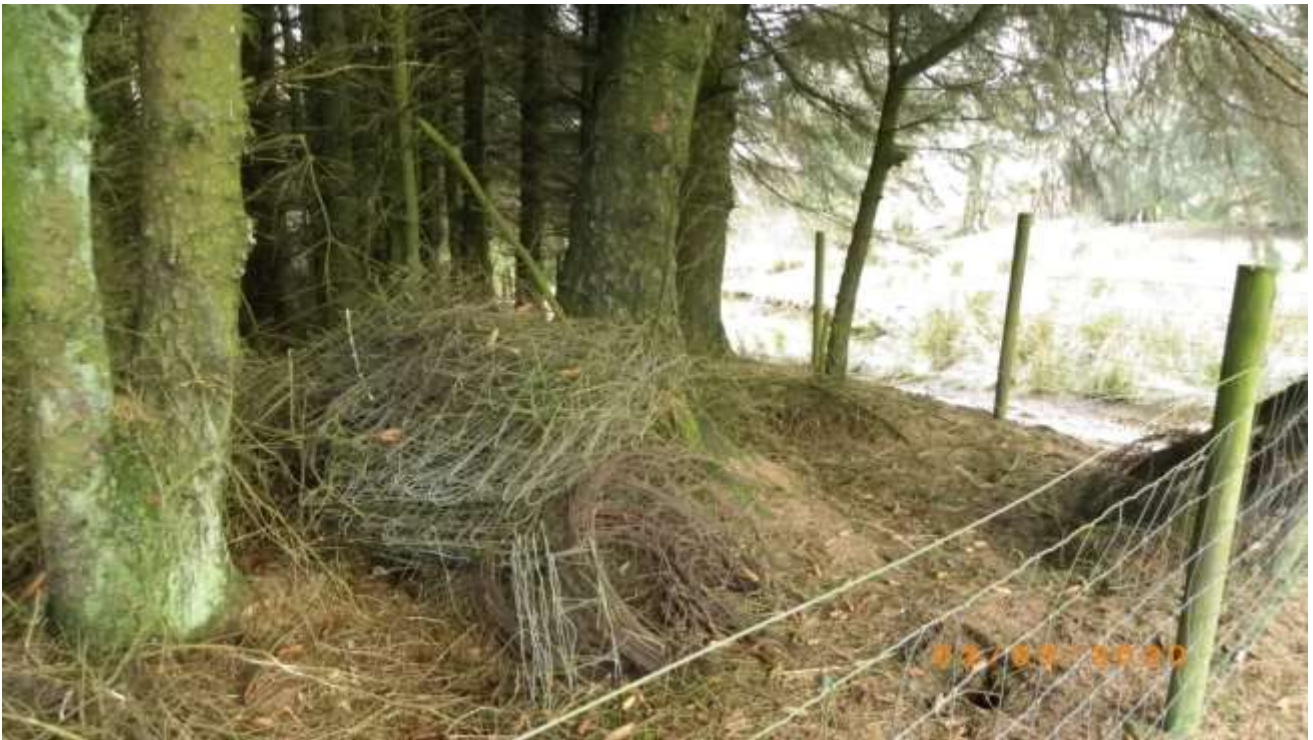
Photo 65 Cpt4b old fencing materials in s/w corner

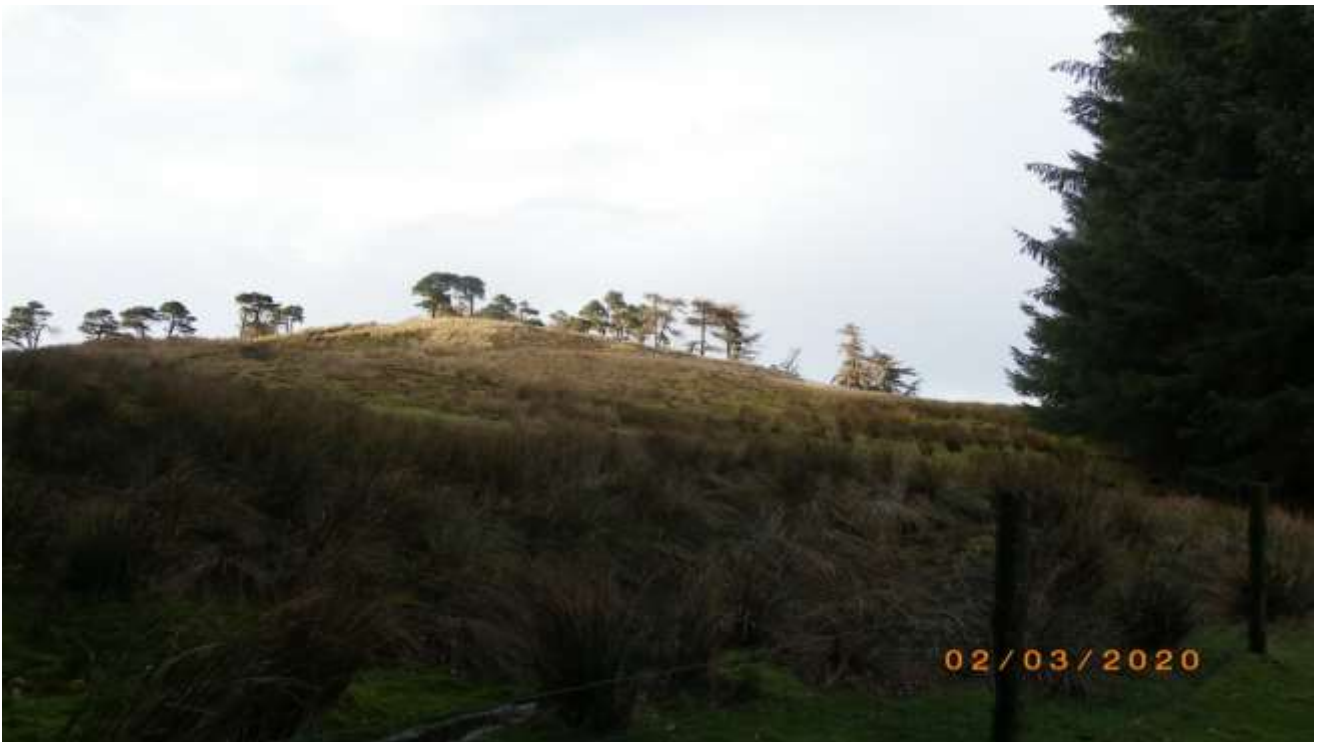
Photo 66 view to the top towards Bransdale cairn

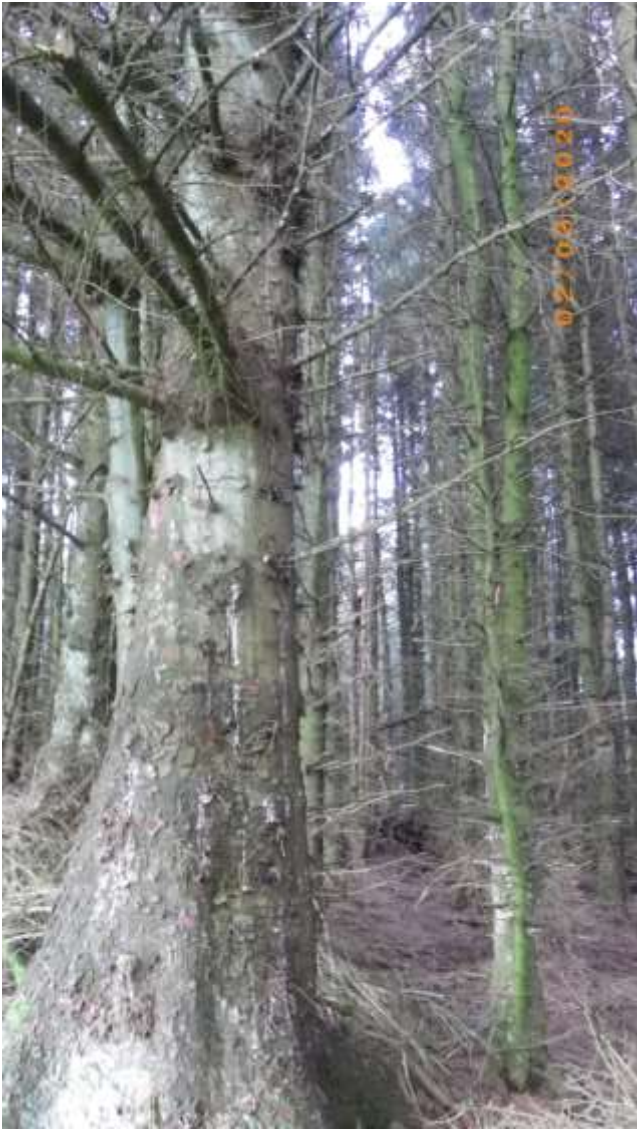
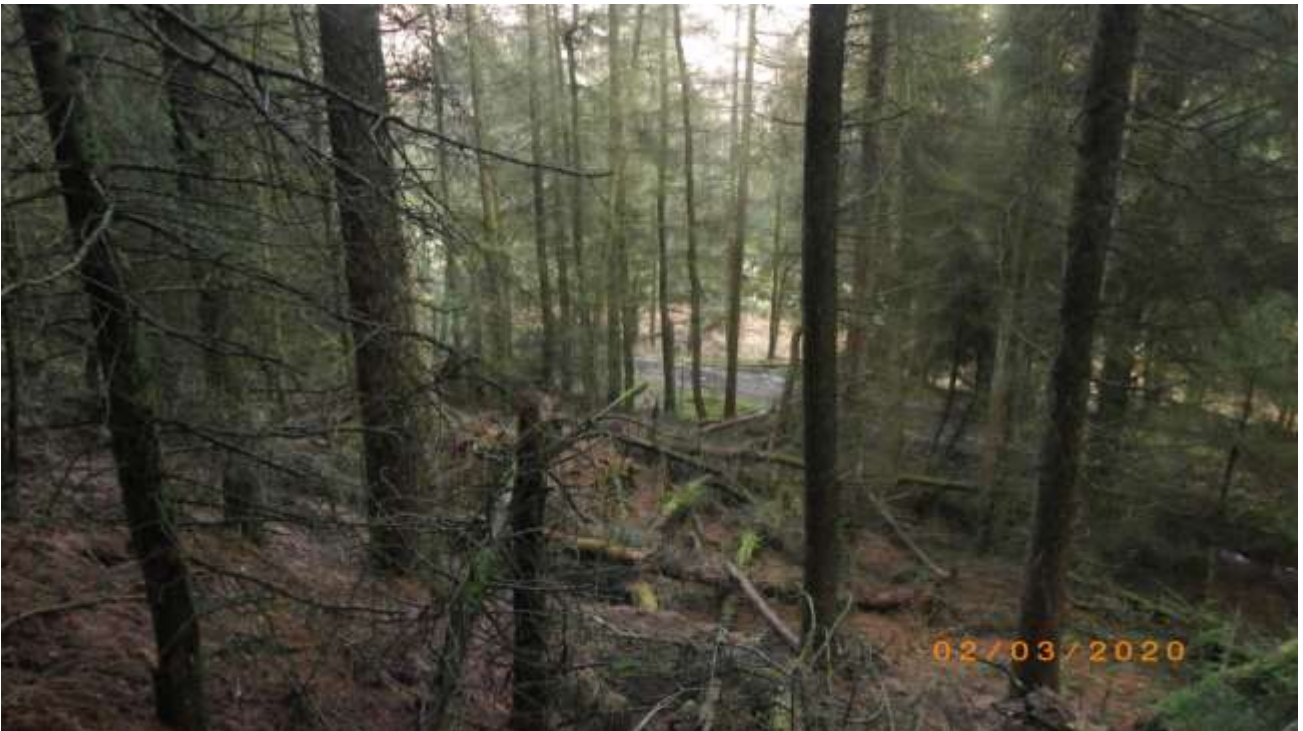
Photo 67 & 68Cpt4b untinned sitka spruce, windblow occurring, steep to track.

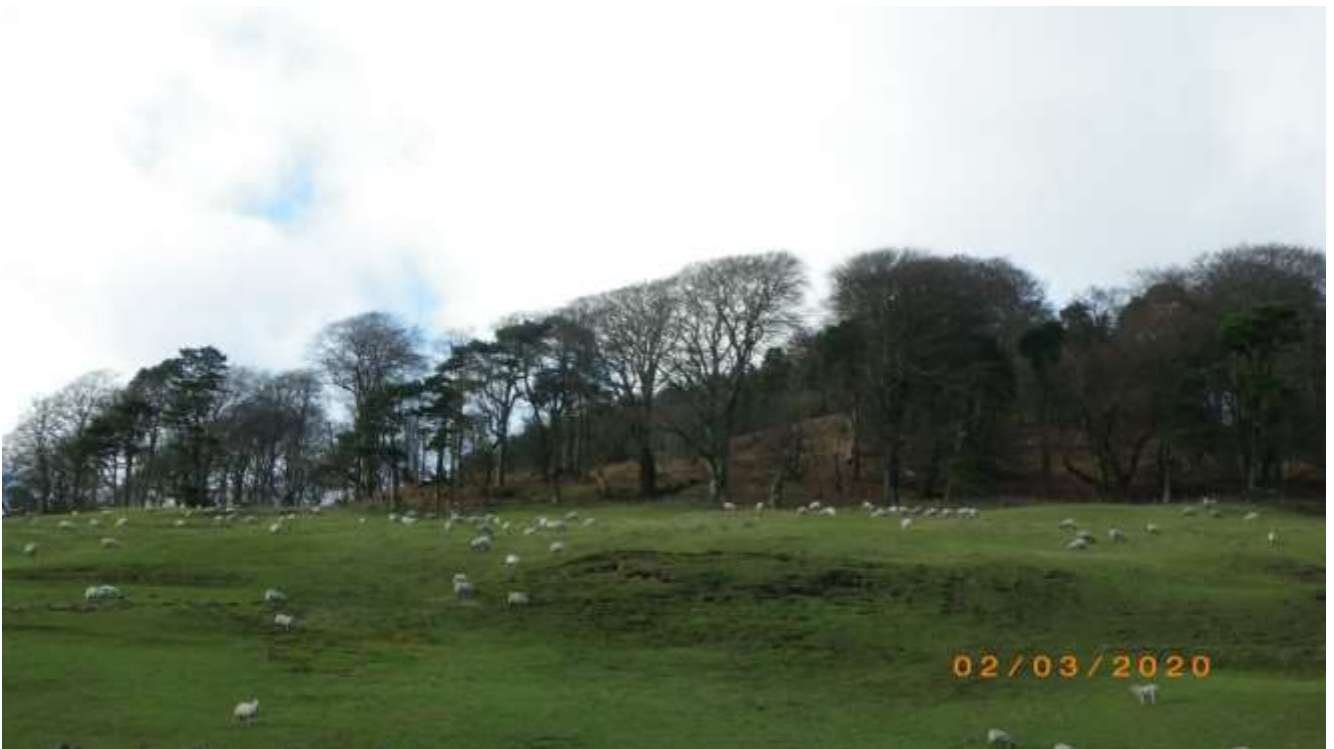
Photo 69 Looking towards cpt5a with its mature open grown trees

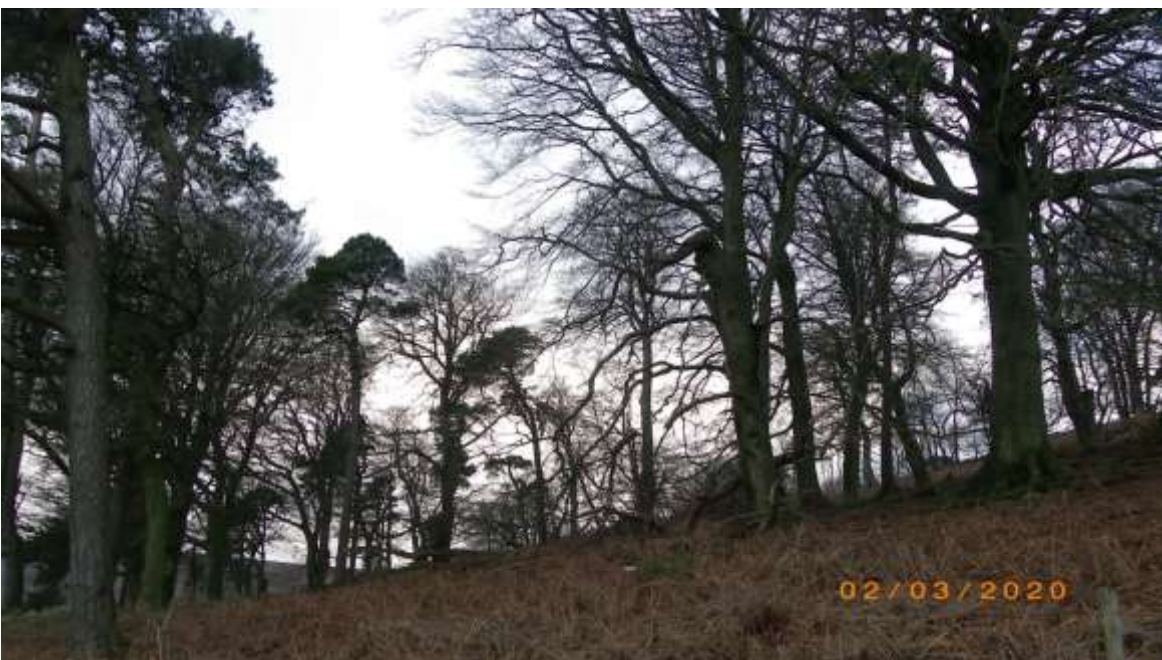
Photo 71 Cpt 5a with open grown mature pine, beech and sycamore

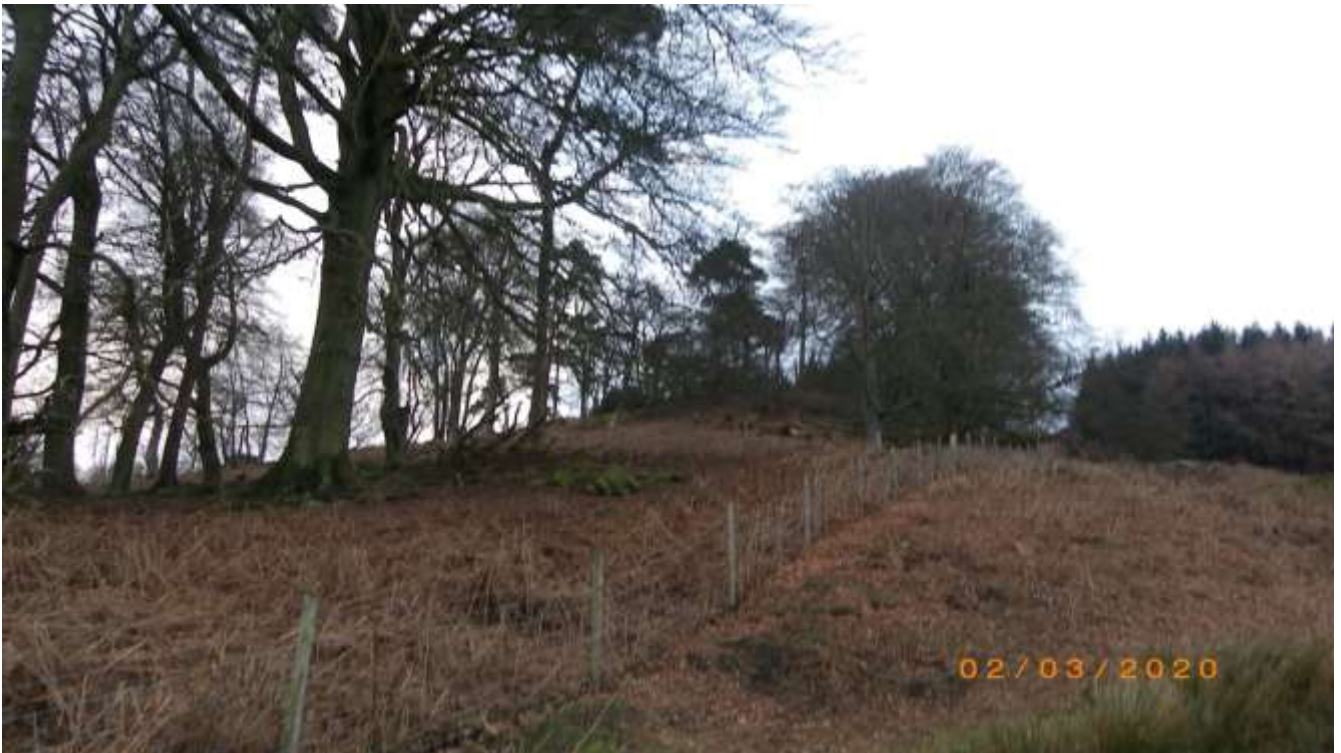
Photo 72 stock fence to eastern boundary of cpt5a

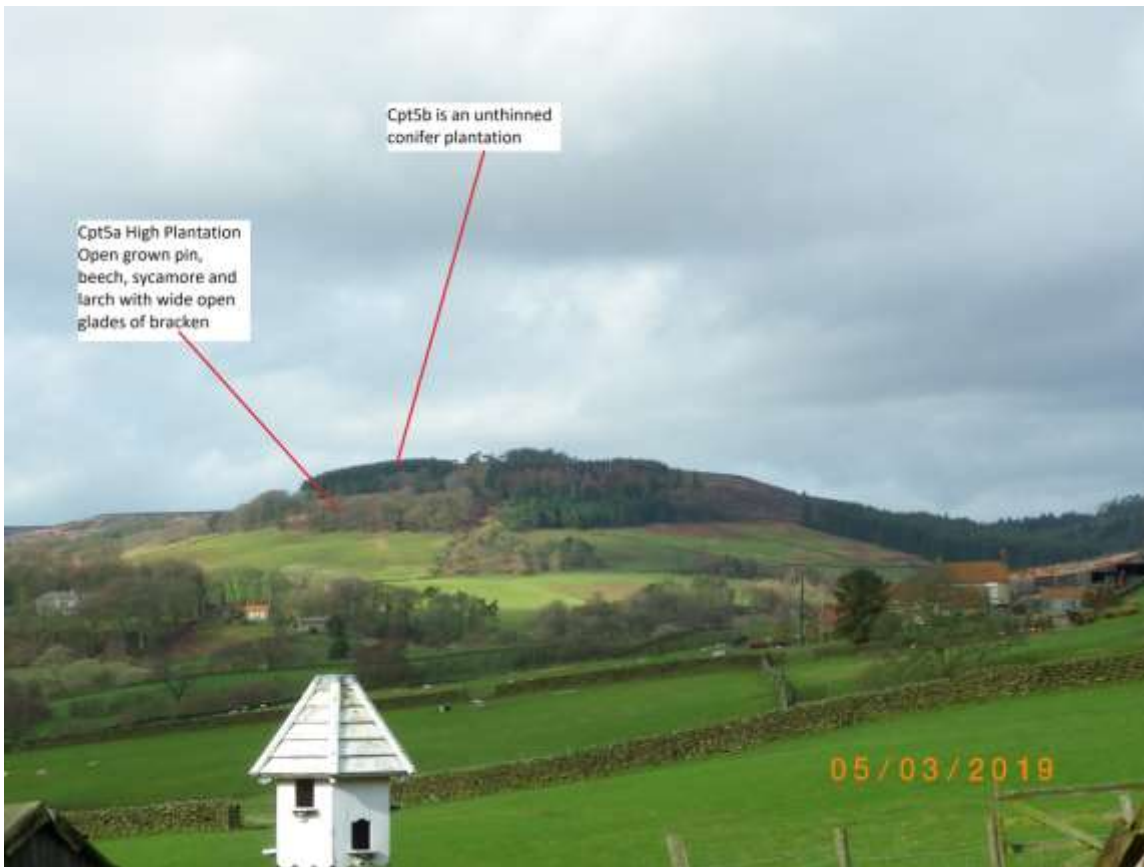
Photo 74 Cpt5 High Plantation viewed from Spout House

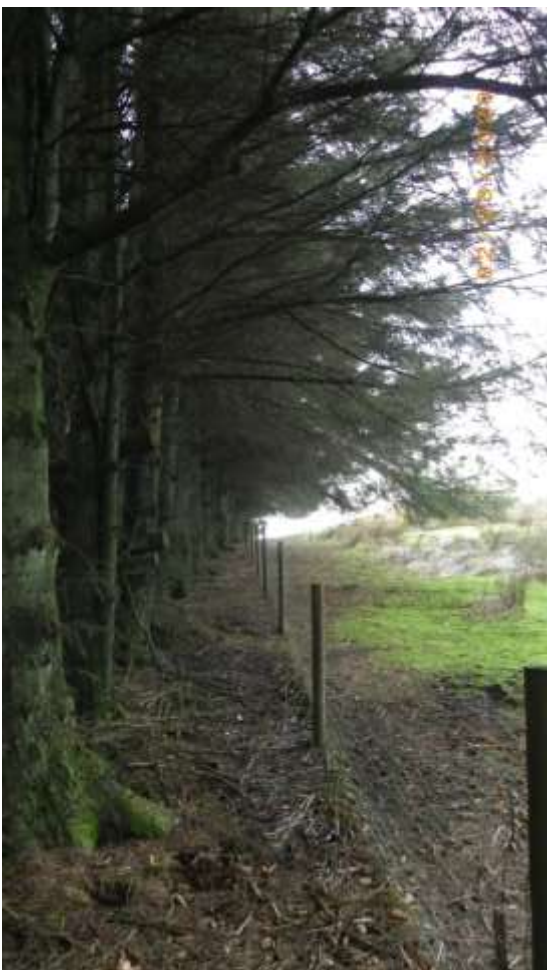
Photo 75 cpt5b the eastern stock fence
