National Trust Bransdale & Farndale Woodland Management Plan
Photo and Images Gallery 2021

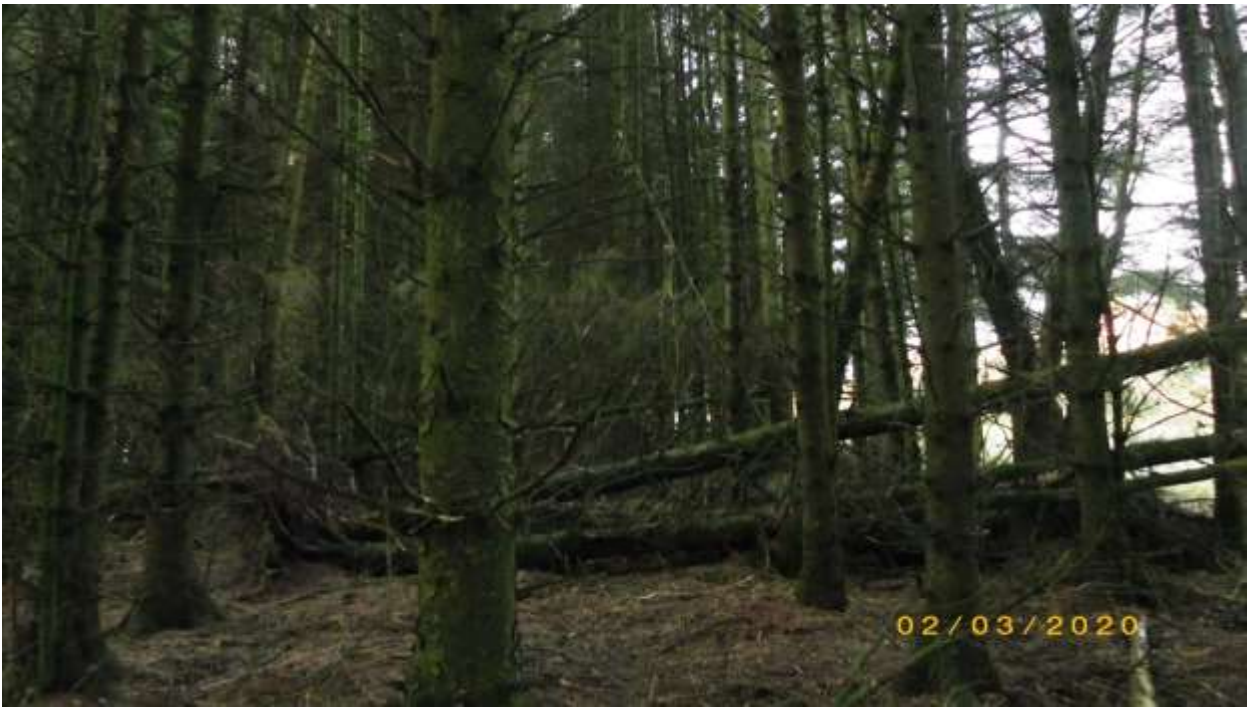
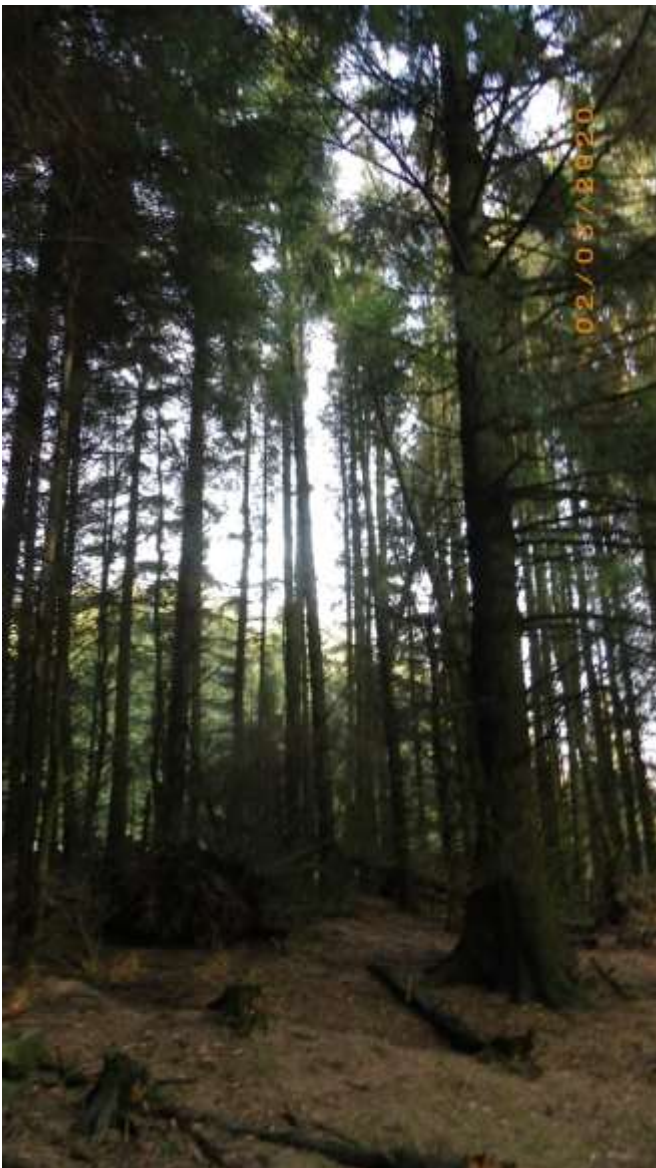
Photo 76 & 77 Cpt5b dense unthinned stand of spruce with a pine edge

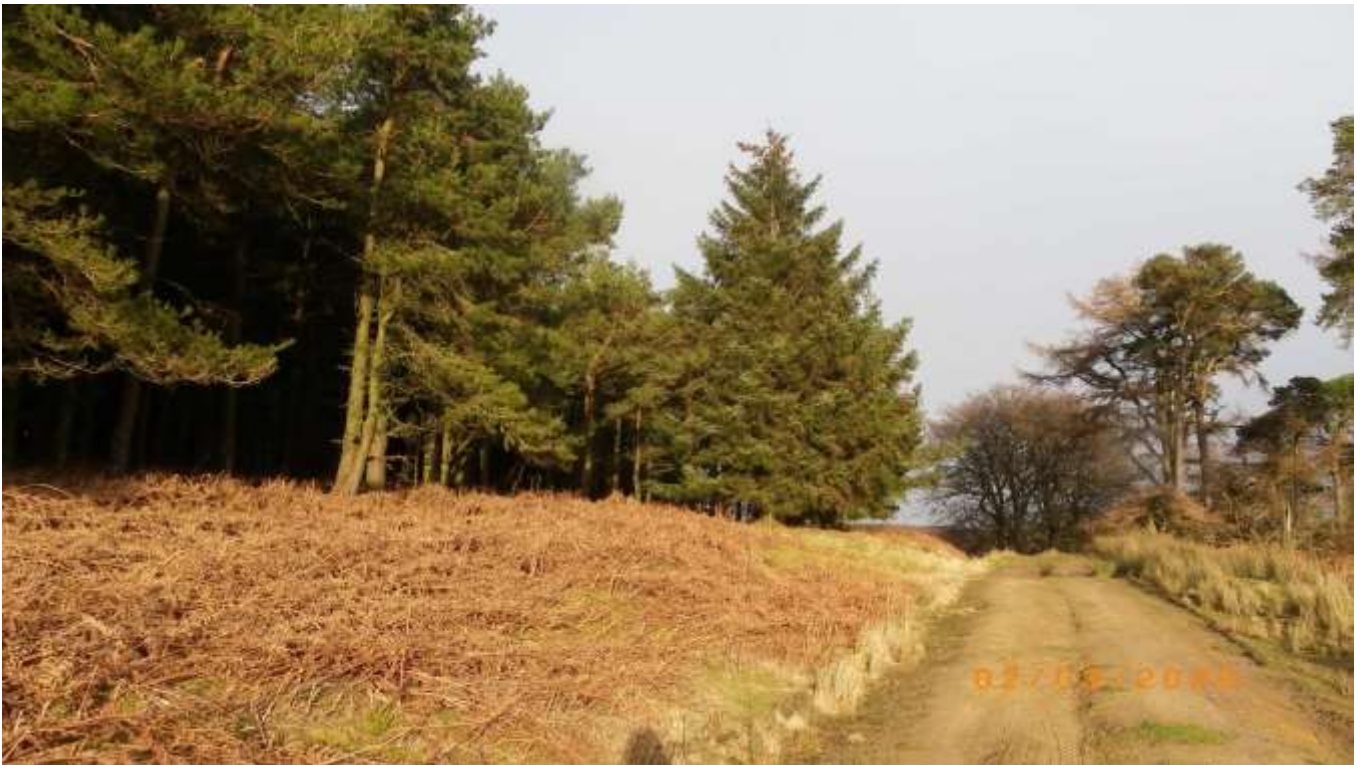
Photo 78 pine edge to cpt5b the southern facing edge

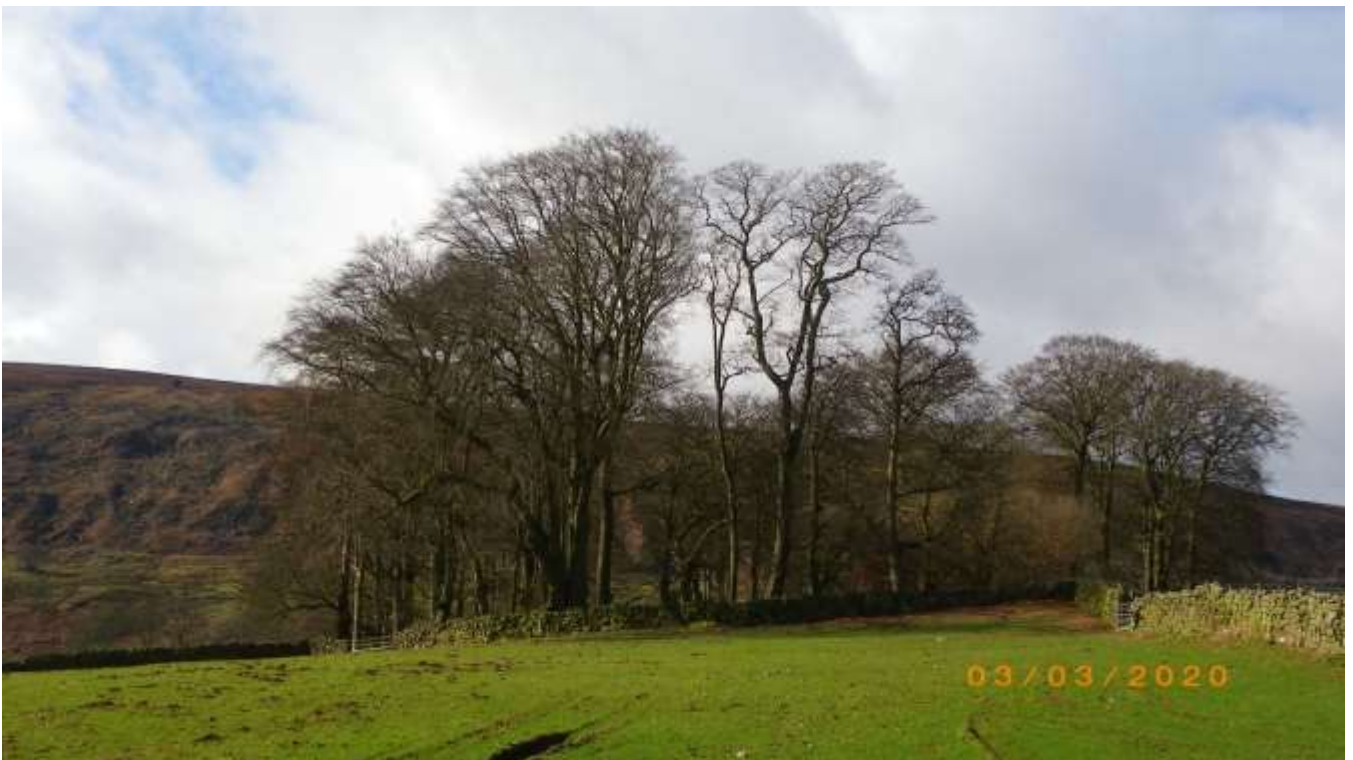
Photo 79 direction west looking at cpt6 Round Plantation

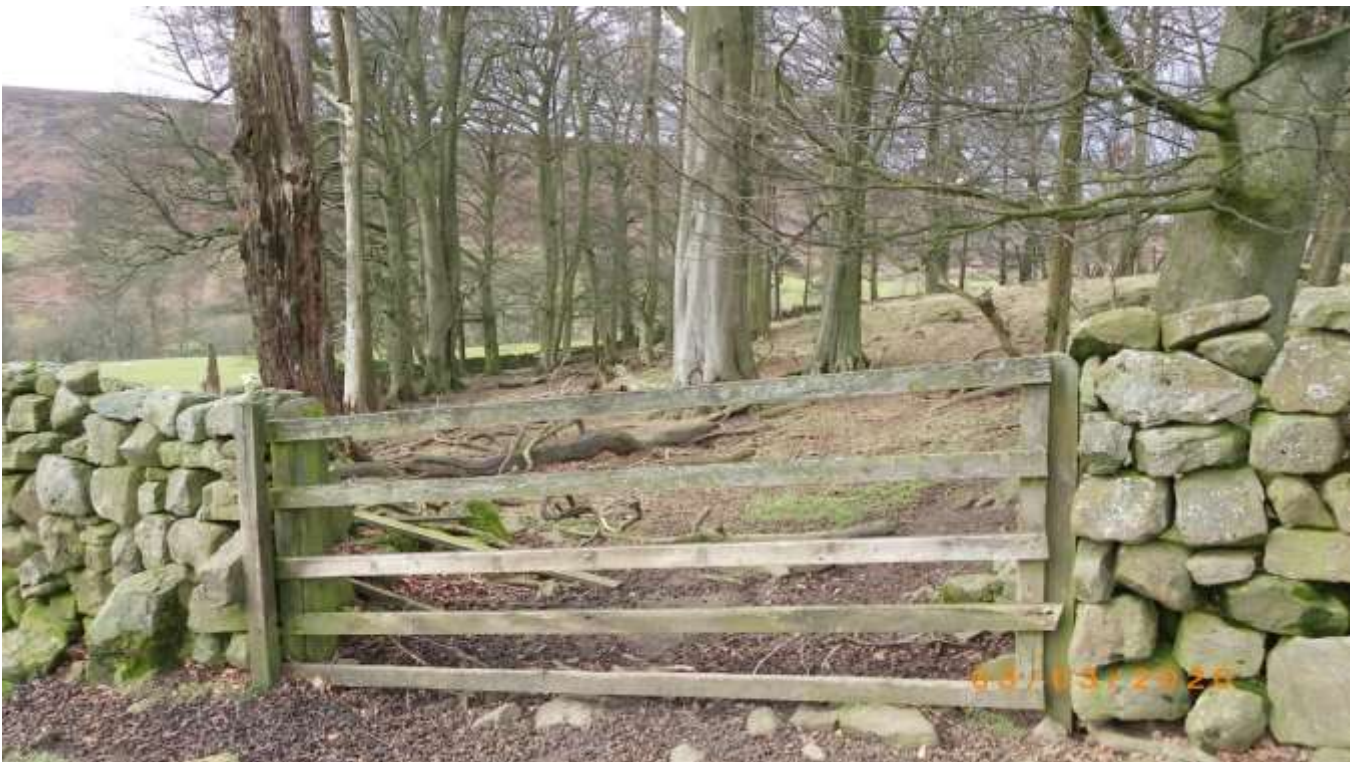
Photo 81 Cpt6 Round Plantation standing and fallen deadwood present

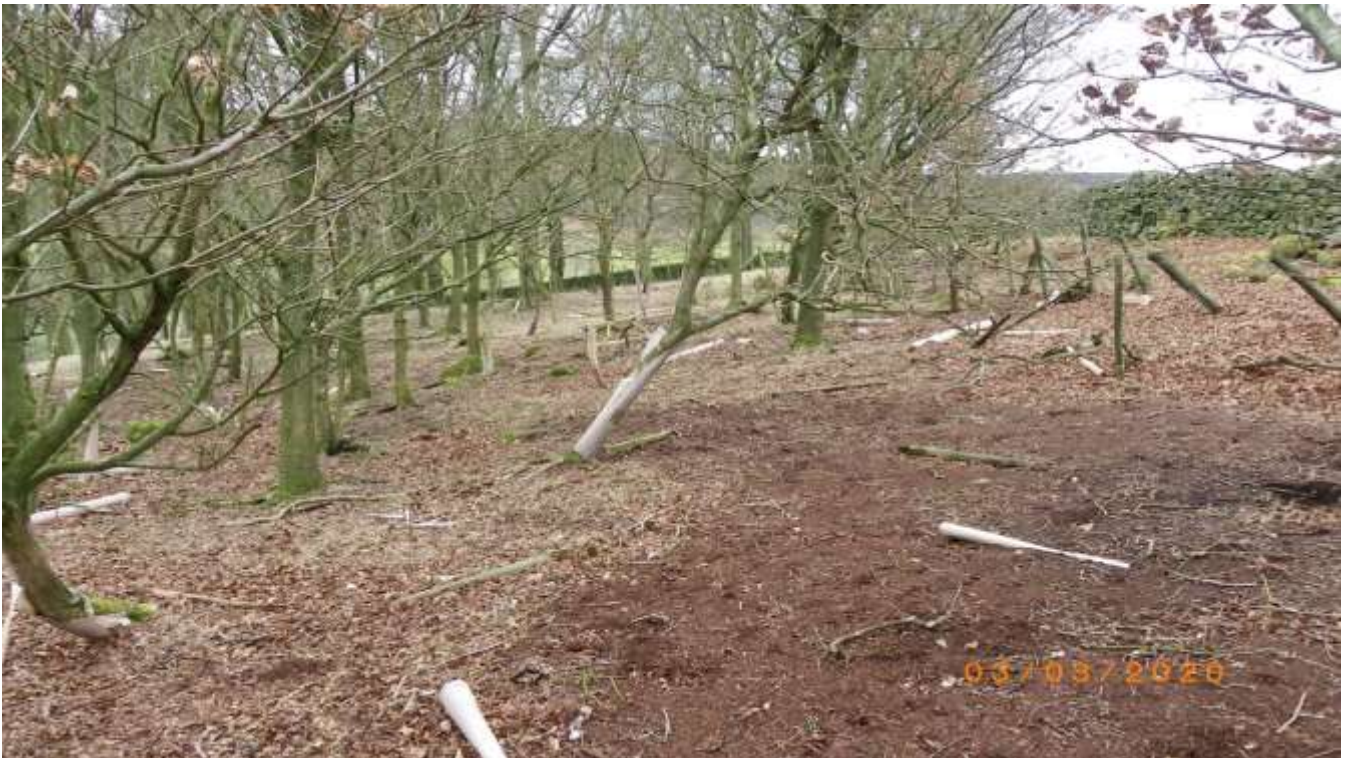
Photo 84 Cpt6a internal rabbit fence present but down and breached

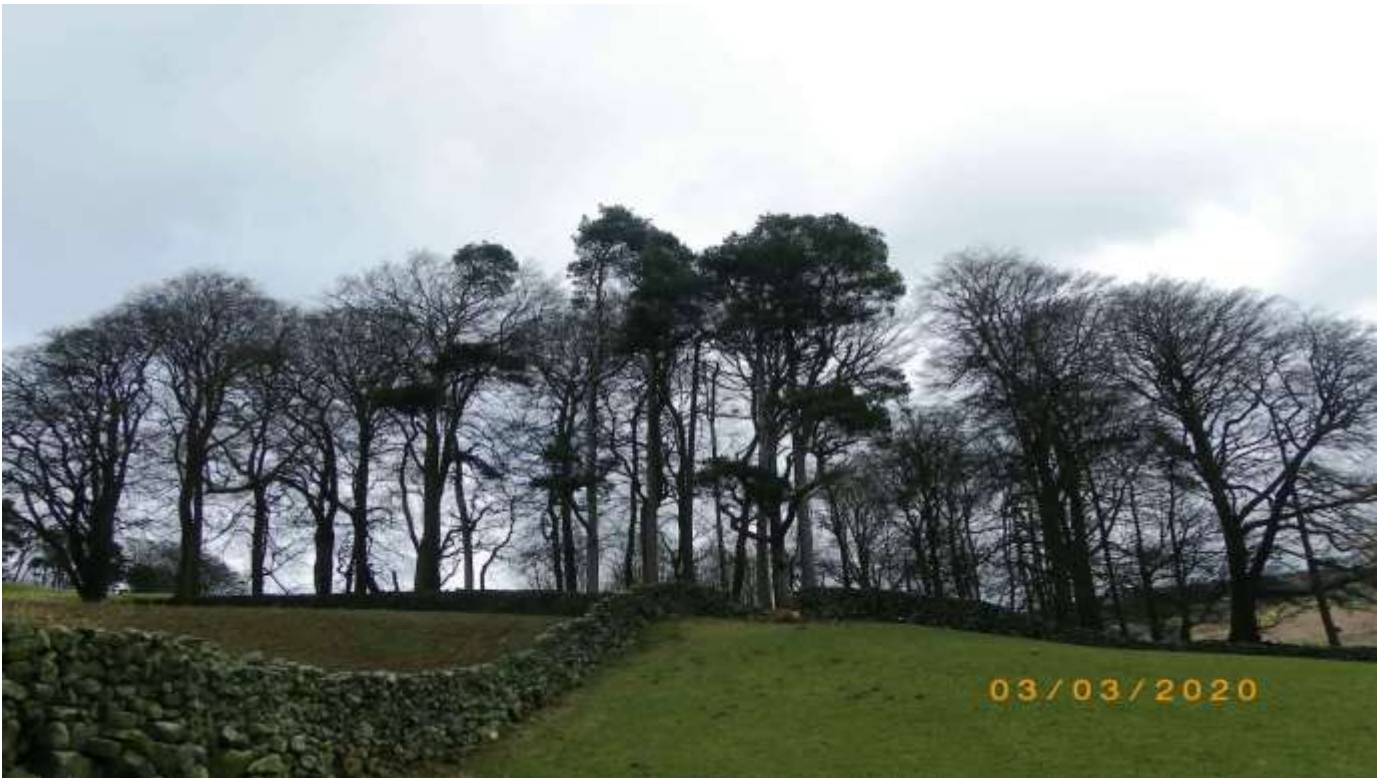
Photo 86 View of Round Plantation looking north east

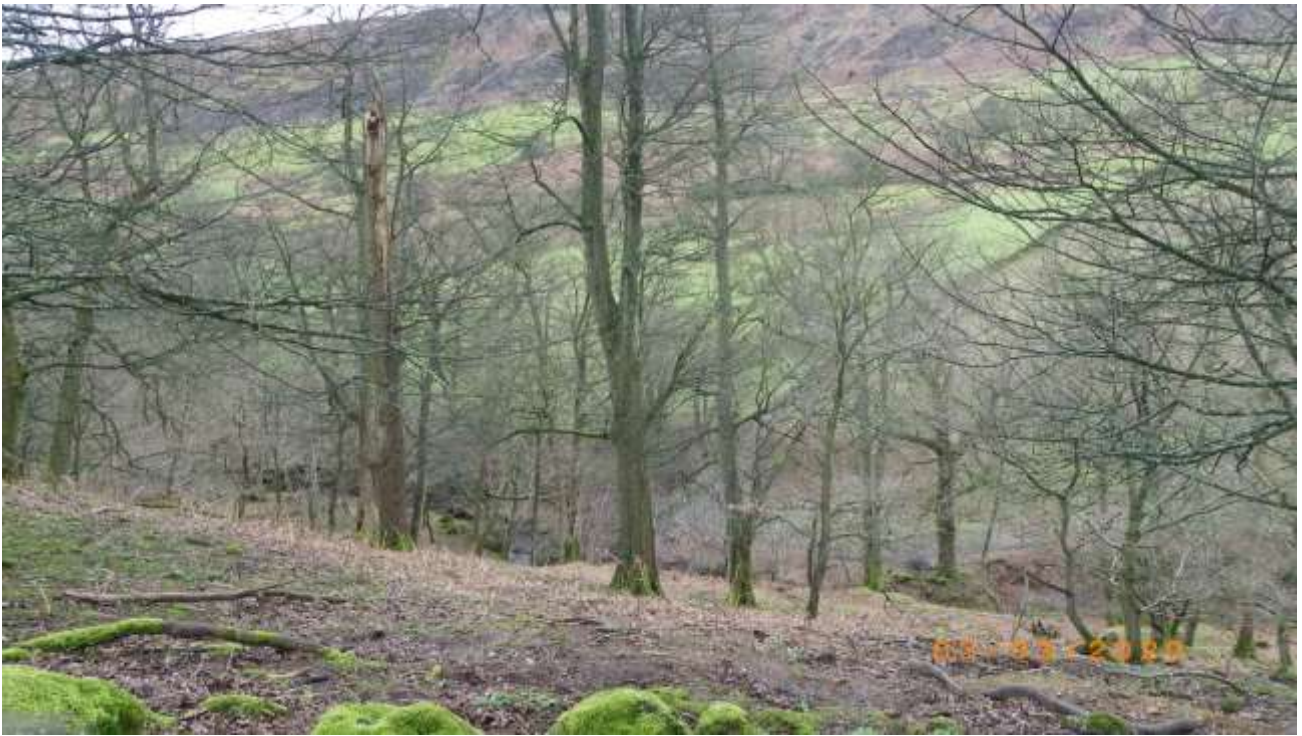
Photo 87 Cpt7a the wet facing slope of Beck Plantation

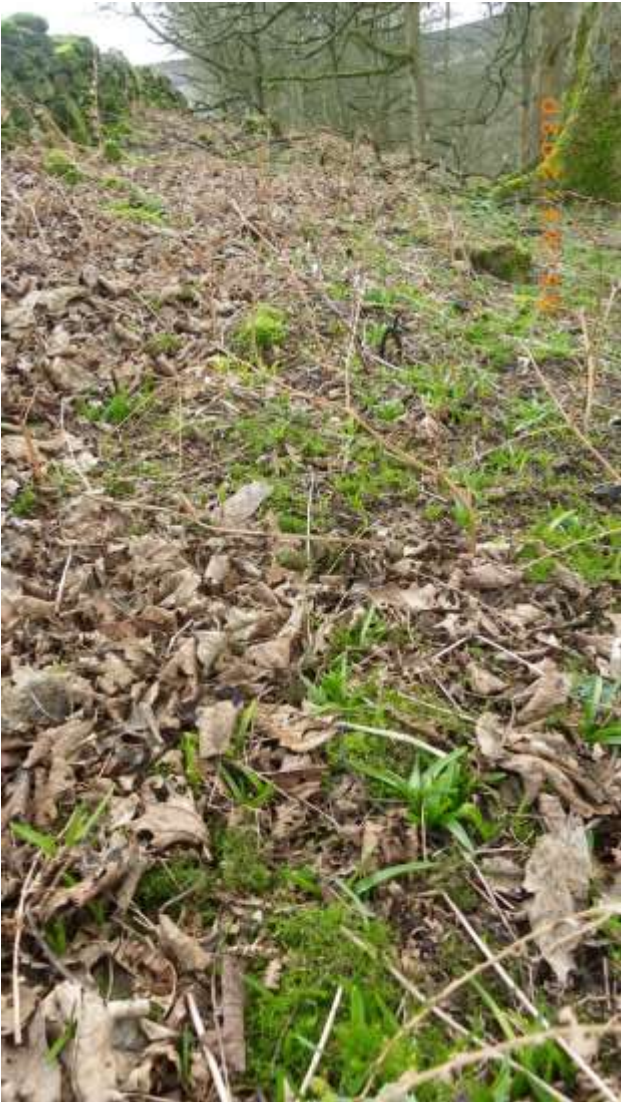
Photo 89 Cpt7a Beck Plantation generally good leaf litter, bluebells abundant with primroses.

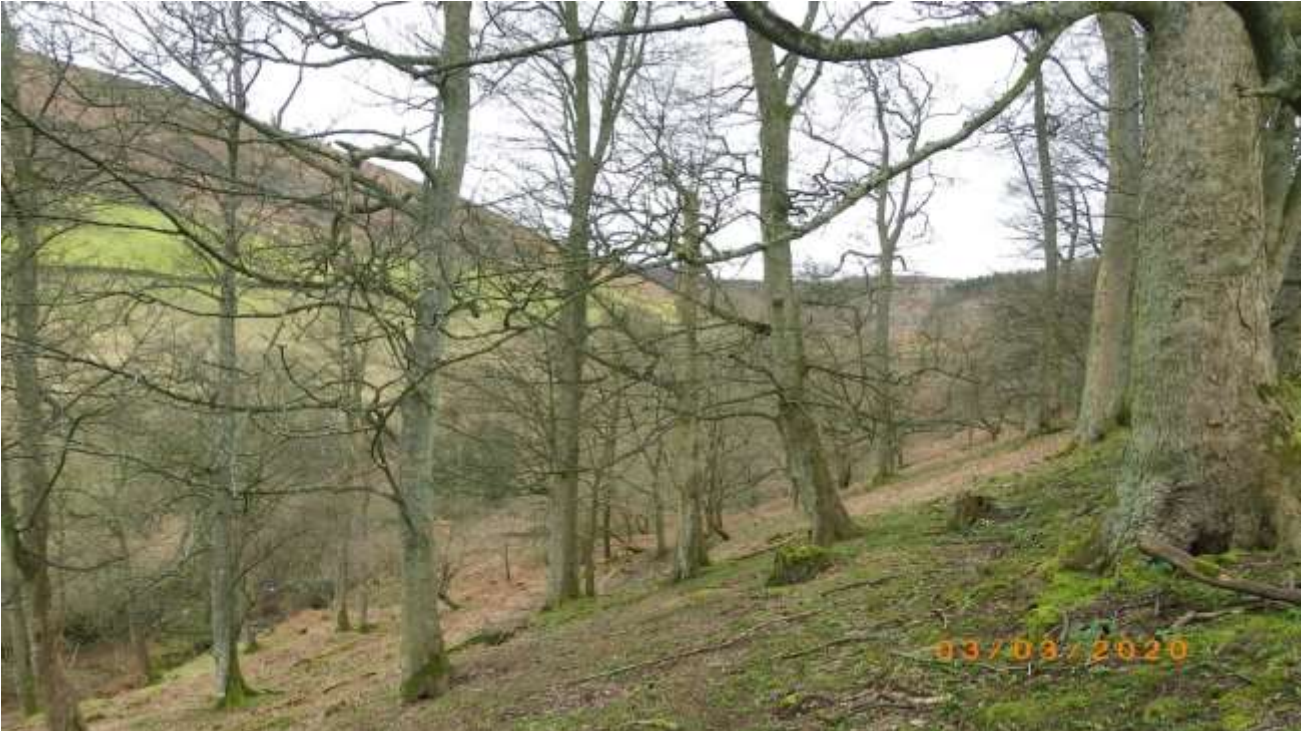
Photo 90 cpt7a mature sycamore dominant

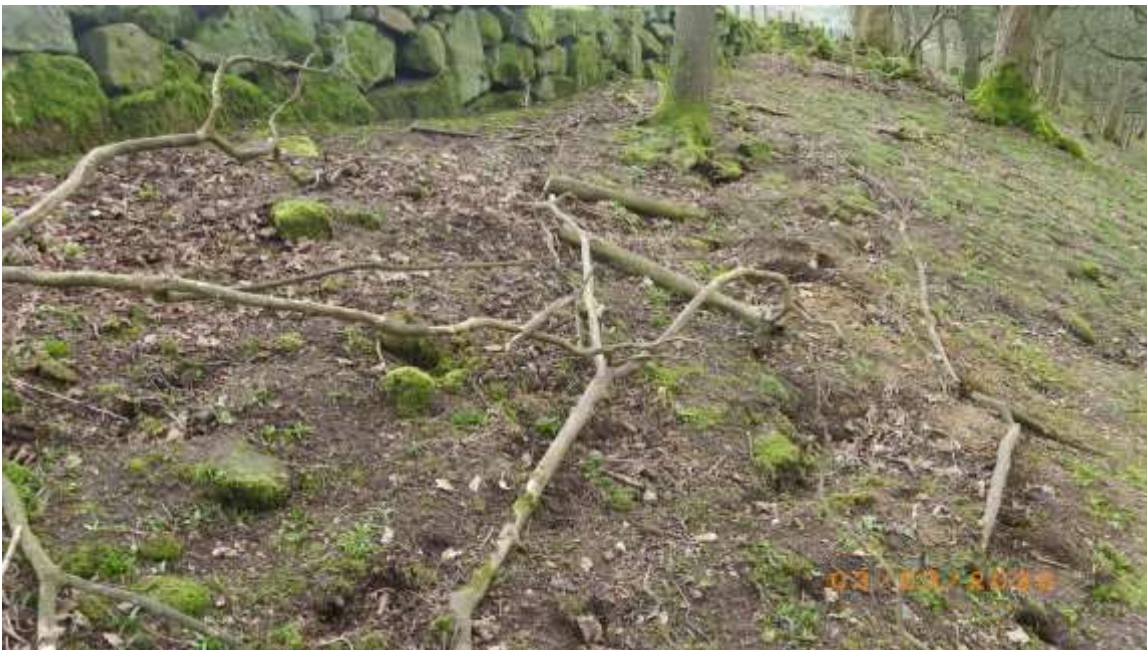
Photo 92 evidence of rabbit activity Beck Plantation

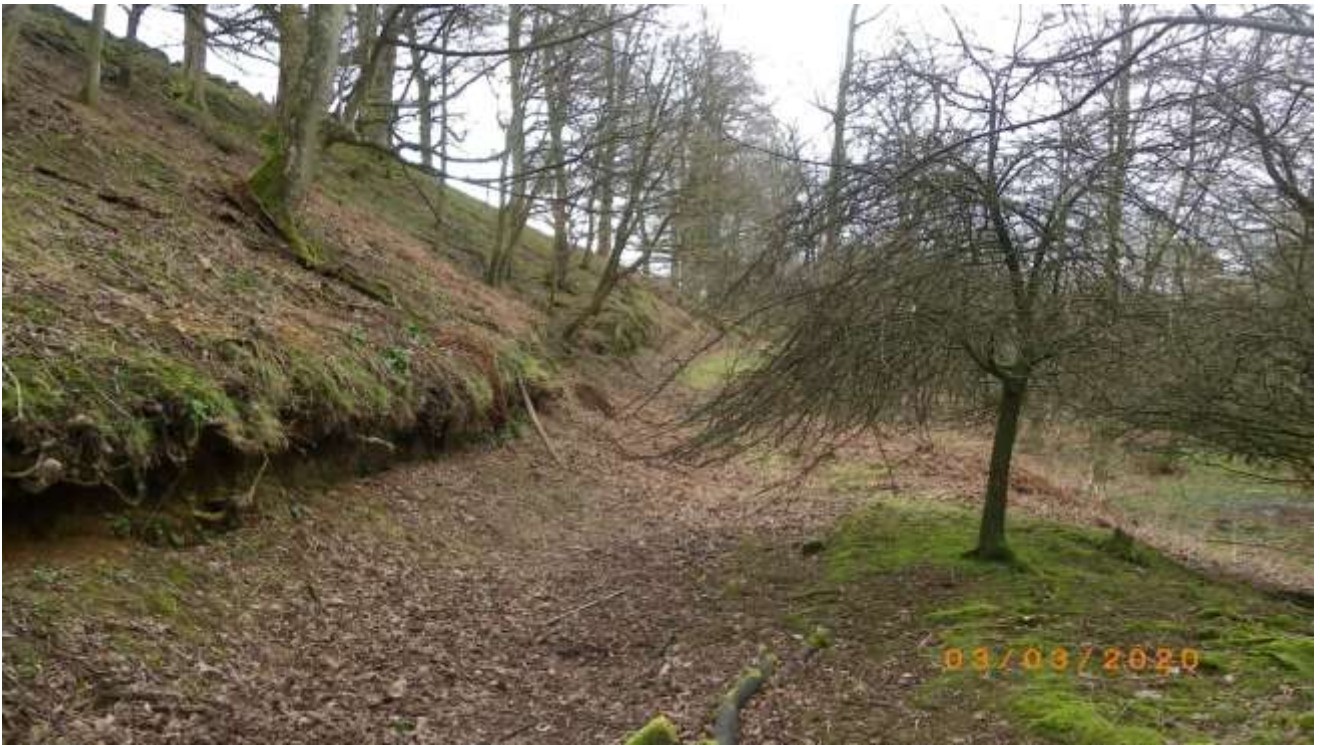
Photo 93 Cpt7a Beck Plantation benched track within the wood for access

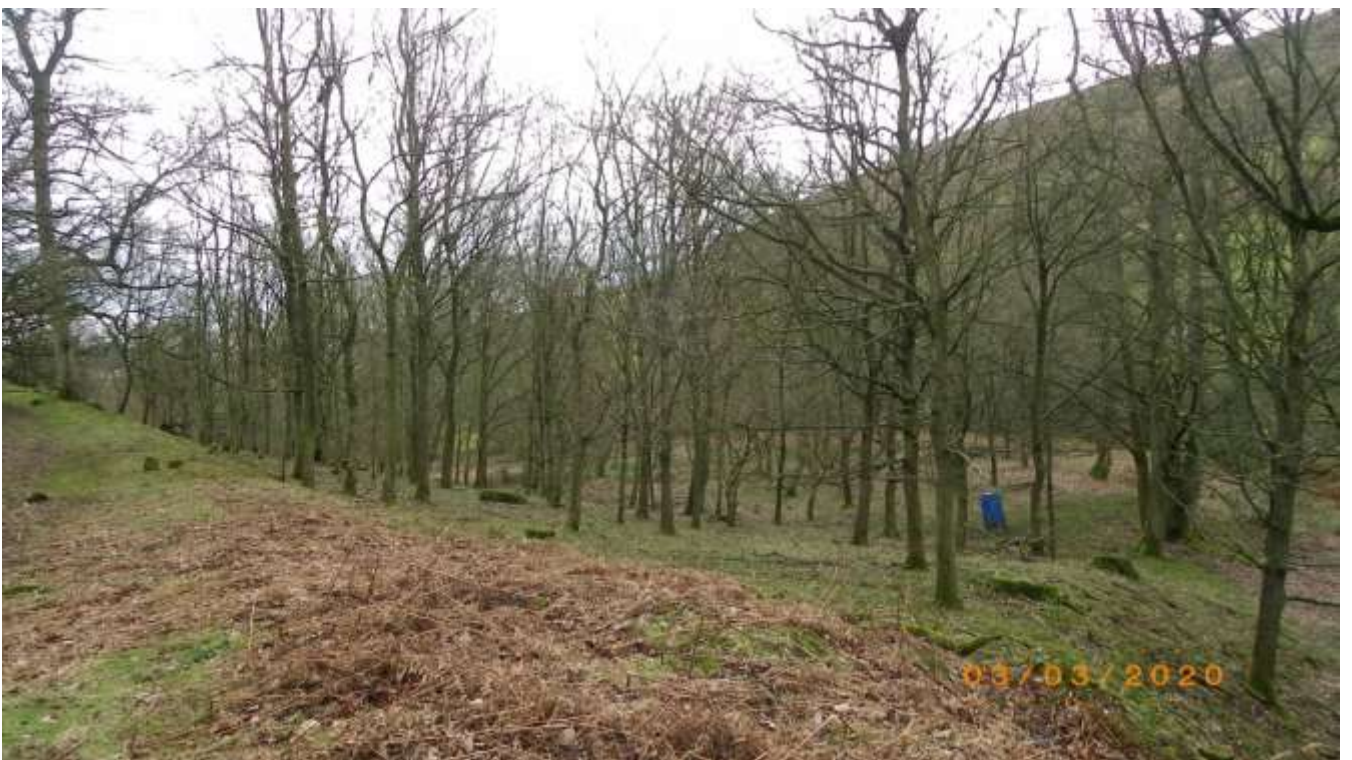
Photo 95 & 96 Beck Plantation Cpt7a with wet open glades and alder carr along the riparian zone to Hodge Beck

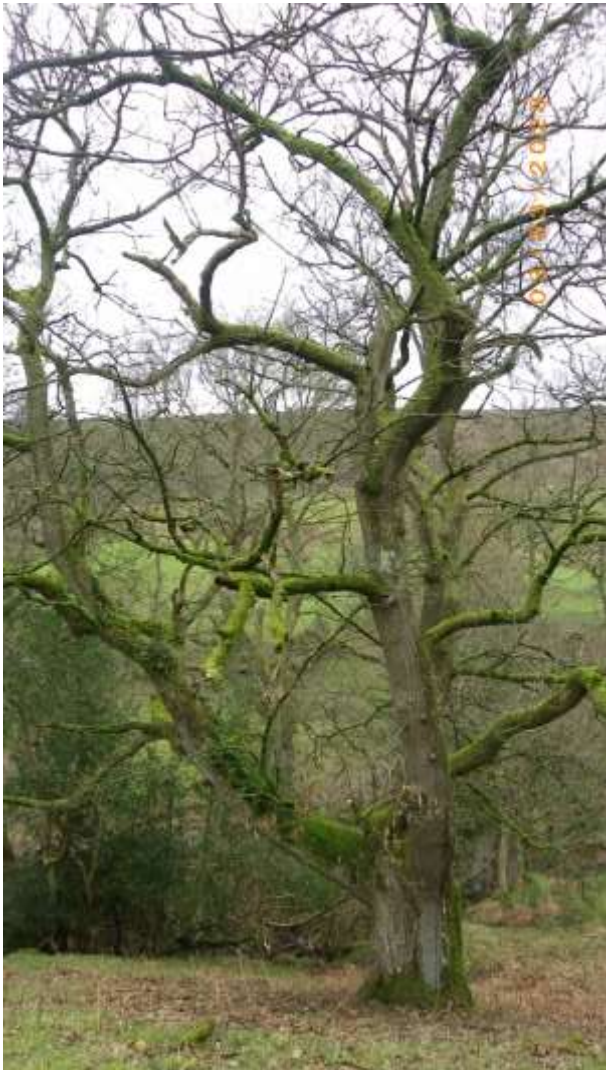
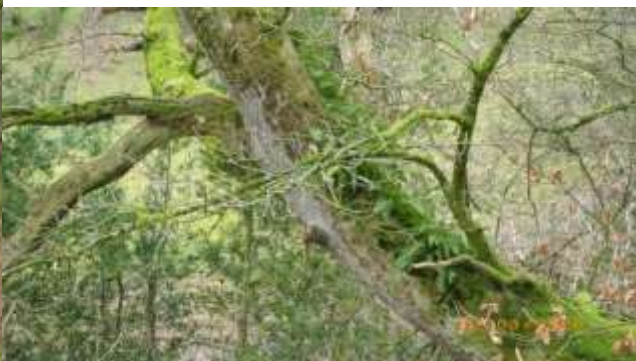
Photo 98 & 99 mature oak with polypody fern on old thick branch

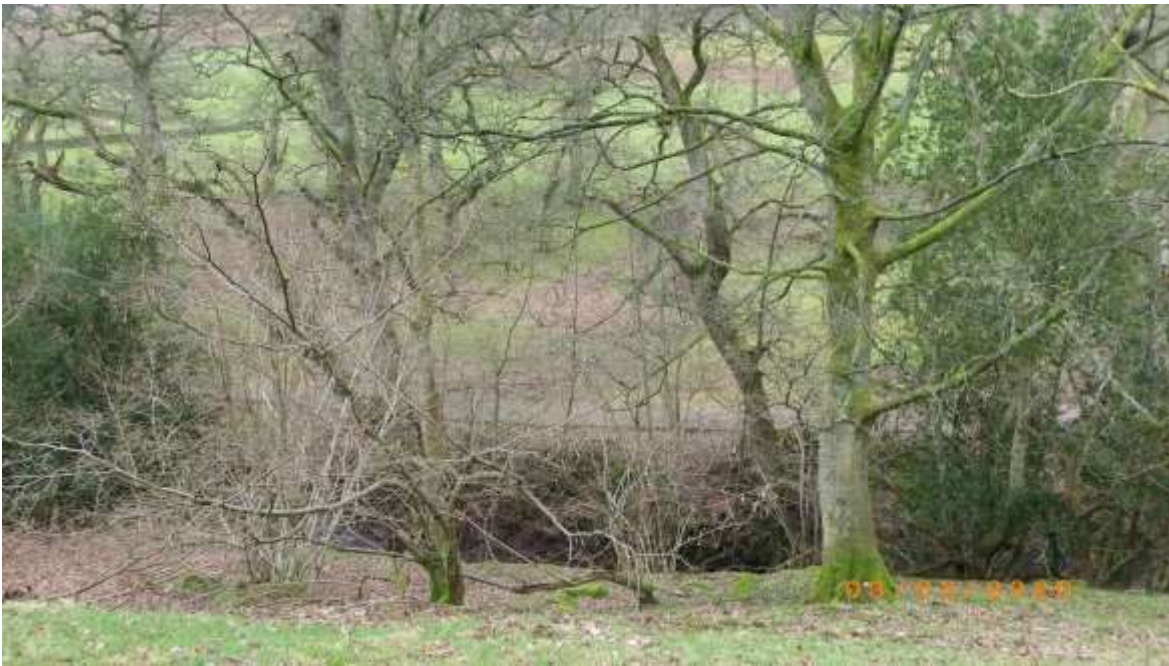
Photo 100 Cpt7a good understorey in places hazel, holly and thorn

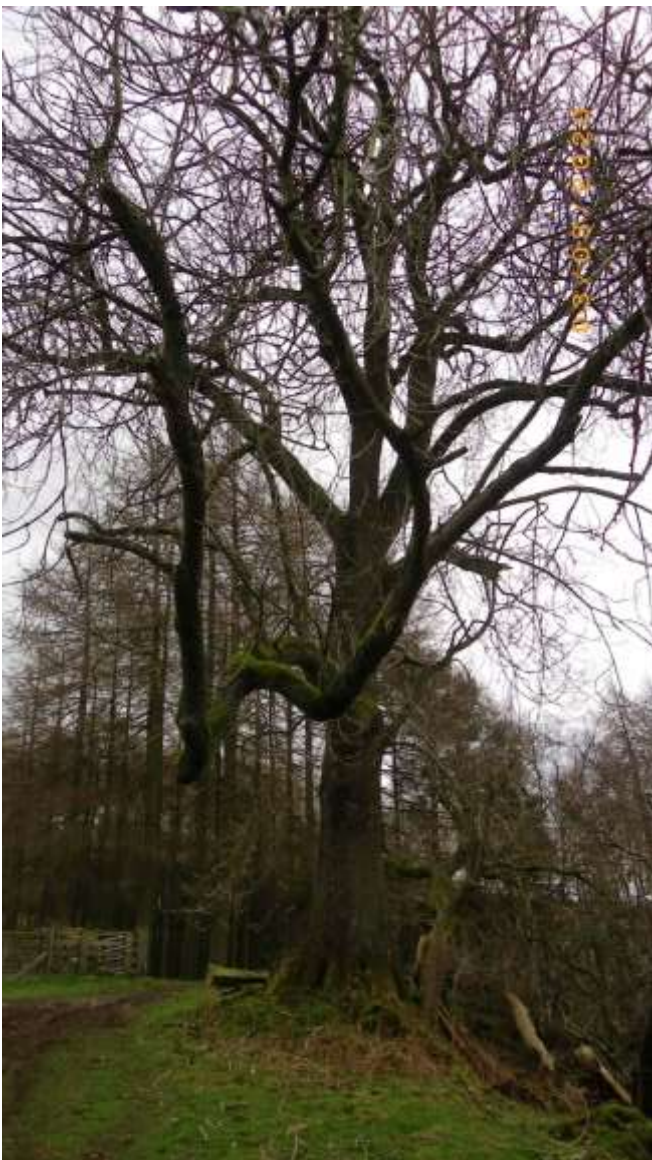
Photo 102 Cpt7a mature ash near track at south east entrance point

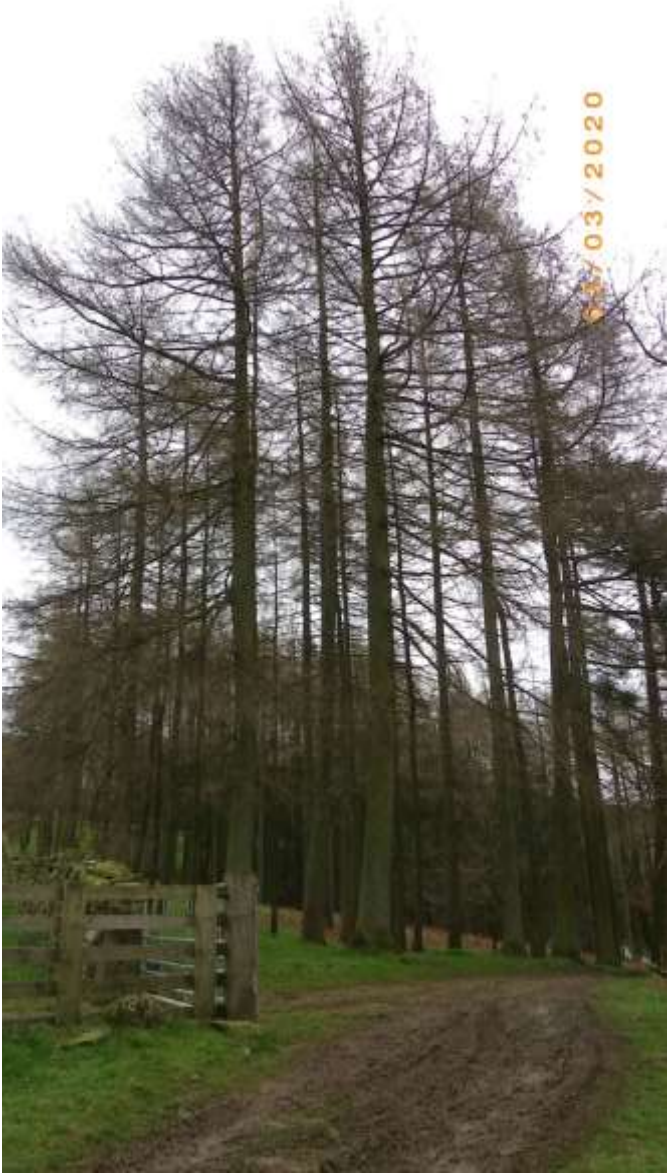
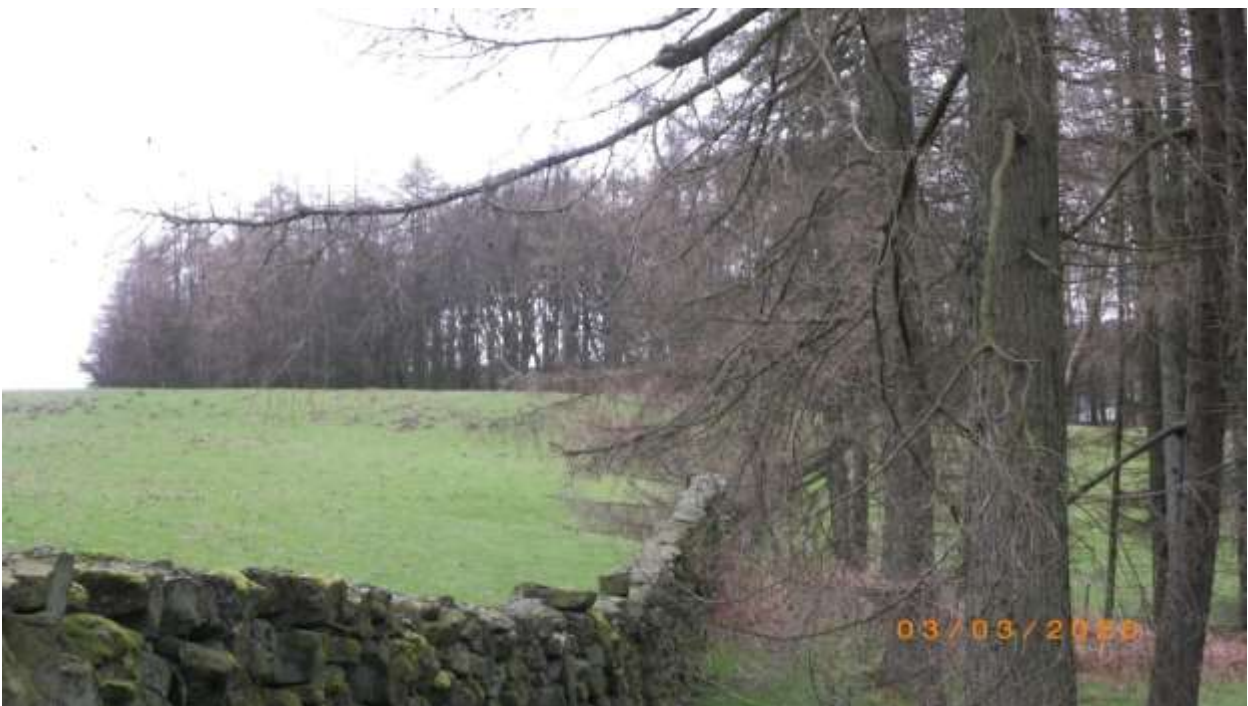
Photo 103 & 104 Cpt7b larch plantation at the back of Bransdale Lodge

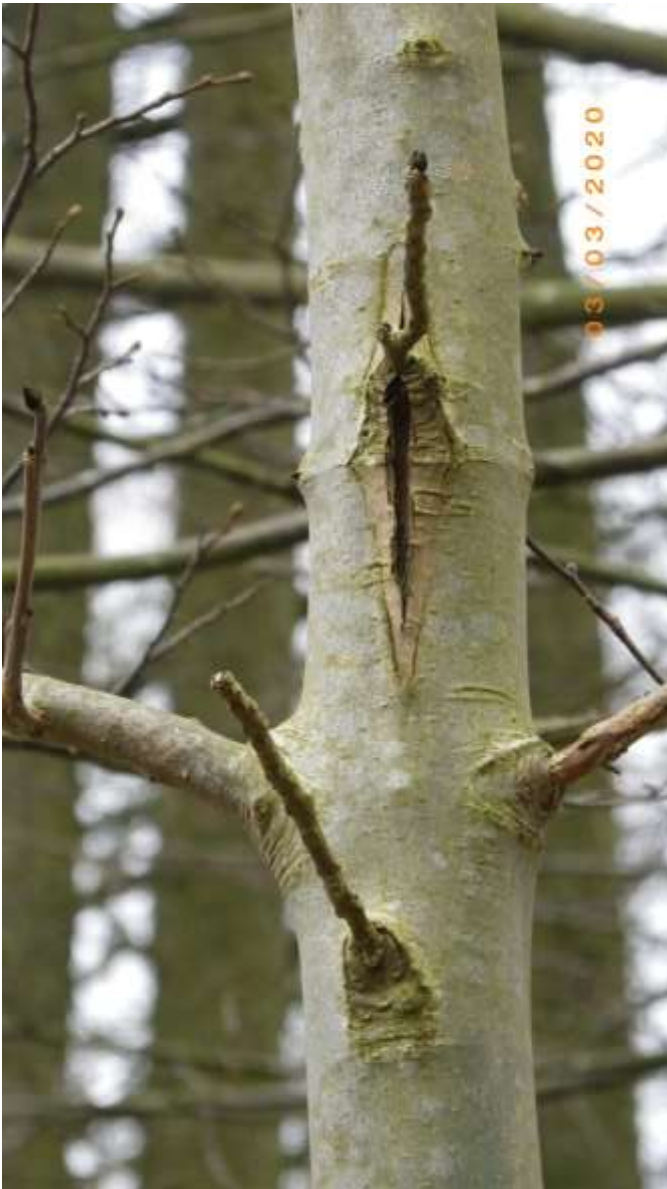
Photo 105 cpt7b Hall Wood young ash showinh ash dieback symptoms

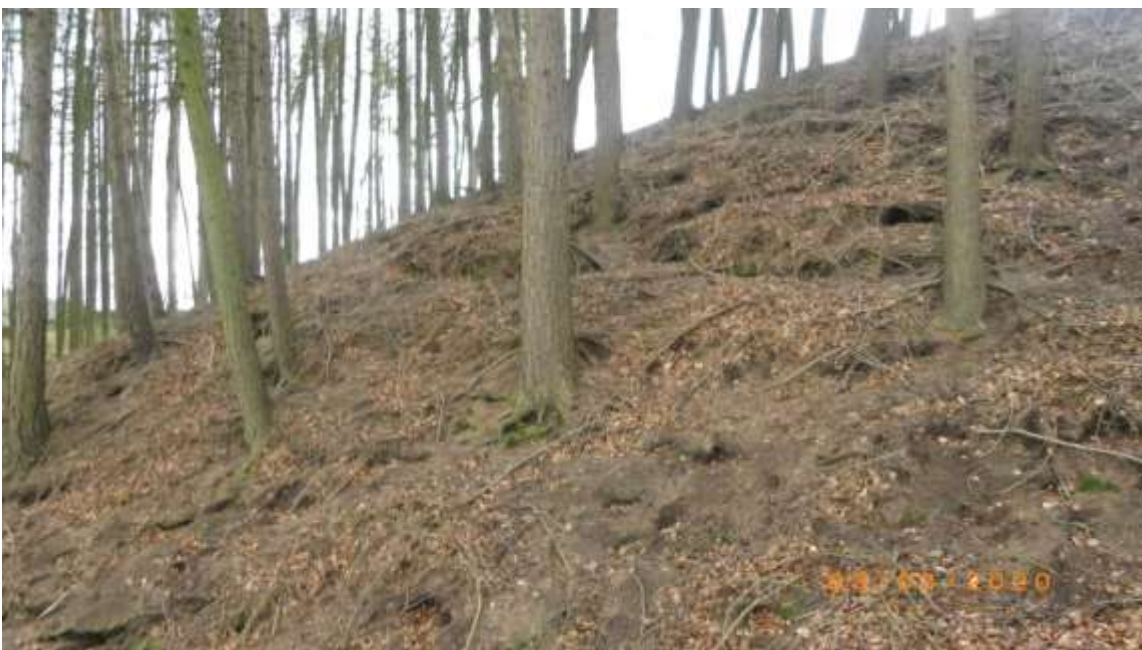
Photo 106 Cpt7b rabbit warren in the bank

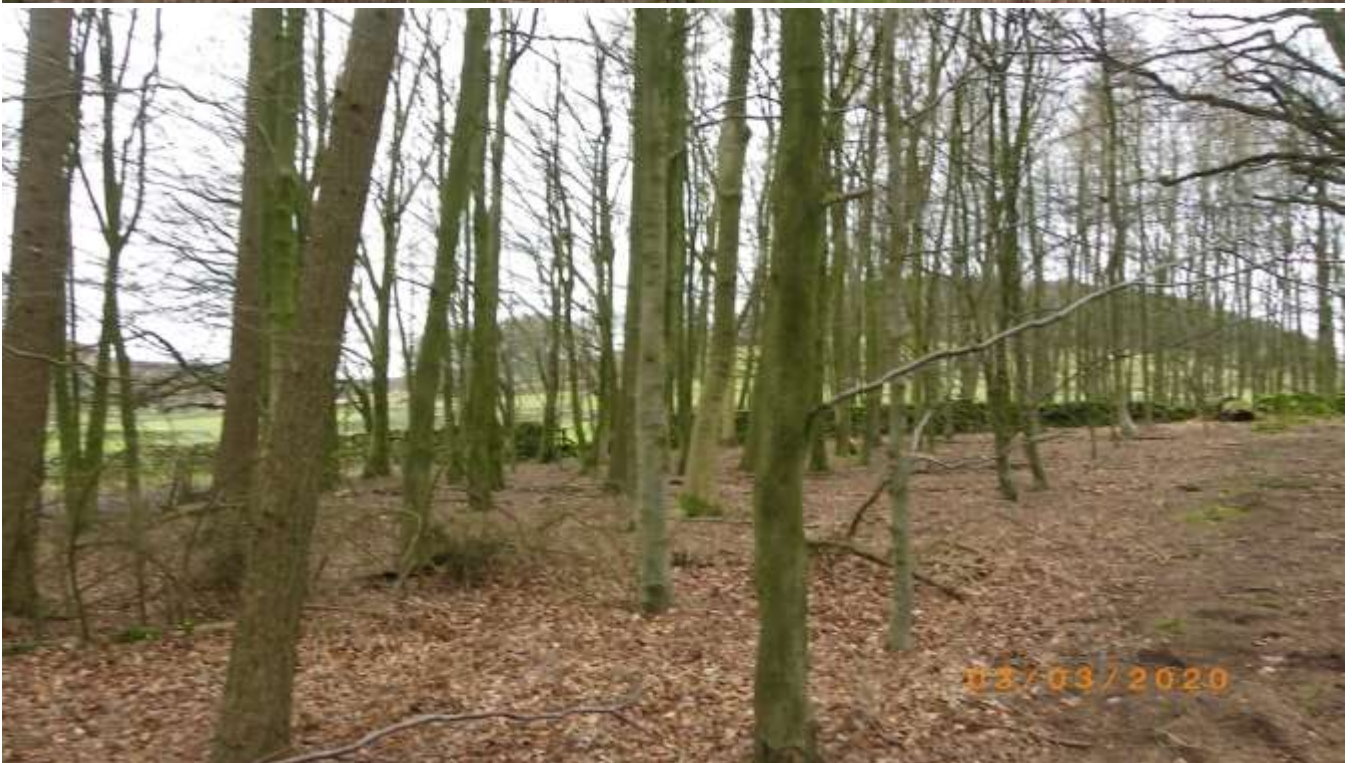
Photo 107 & 108 Beech with the larch to the middle of cpt7b part of the Hall Wood

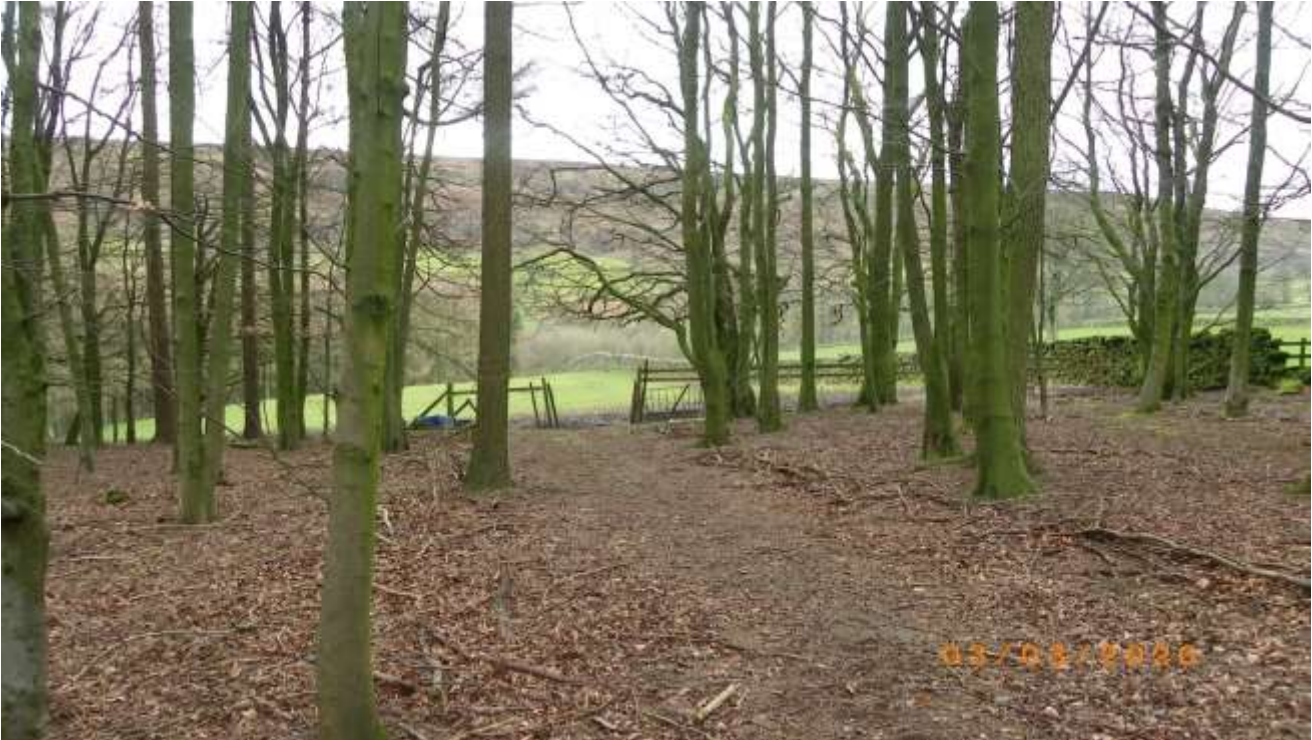
Photo 110 access to field through cpt7b

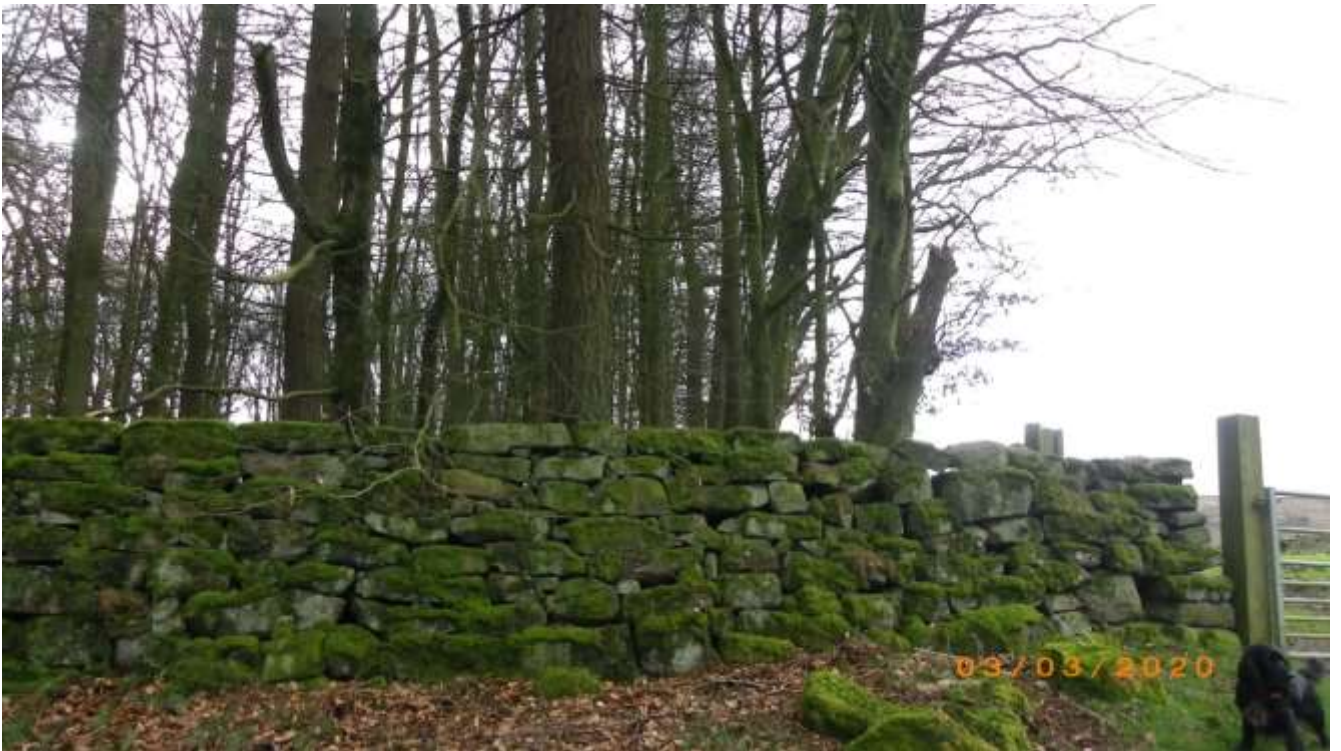
Photo 113 Cpt7b north eastern boundary wall

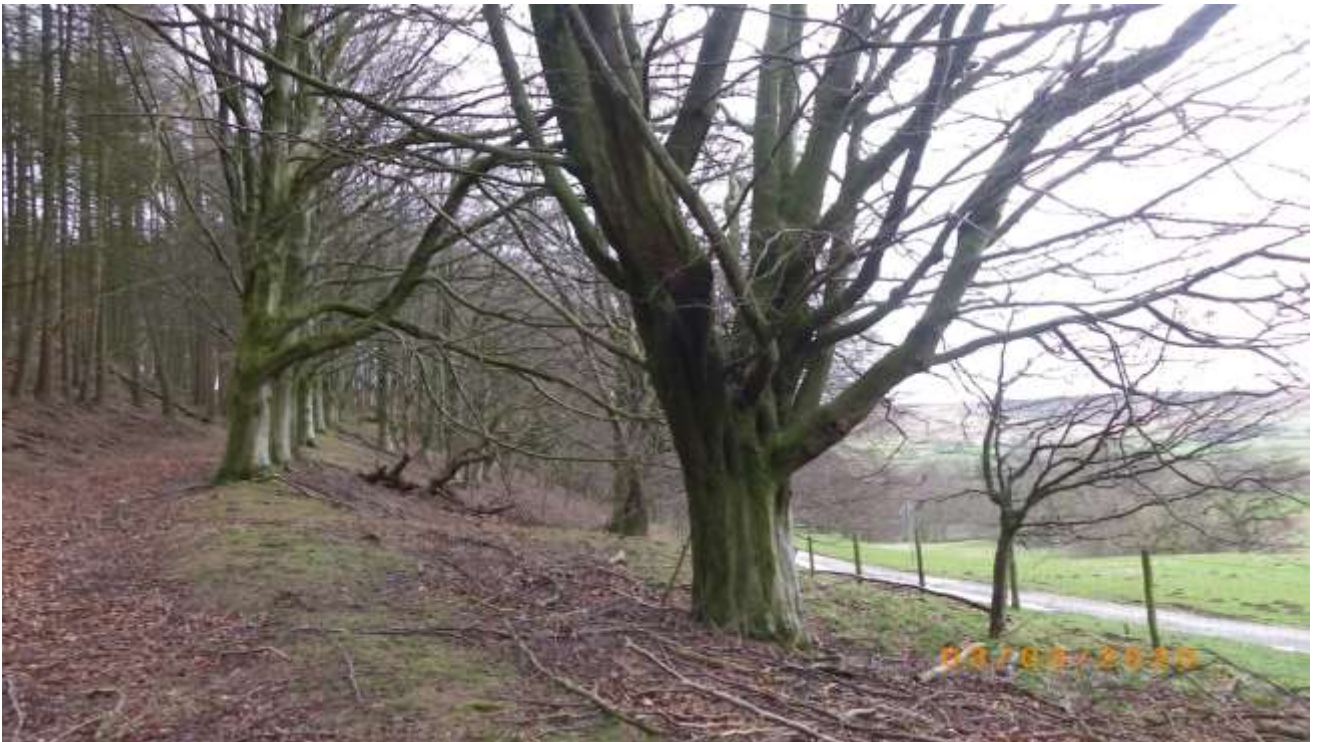
Photo 115 Cpt7c mature beech probably over 200 years old
