National Trust Bransdale & Farndale Woodland Management Plan
Photo and Images Gallery 2021

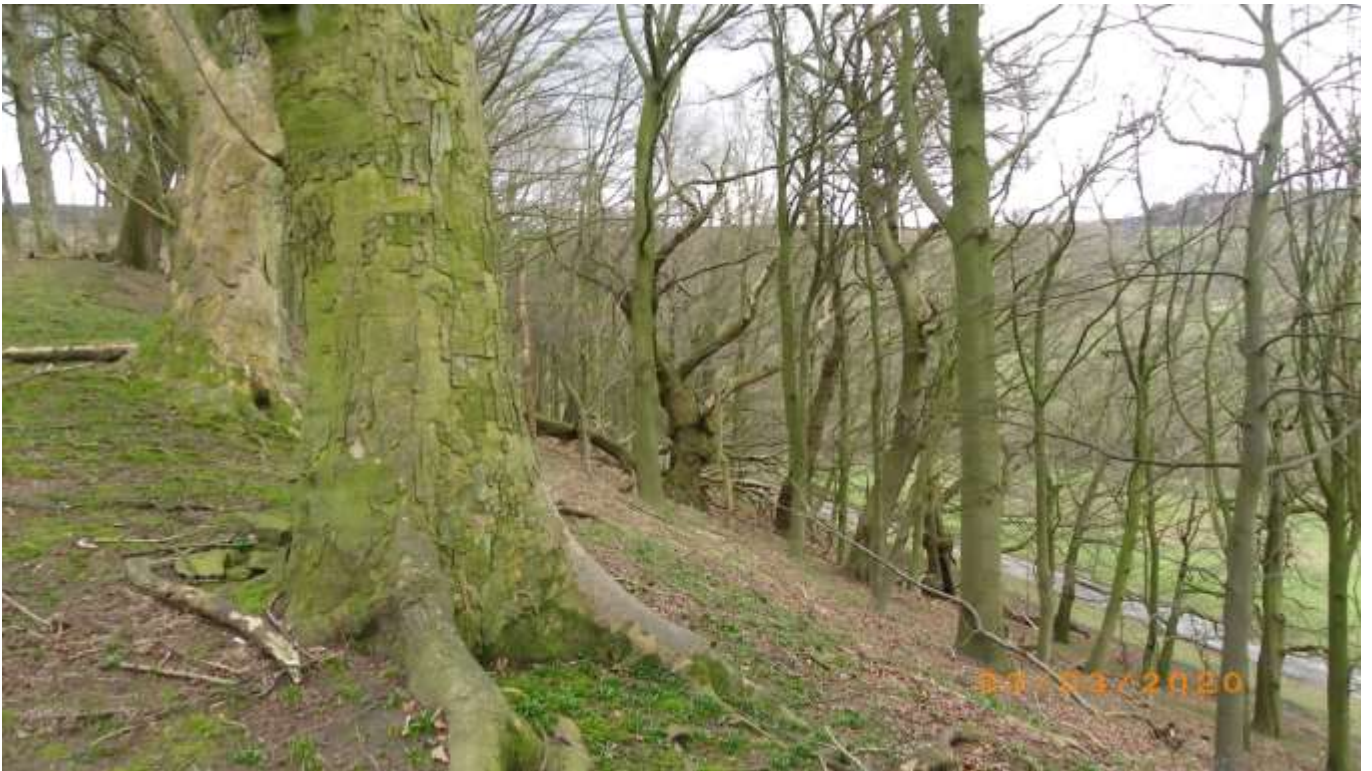
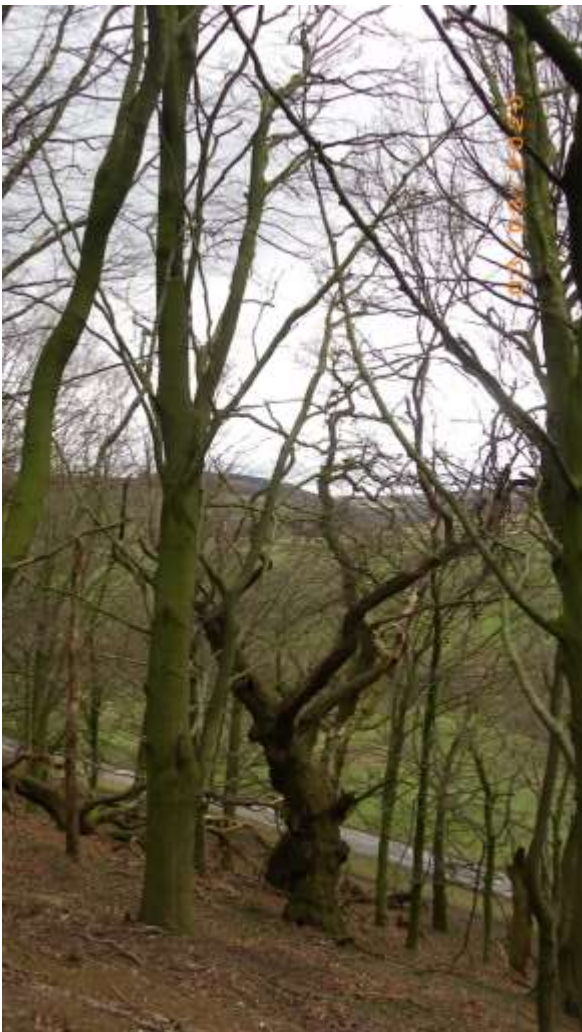
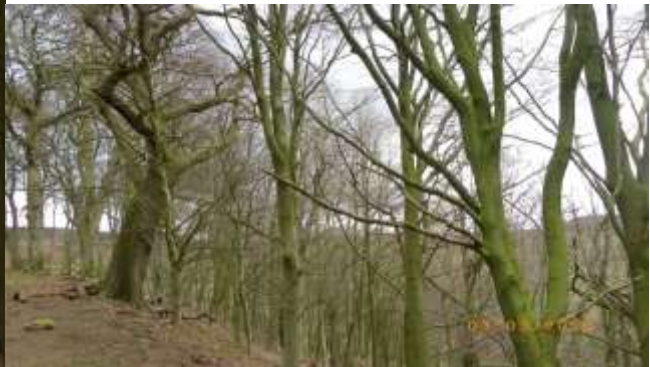
Photo 117 & 118 Cpt7c ancient oaks need gradually haloing

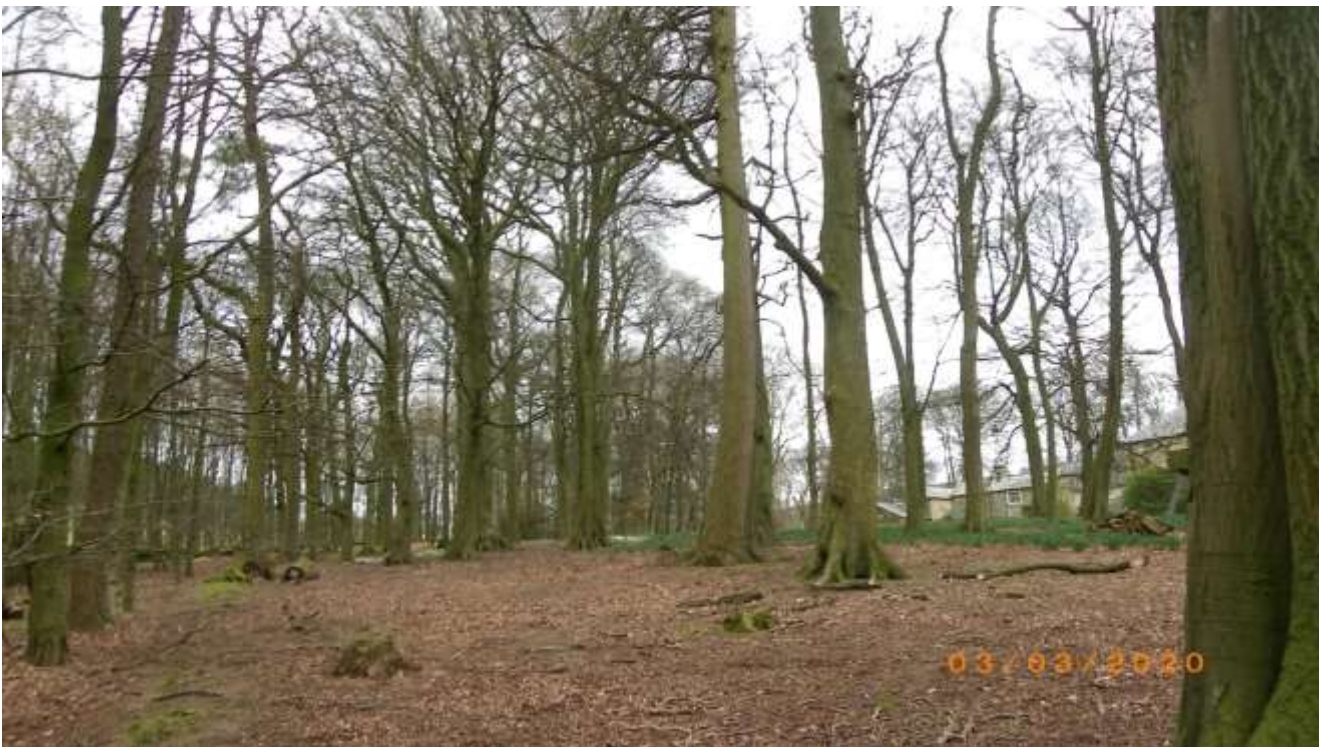
Photo 120 & 121 Cpt7c mature beech and sycamore in the wooded garden around the Hall

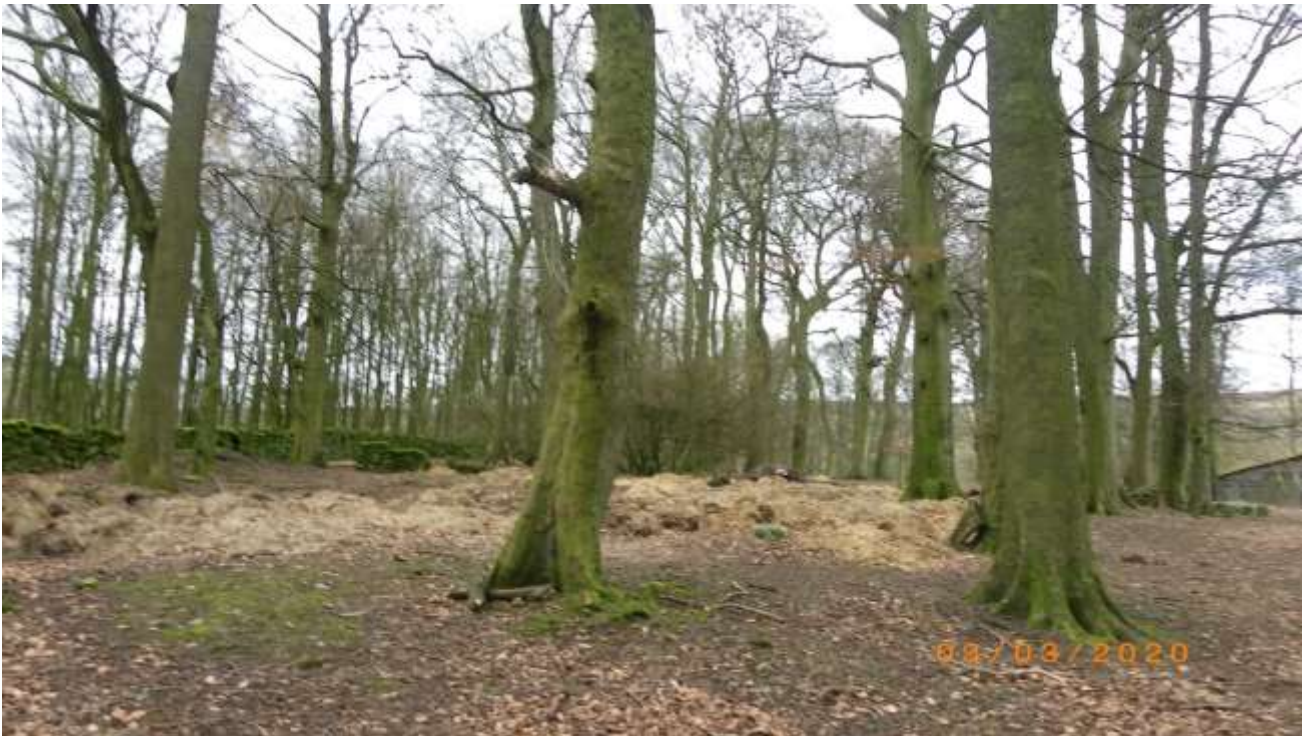
Photo 122 Cpt7c woodland being used to shelter stock TBC

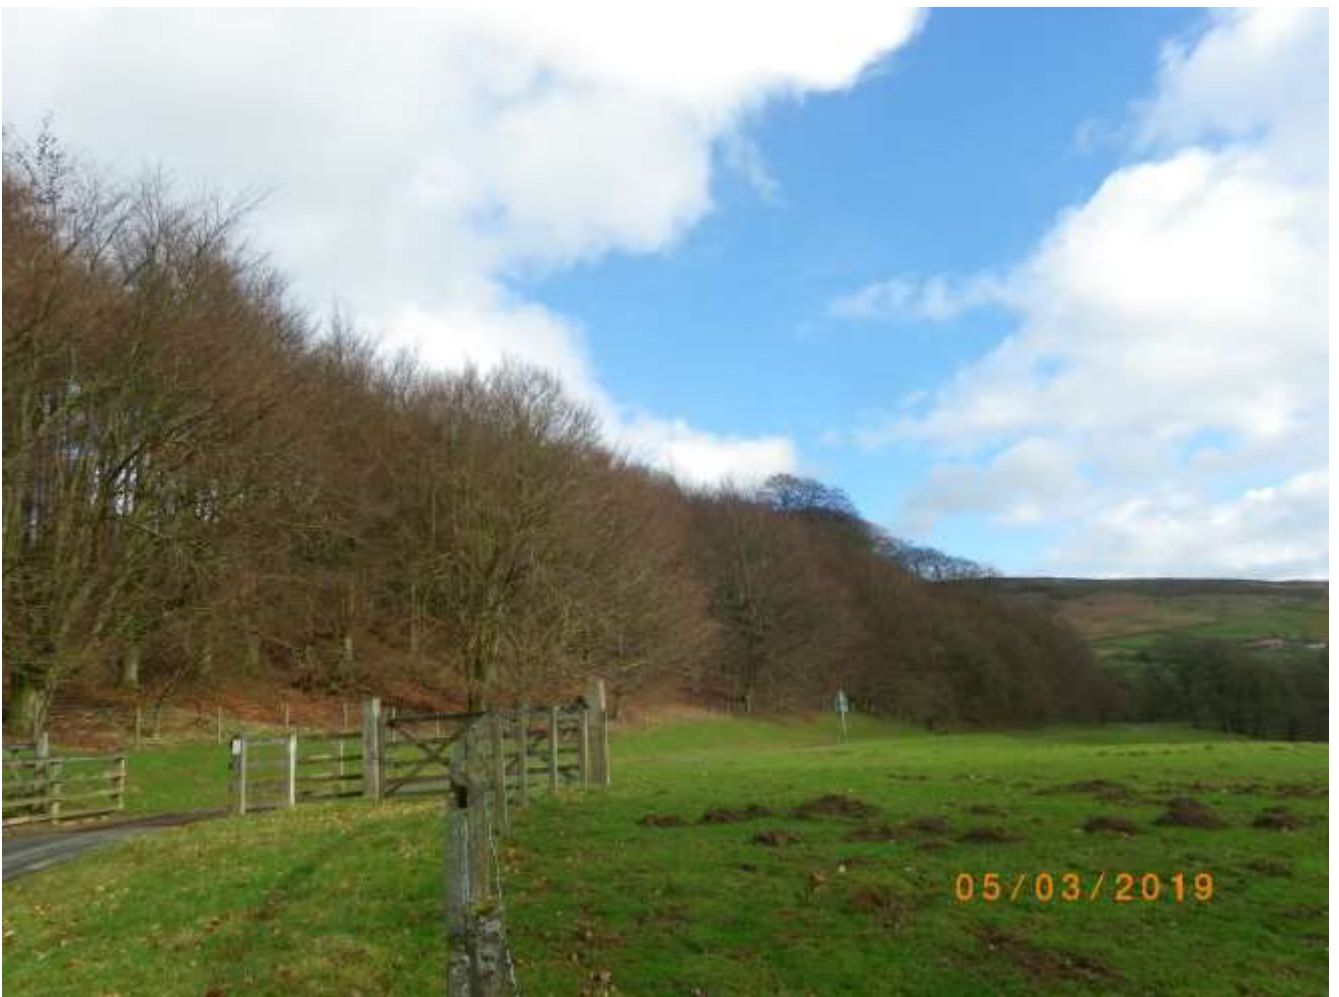
Photo 123 The southern front of cpt7c with beech, sycamore, oak and hazel.

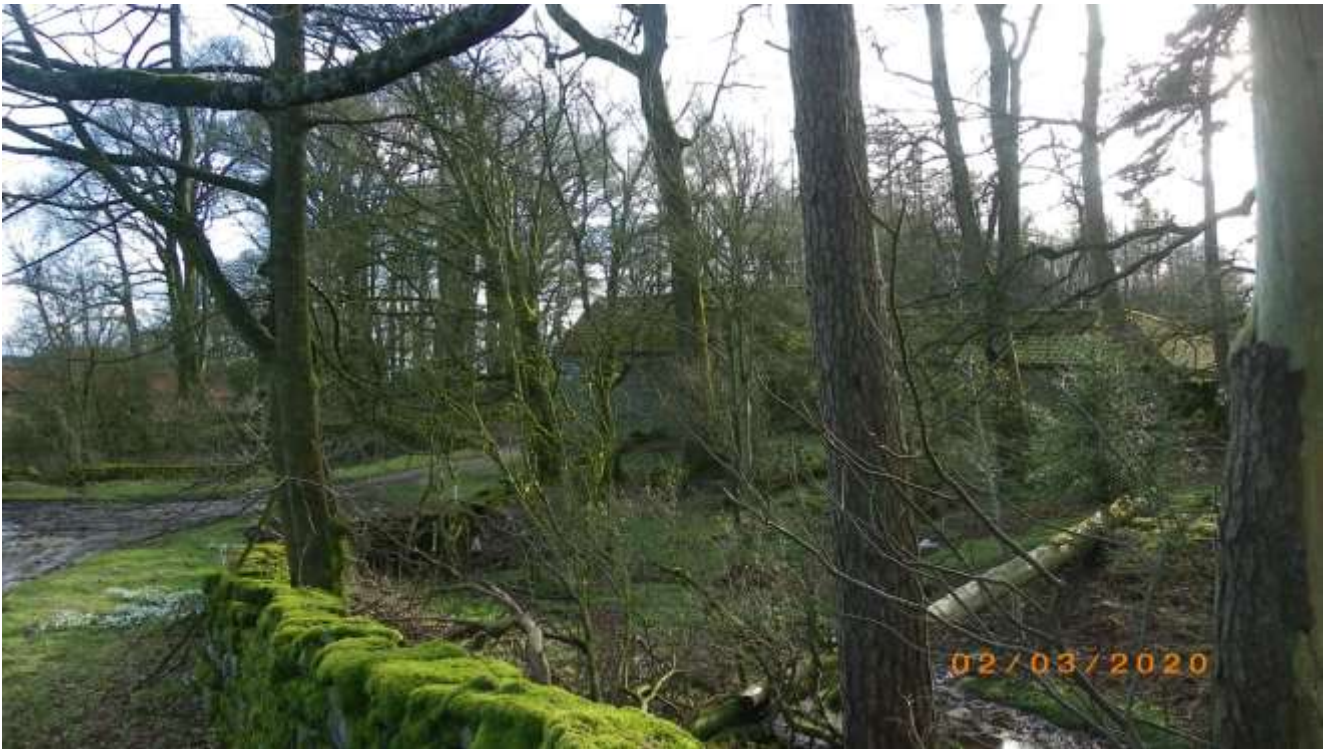
Photo 126 southern section of cpt7d with a small watercourse and mature hardwoods

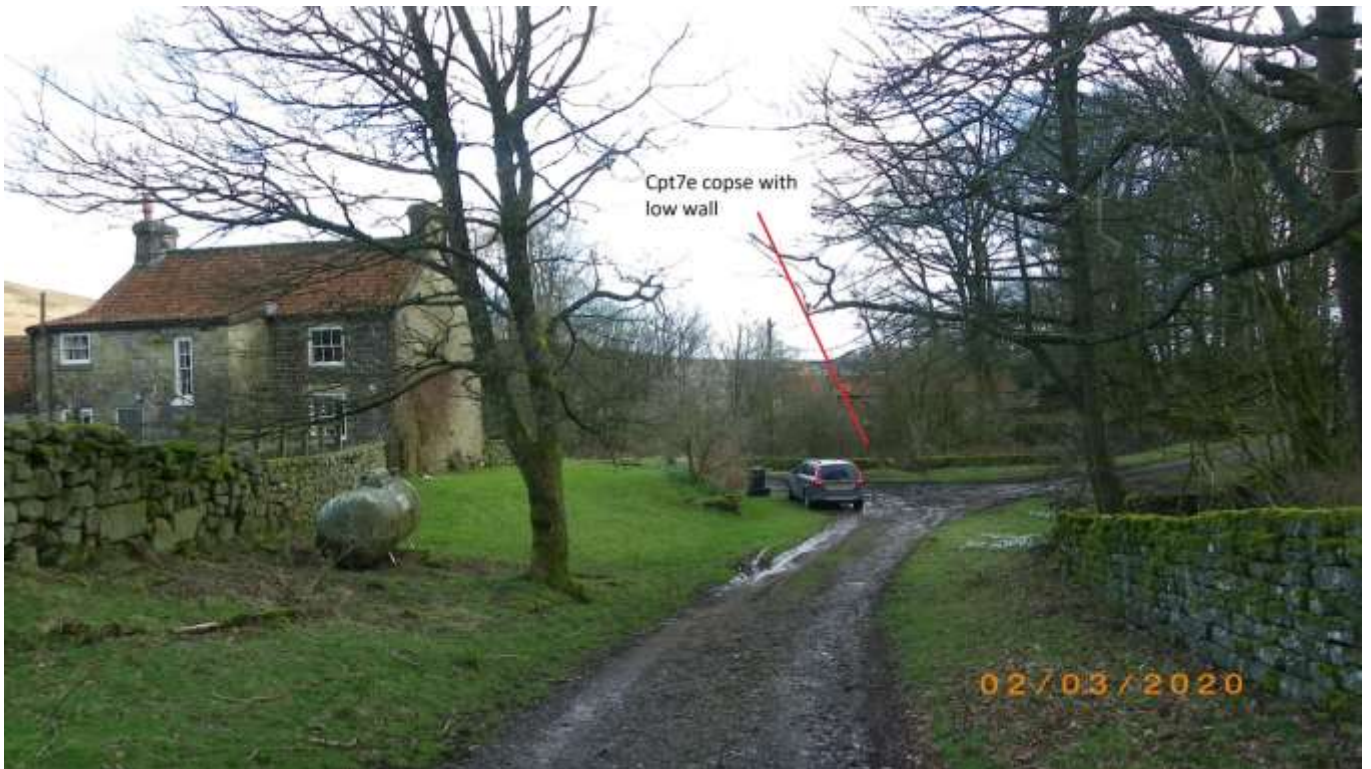
Photo 128 small copse cpt7e with low wall

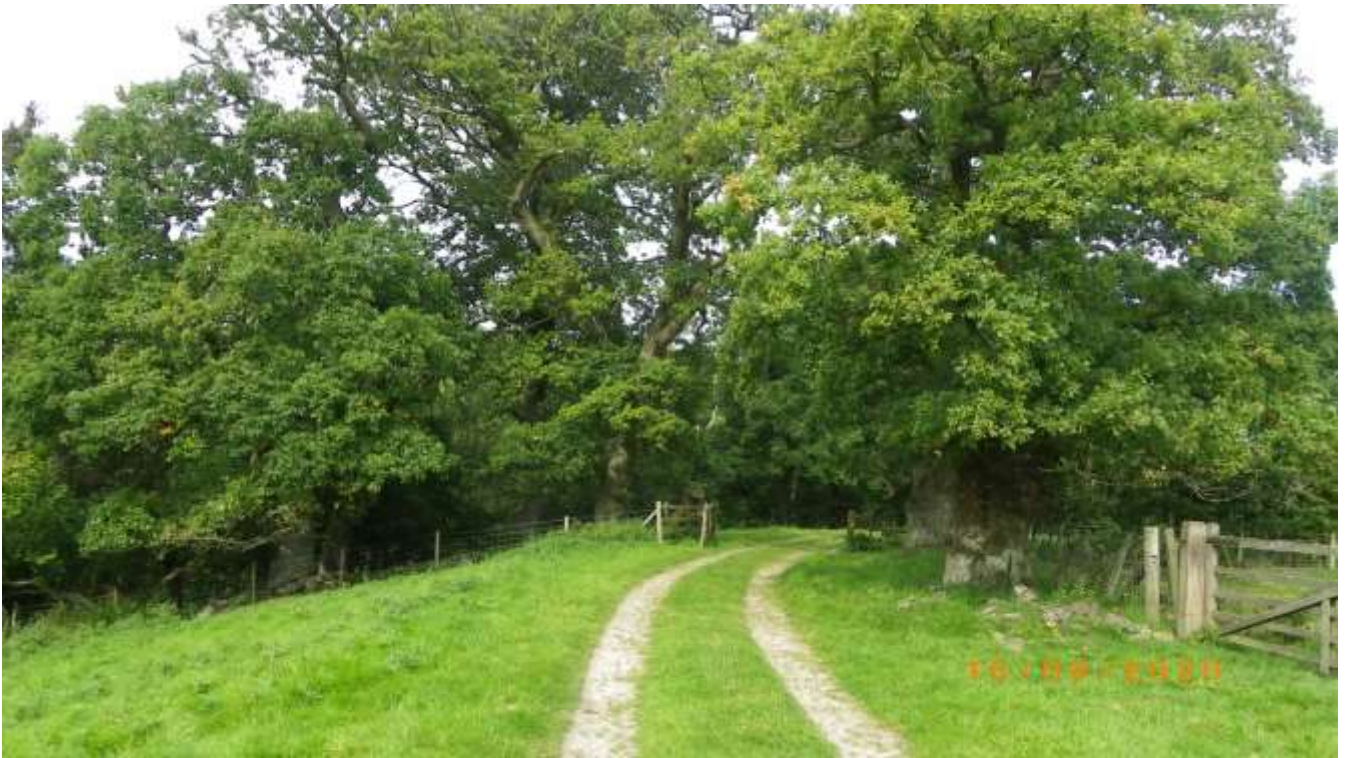
Photo 129 southern entrance to cpt8 from Bransdale Mill

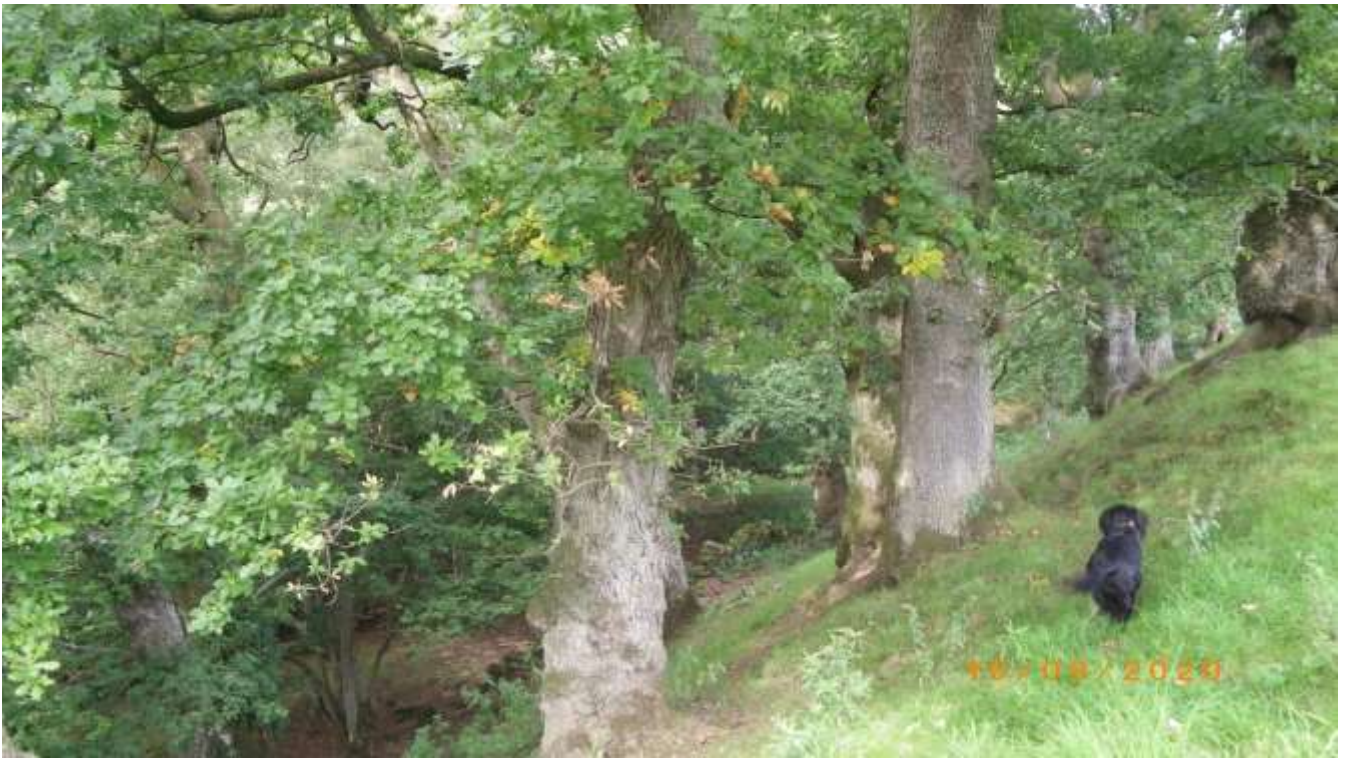
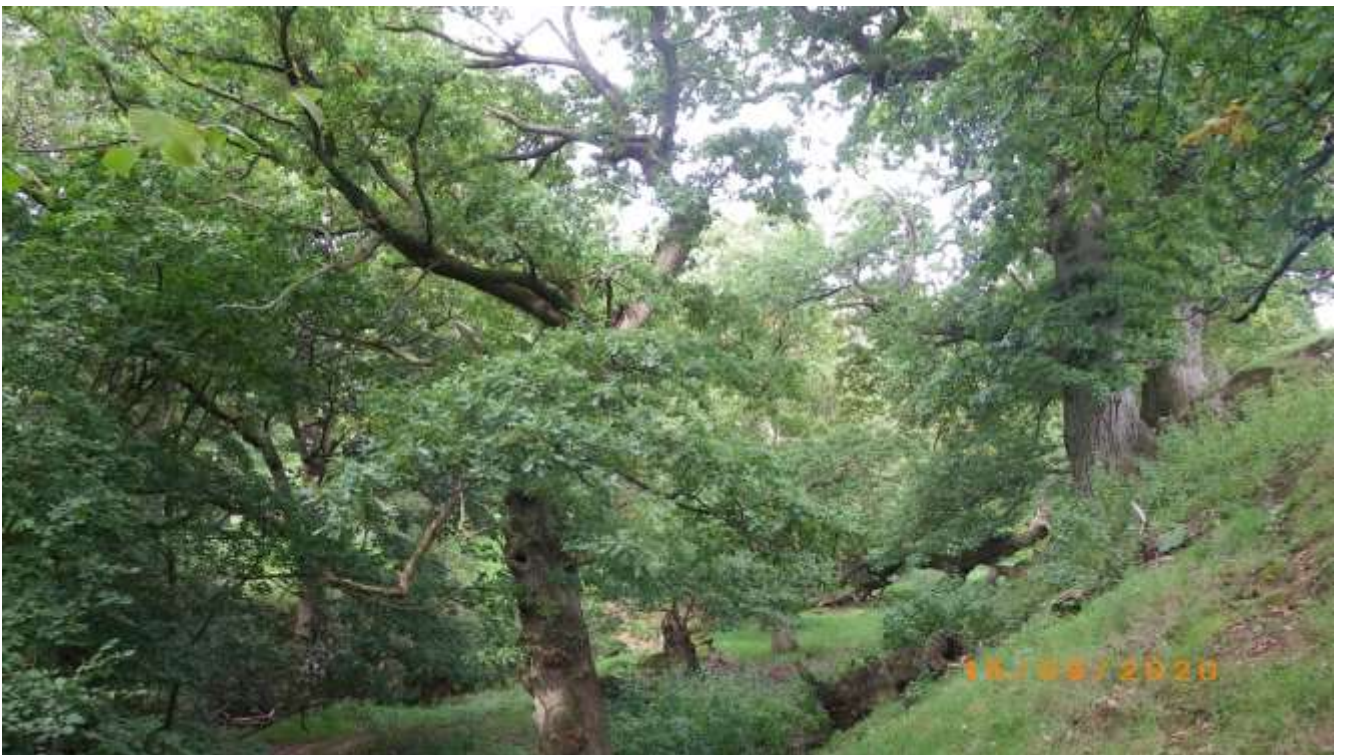
Photo 131 & 132 Mature pedunculate oak showing signs of pasture grazing cpt8

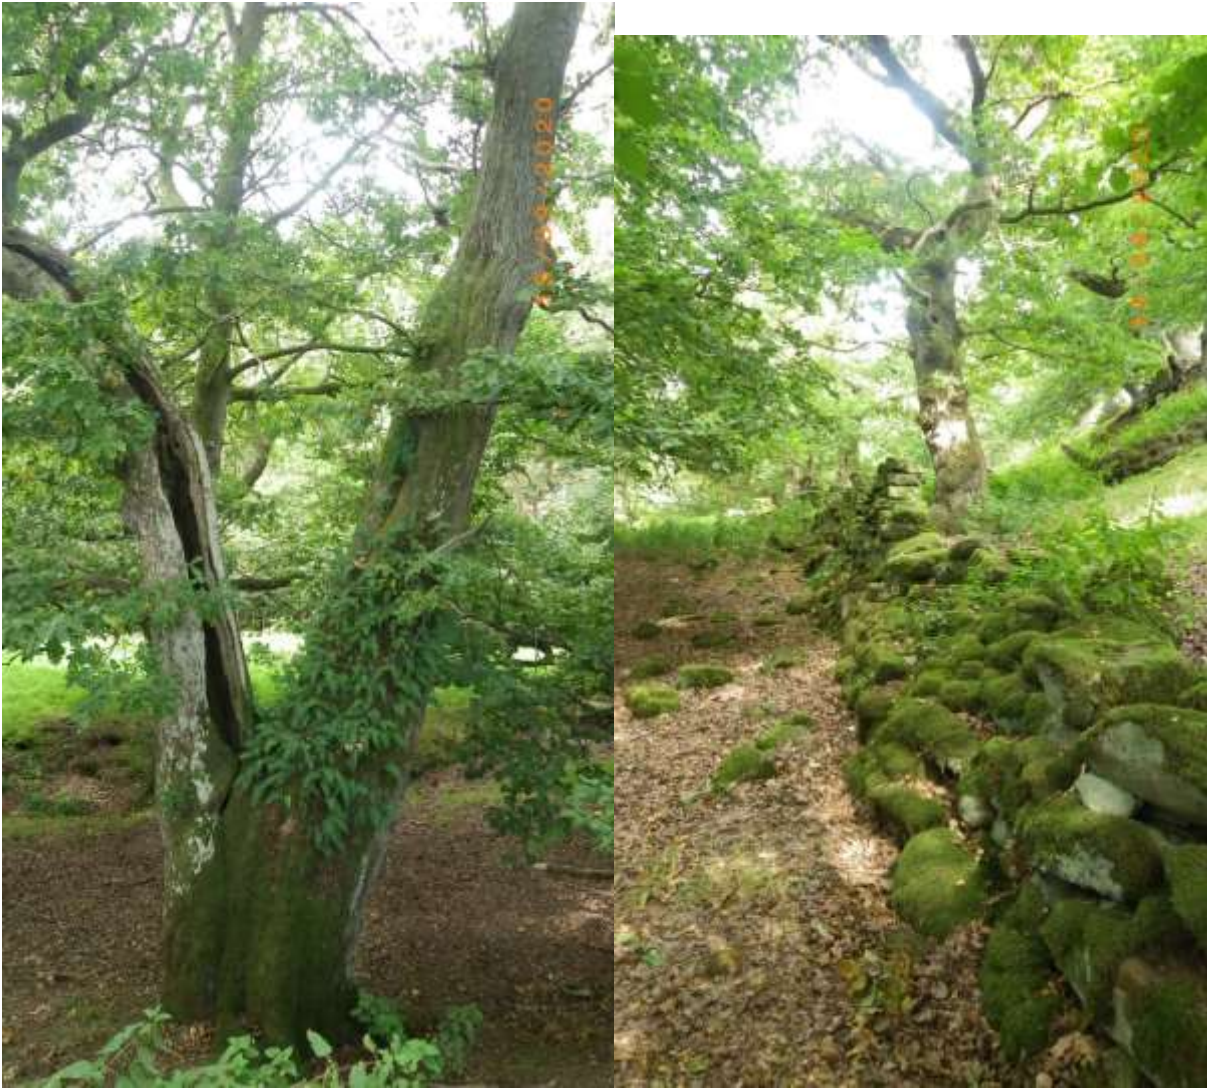
Photo 133 & 134 Standing and fallen deadwood & remnant walls creating niche habitats

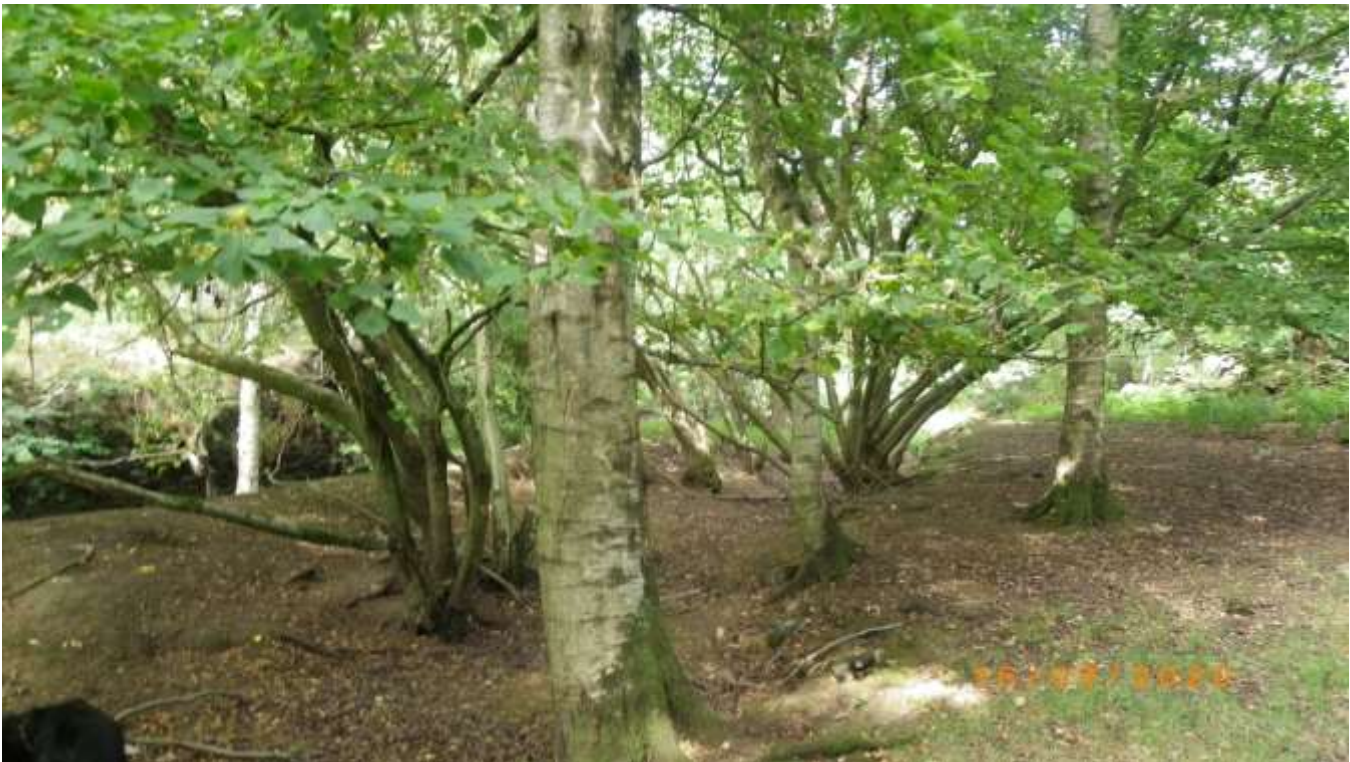
Photo 135 hazel understory cpt8

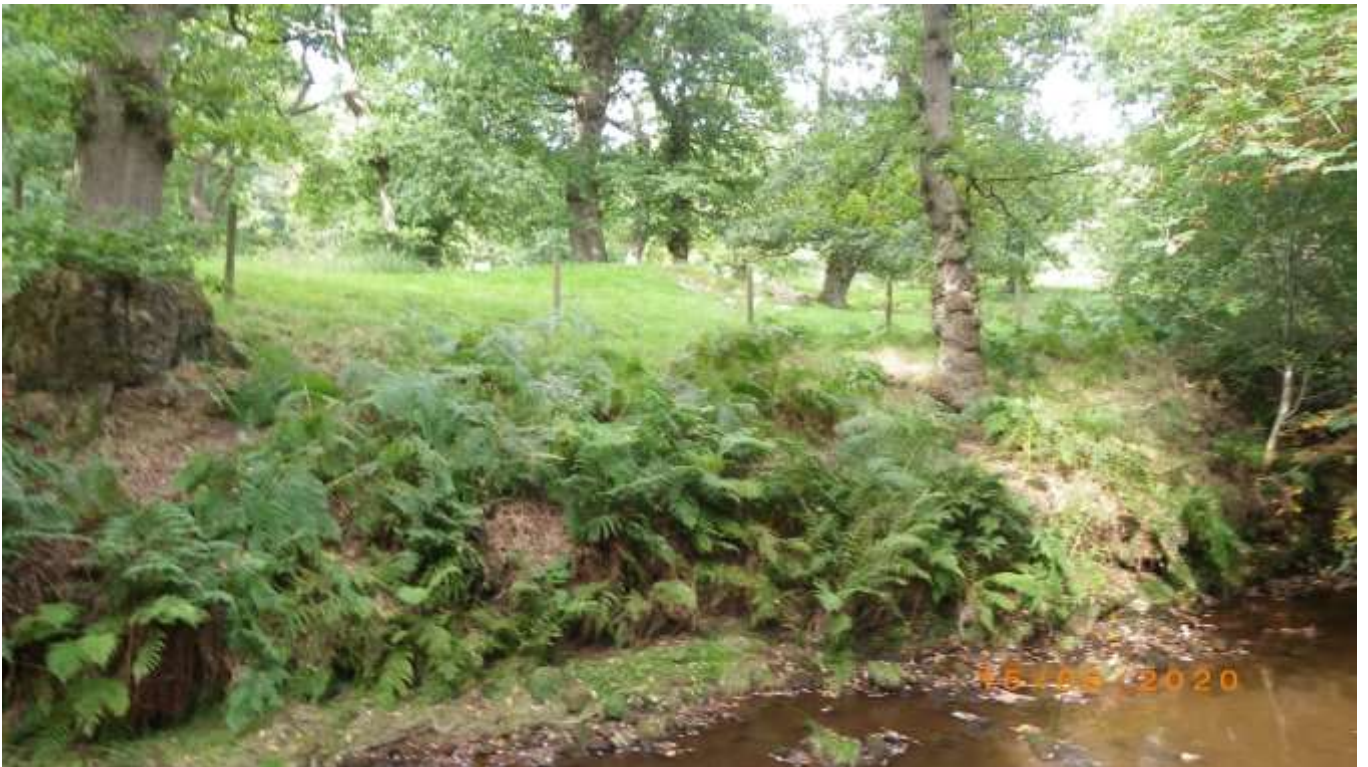
Photo 136 ferns on the opposite bank of the Blowworth Slack cpt8

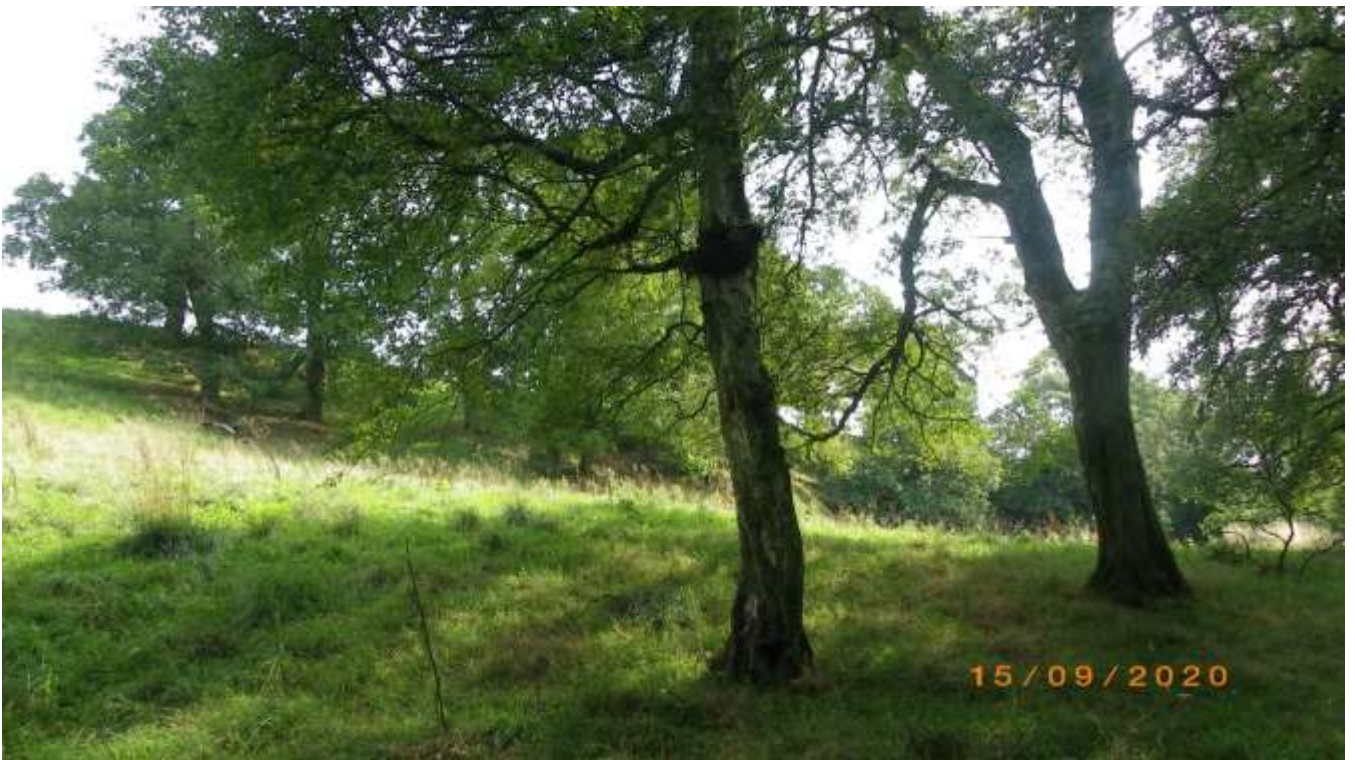
Photo 137 open wood pasture areas of cpt8

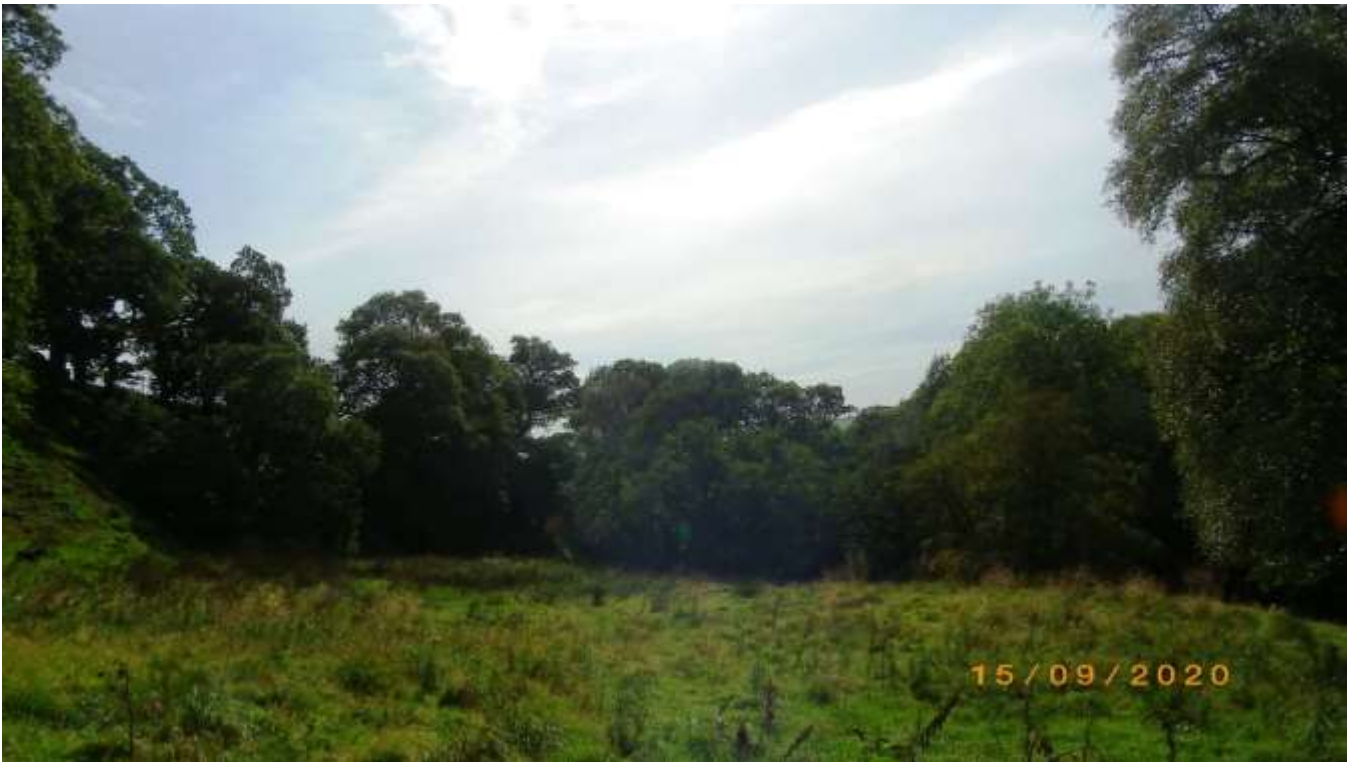
Photo 138 open wood pasture areas of cpt8

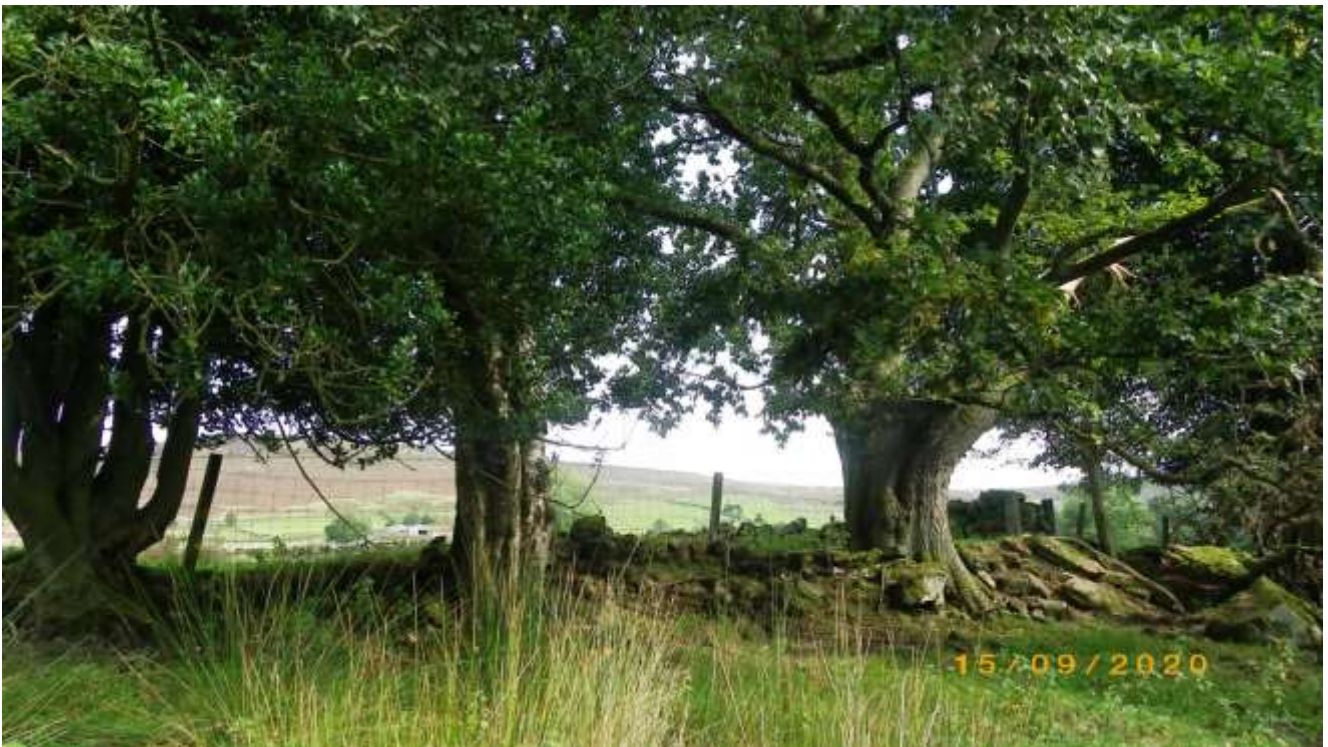
Photo 141 old oak and holly on the eastern boundary

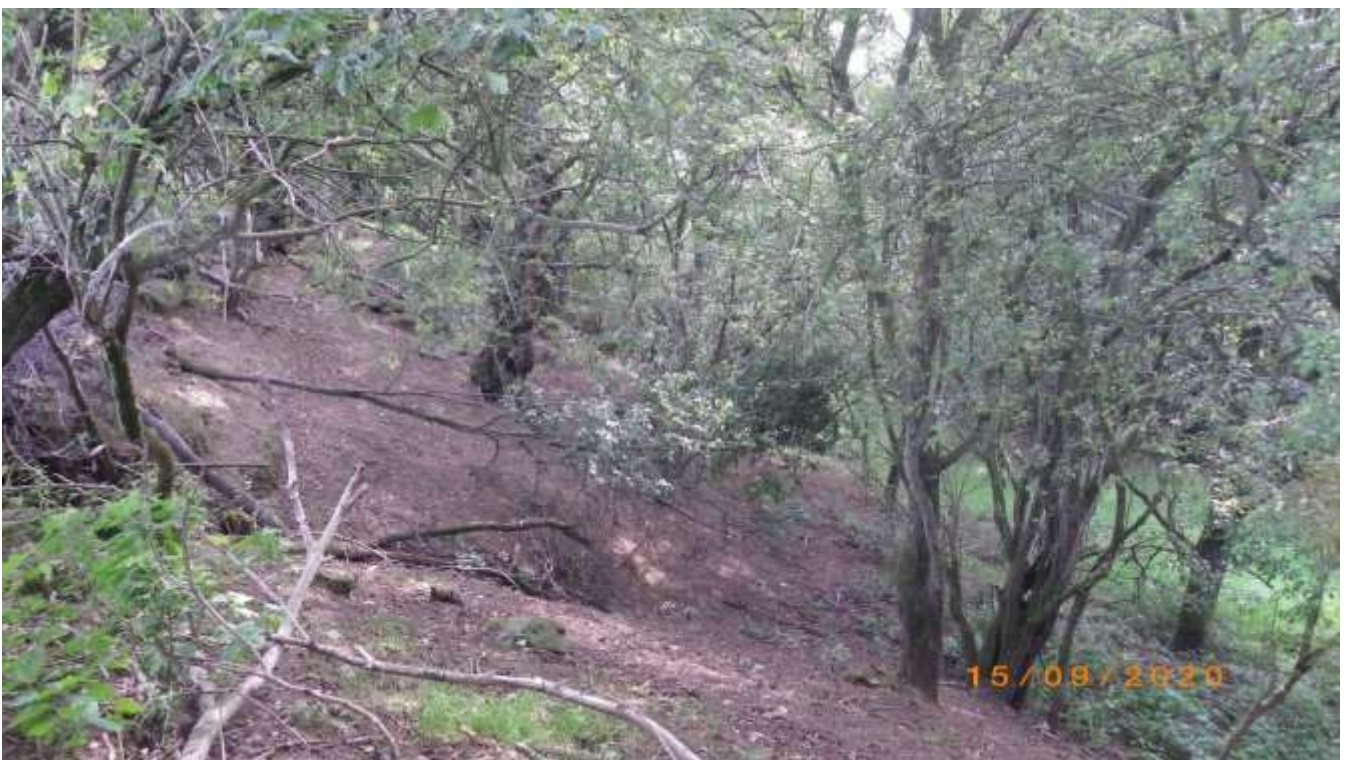
Photo 143 Cpt9a soil exposed possibly due to rabbit activity on the slope

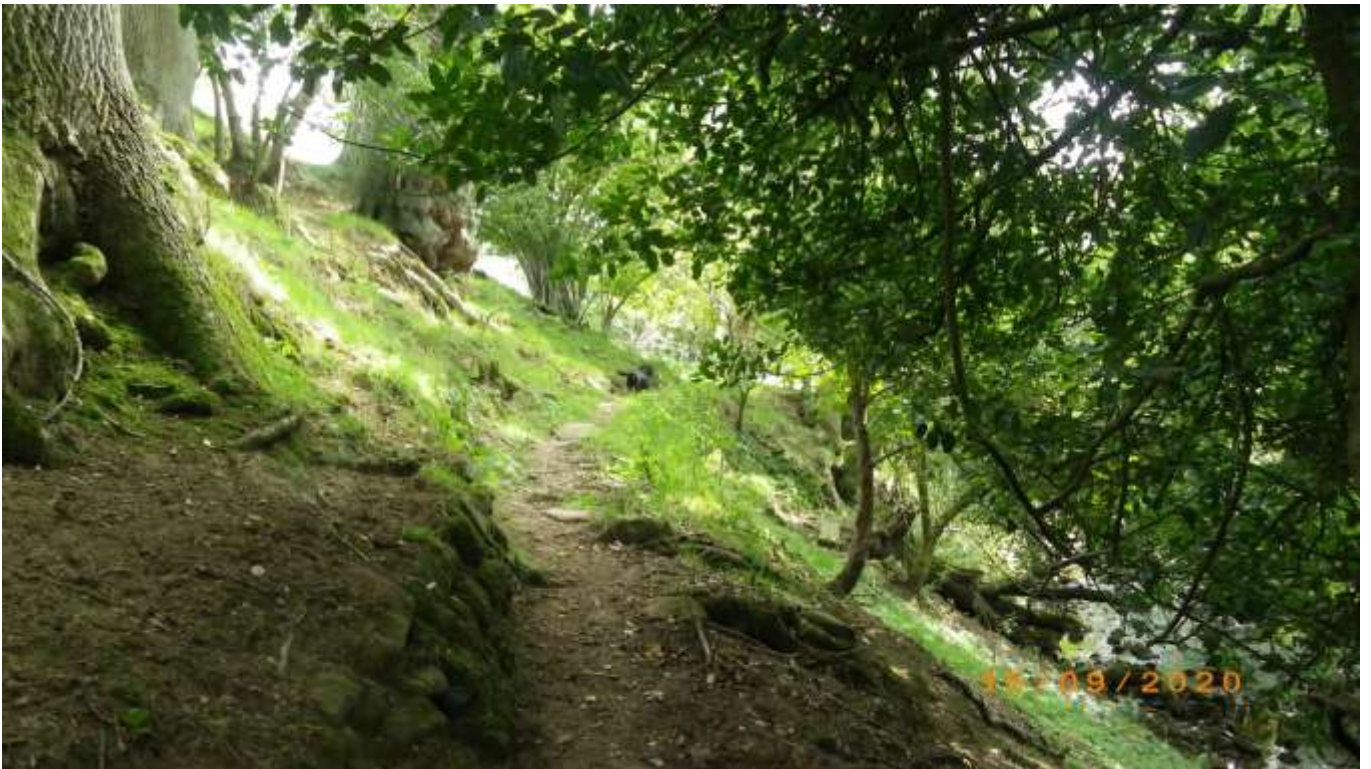
Photo 144 Cpt9a footpath through woodland mature oak and ash present

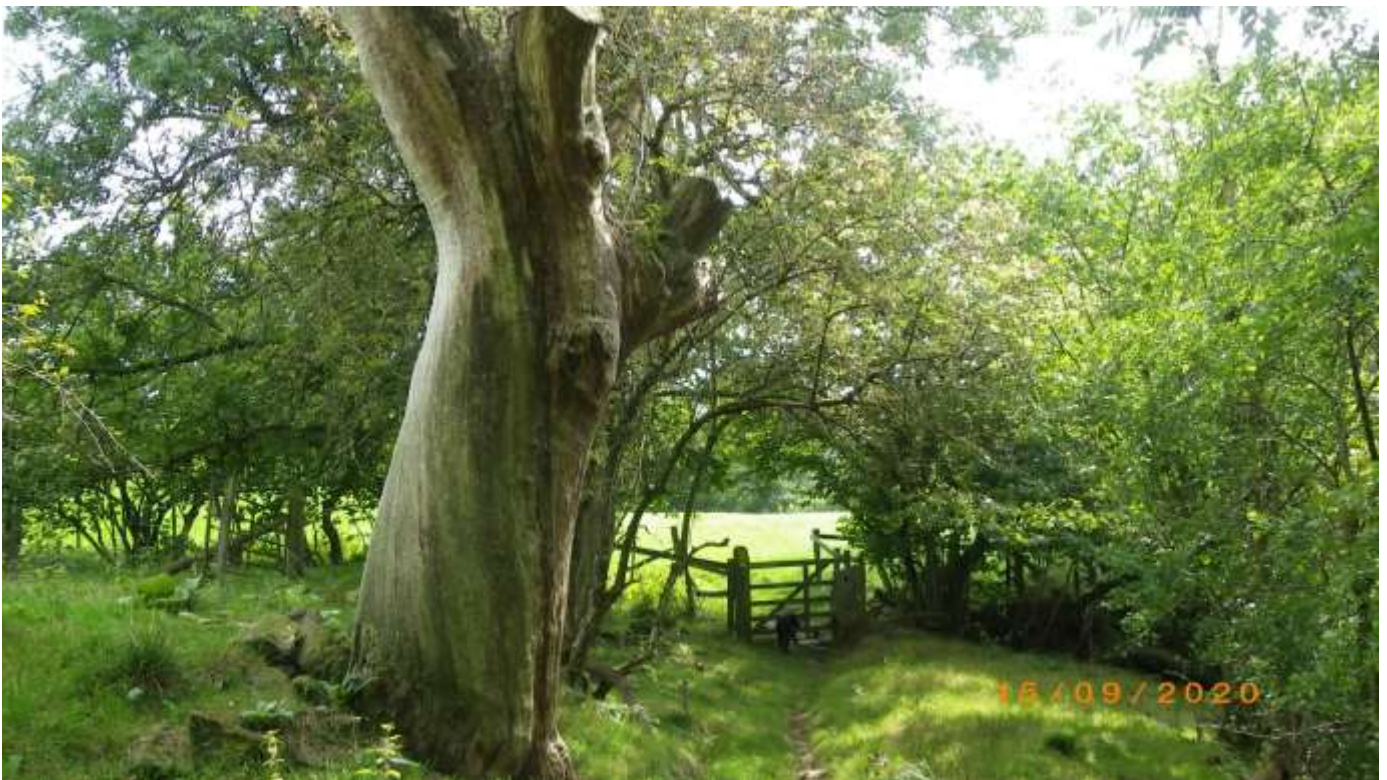
Photo 145 Footpath gateway in southern boundary of cpt9a; note large standing deadwood.

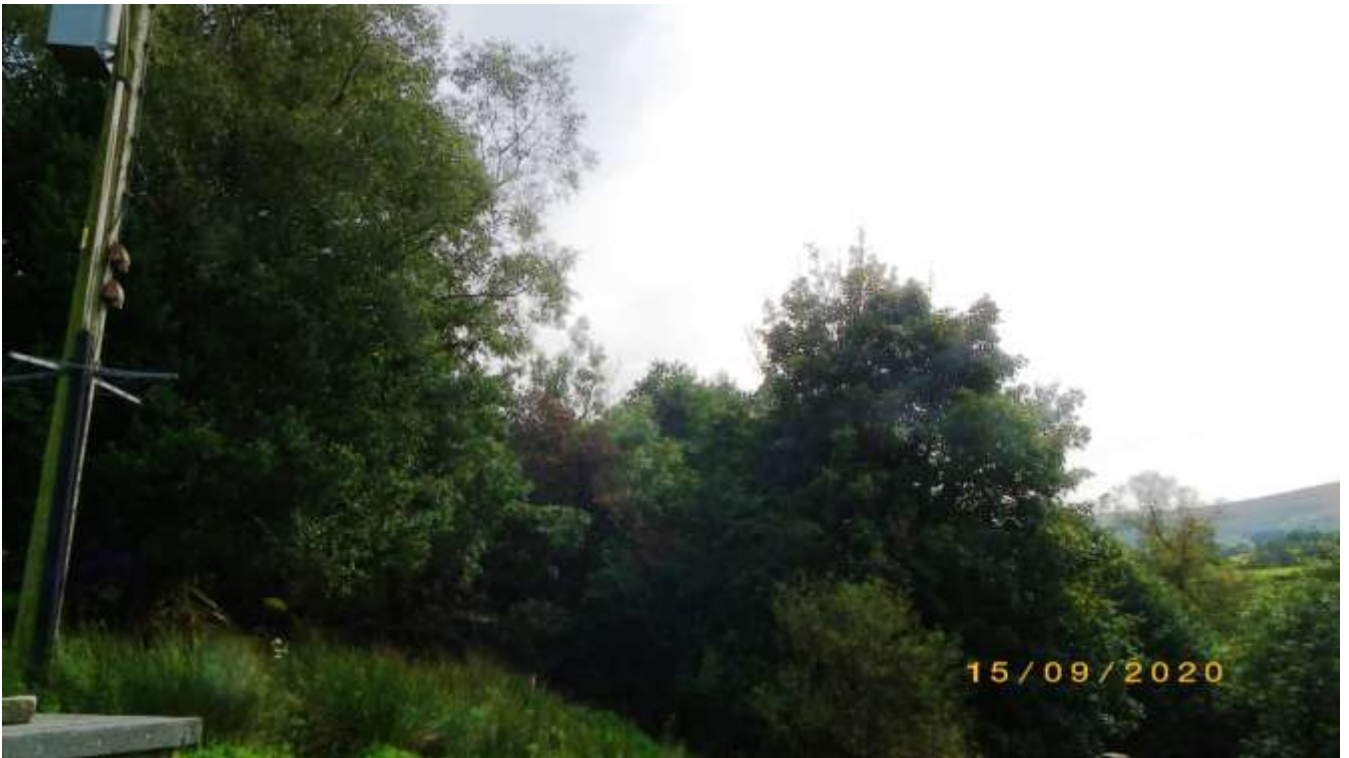
Photo 146 Cpt9a ash dieback symptoms in crowns are visible throughout the wood.

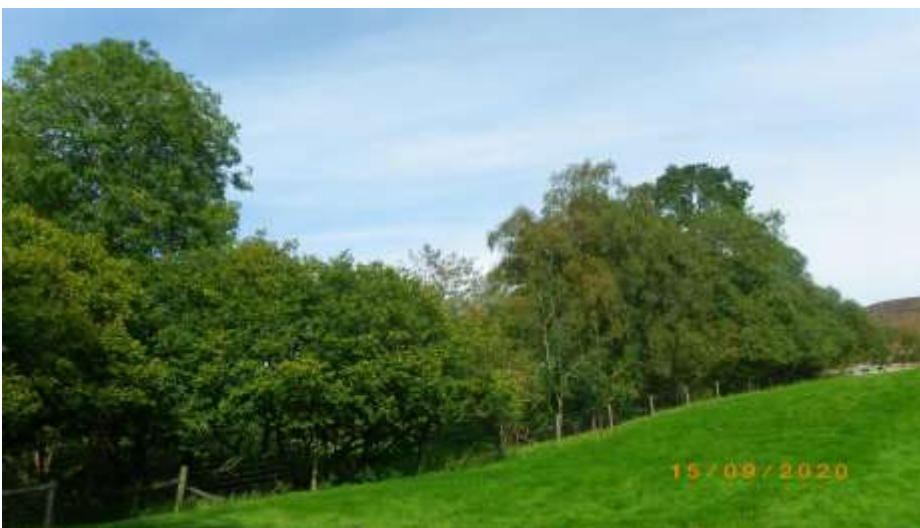
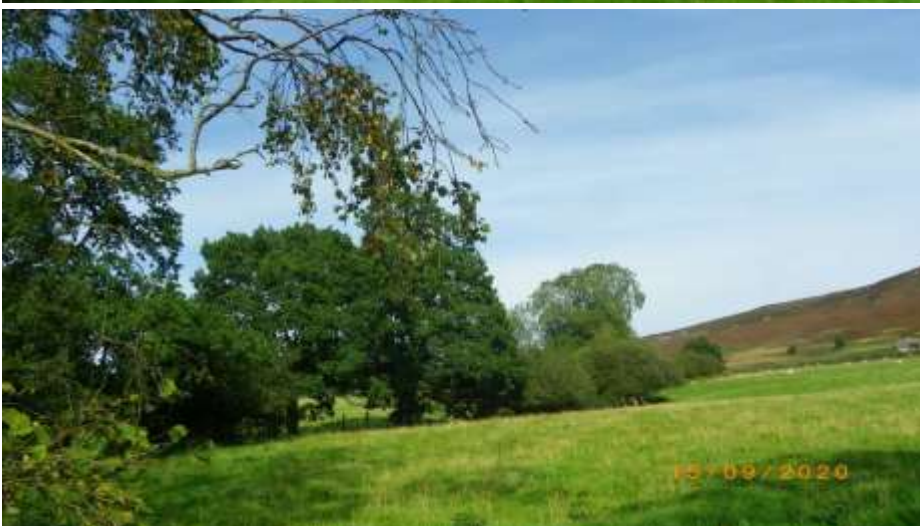
Photo 147 & 148 the narrow eastern leg of cpt9a

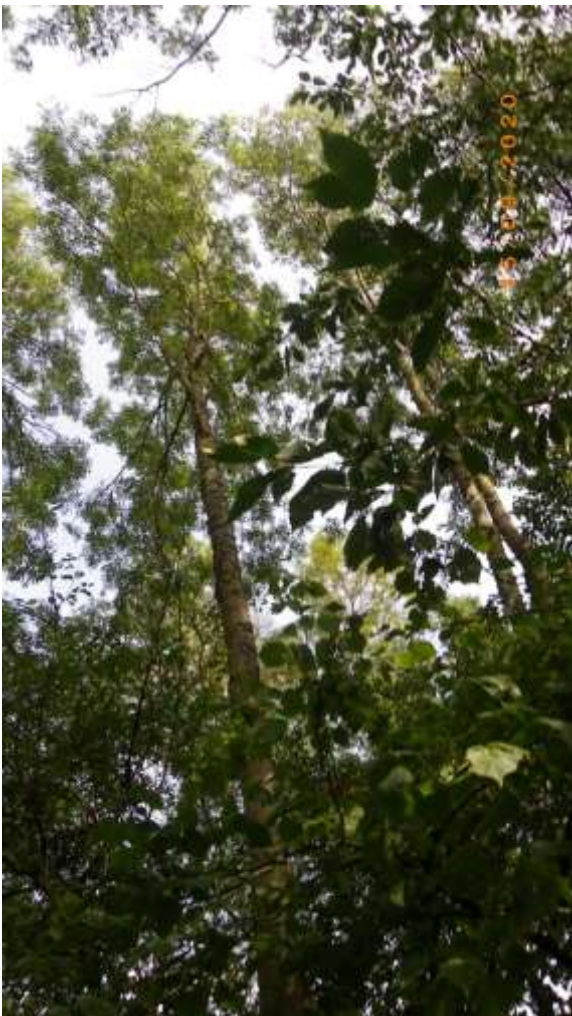
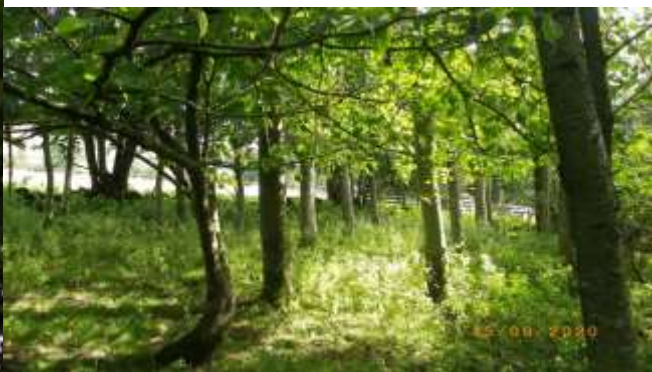
Photo 150 & 151 Cpt9b with semi mature ash (dominant) with cherry, lime, sycamore
