National Trust Bransdale & Farndale Woodland Management Plan
Photo and Images Gallery 2021

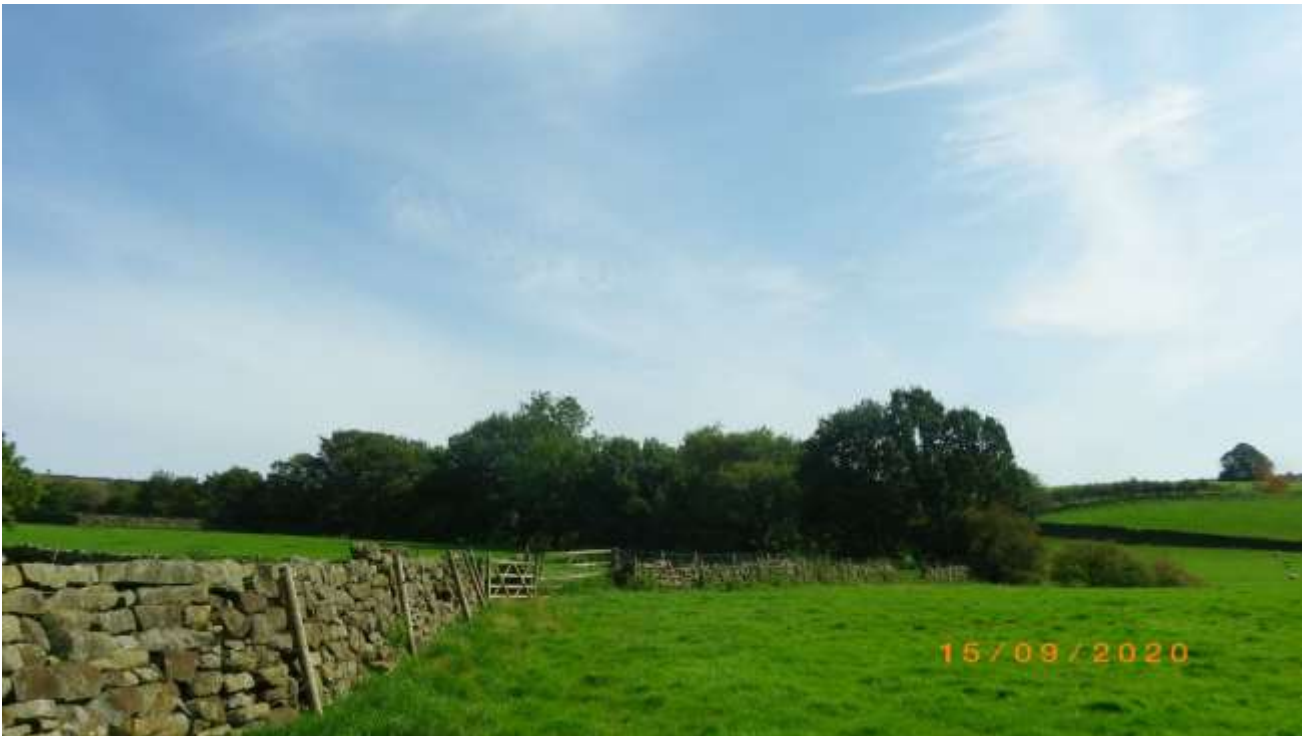
Photo 153 Looking south east to Coronation Shelterbelt cpt10a

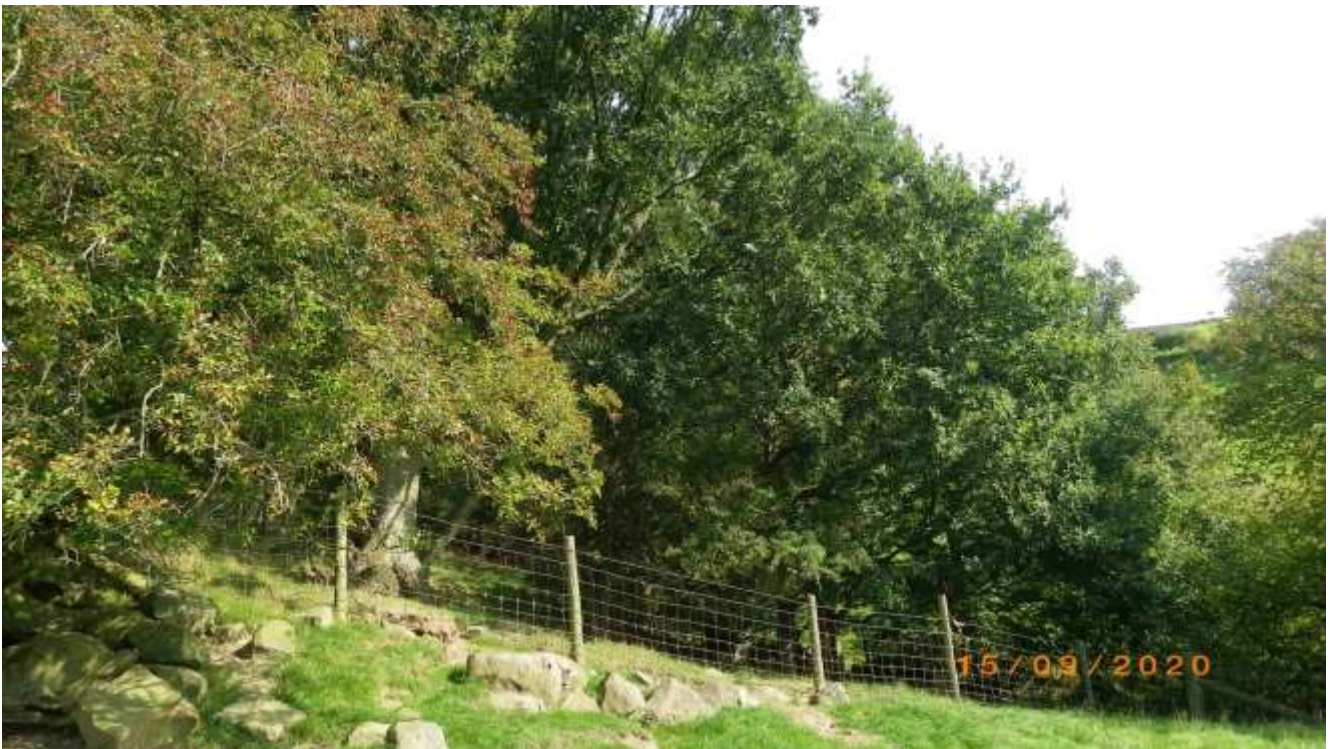
Photo 154 western boundary of cpt10a Coronation Shelterbelt

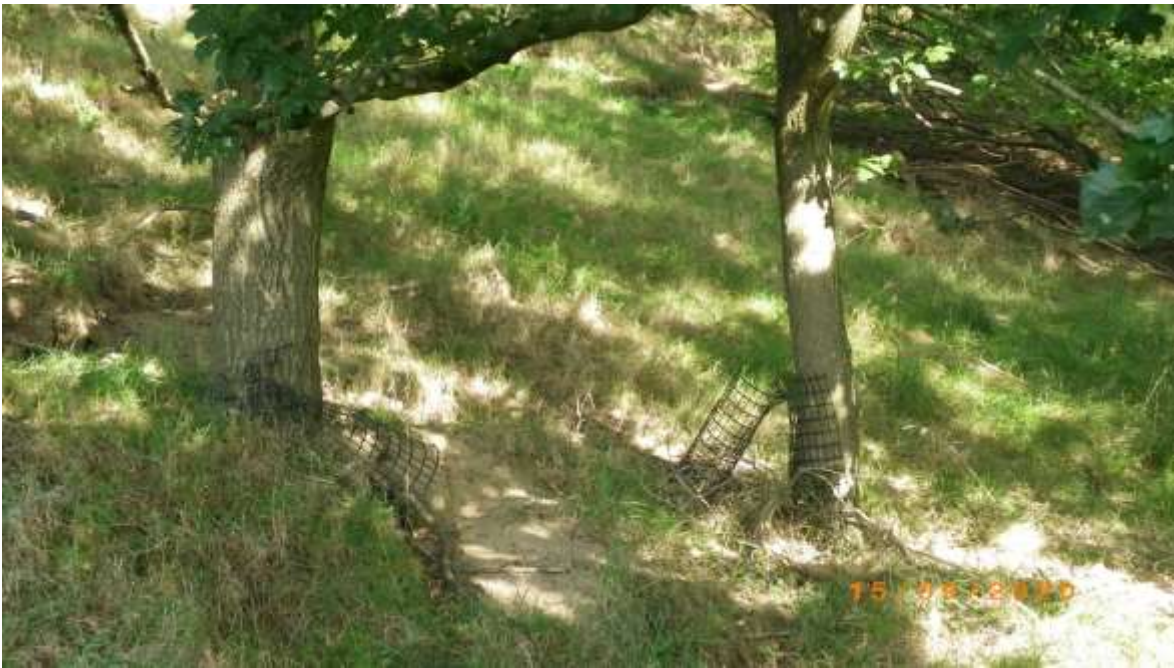
Photo 155 Cpt10a plastic guards still present in the woodland

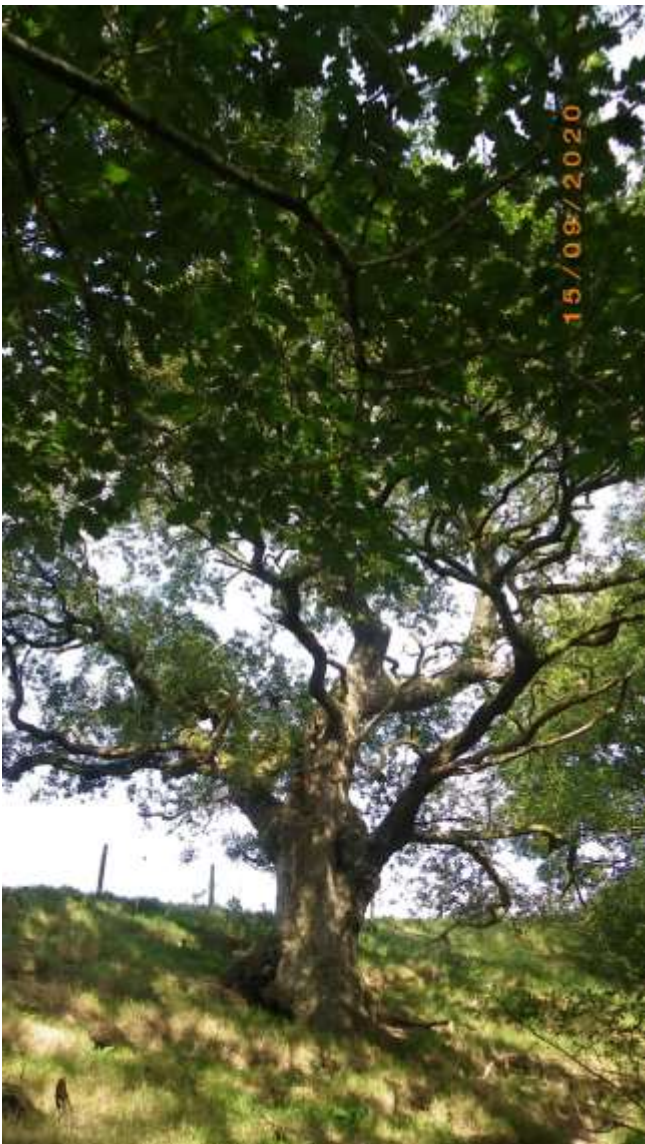
Photo 156 Cpt10a veteran oak to the northern boundary

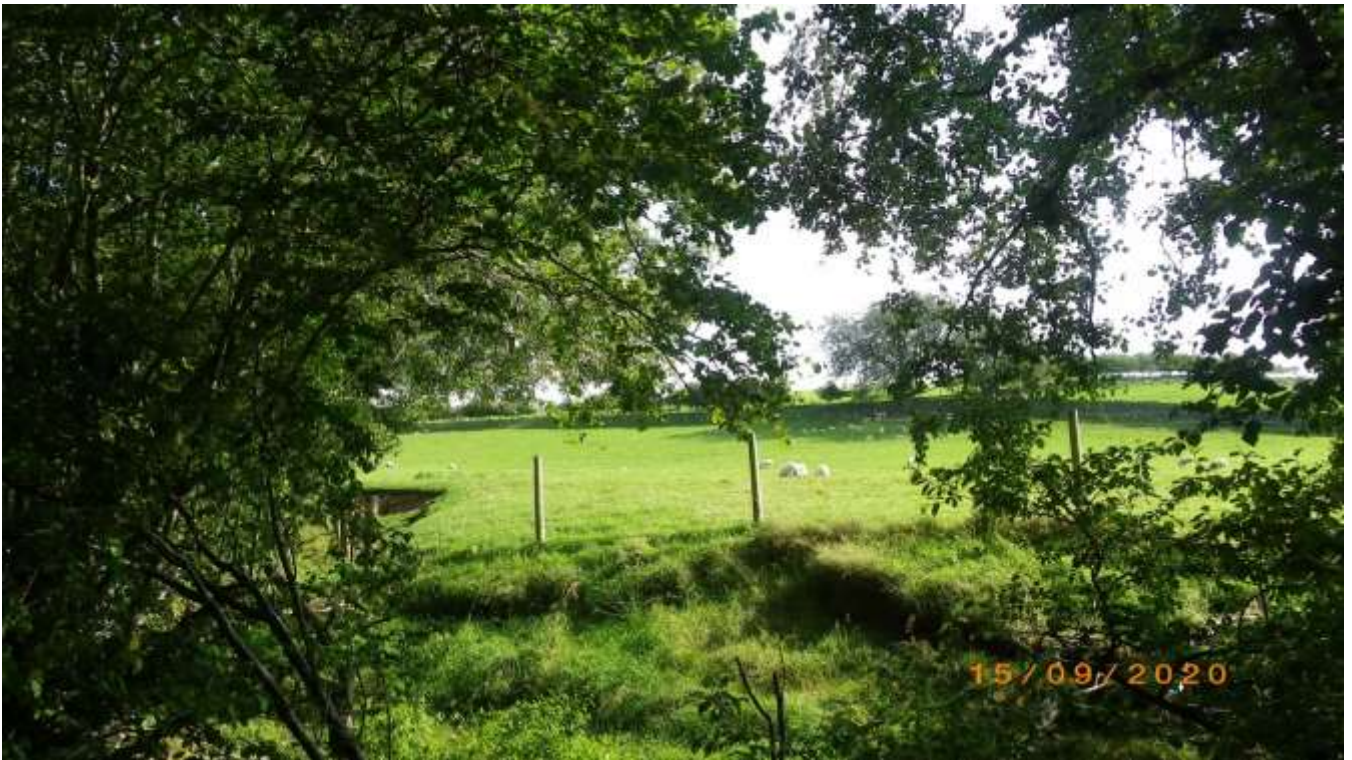
Photo 157 cpt10a northern boundary fence good – stock proof

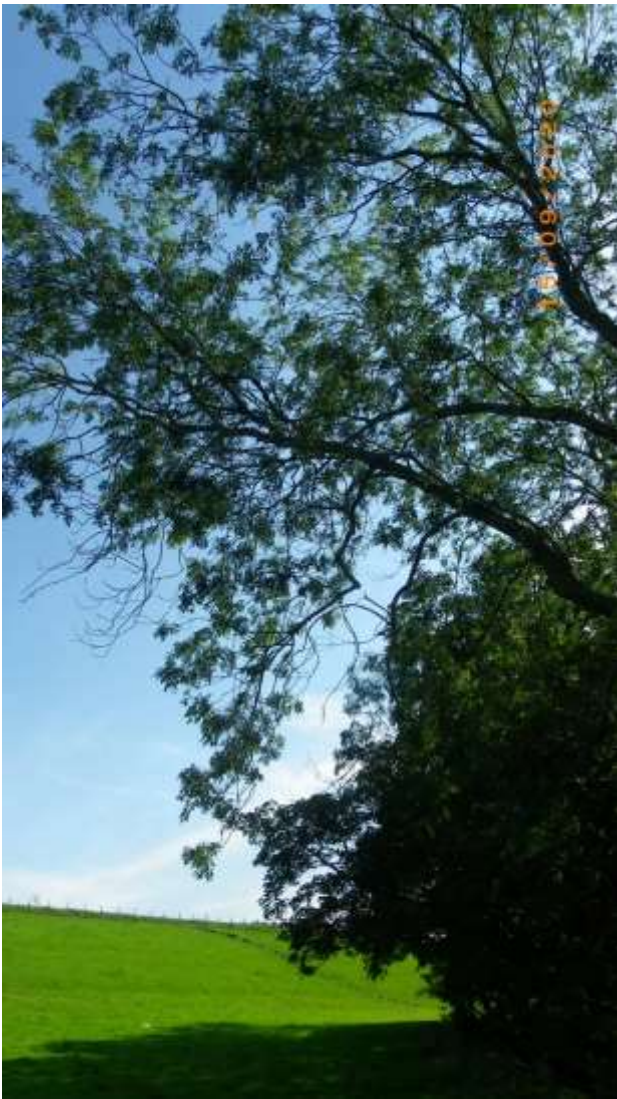
Photo 168 ash dieback symptoms seen throughout the wood in mature stems

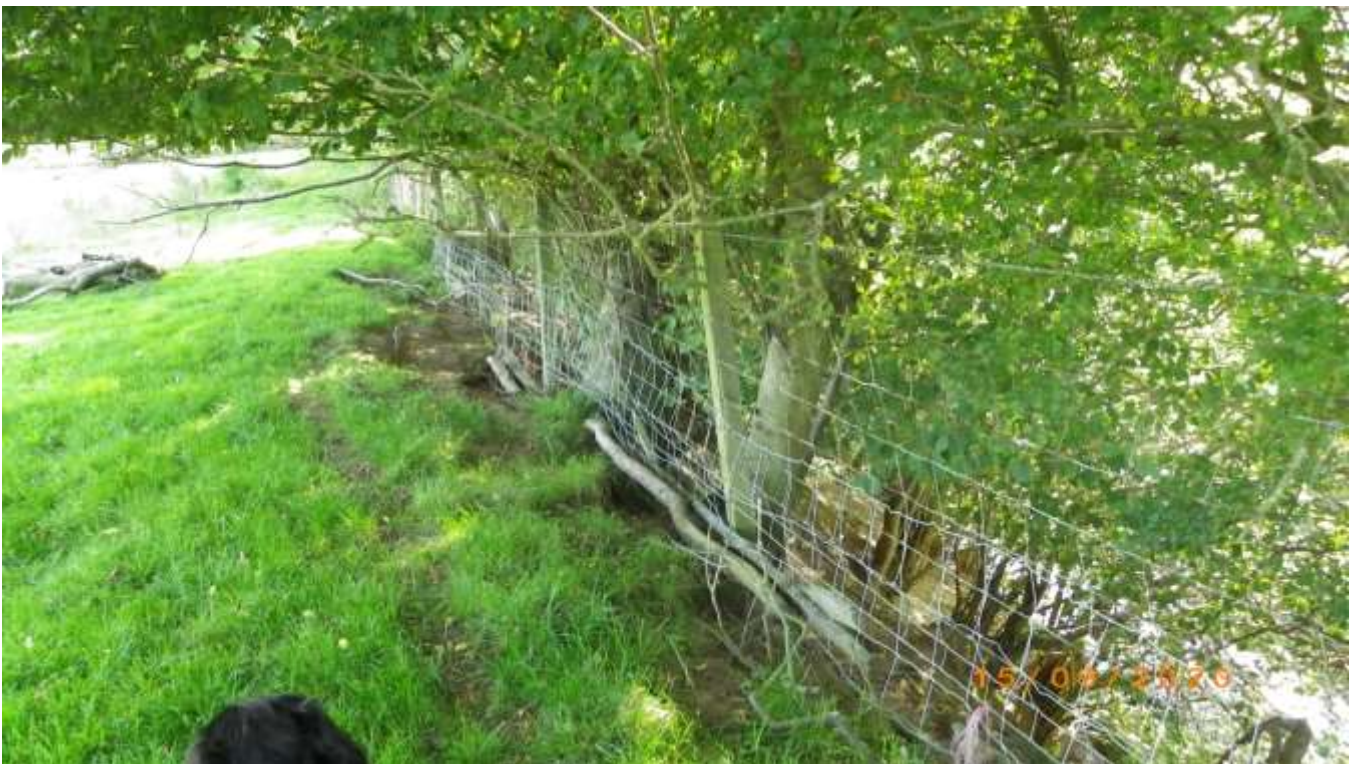
Photo 174 & 175 fencing to Hodge Beck just south of the footbridge between cpt10a & cpt11

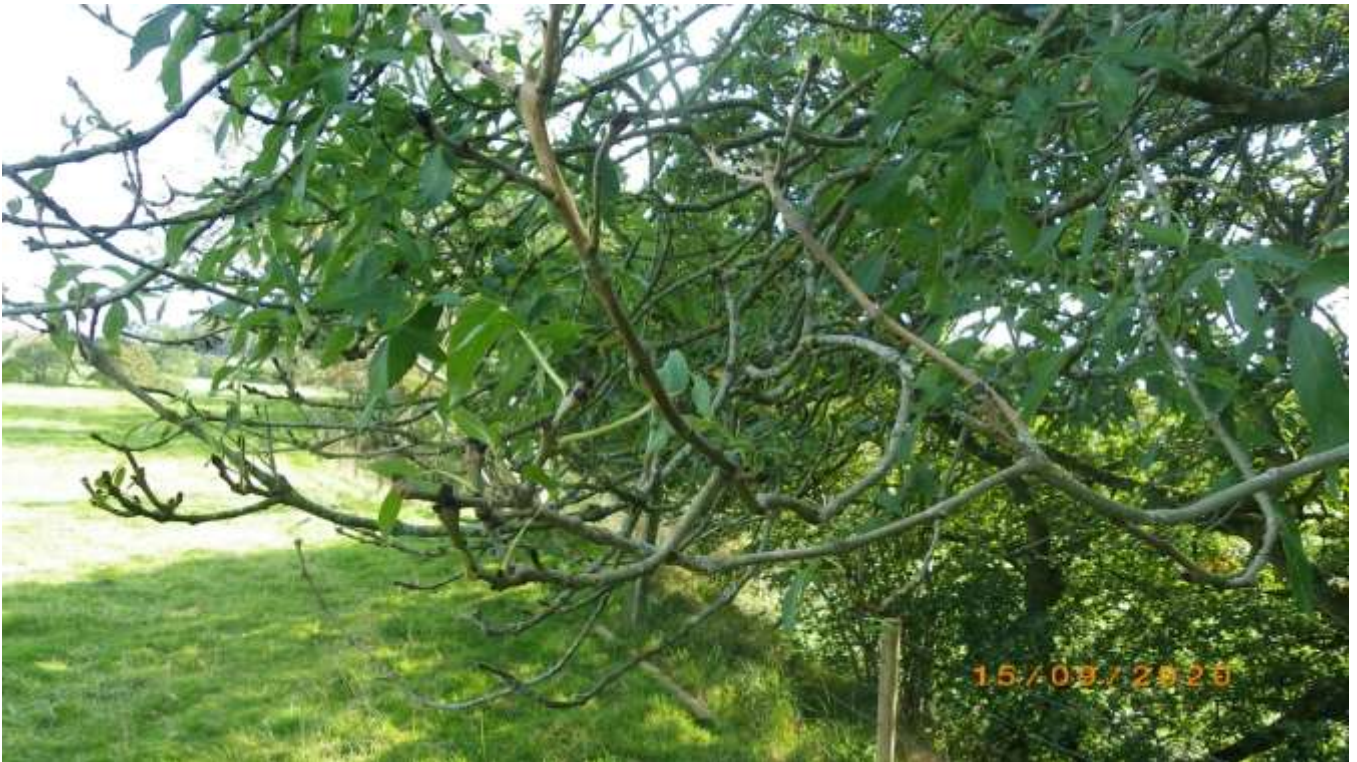
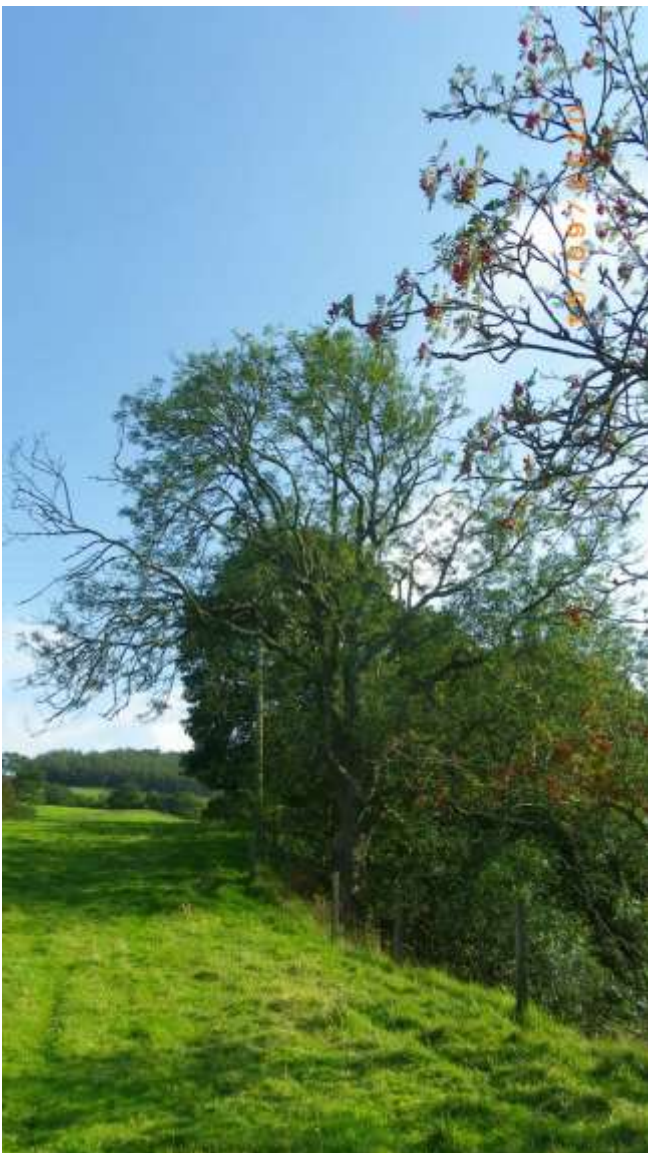
Photo 176 & 177 Cpt11a ash dieback present in mature stems – see necrotic branches

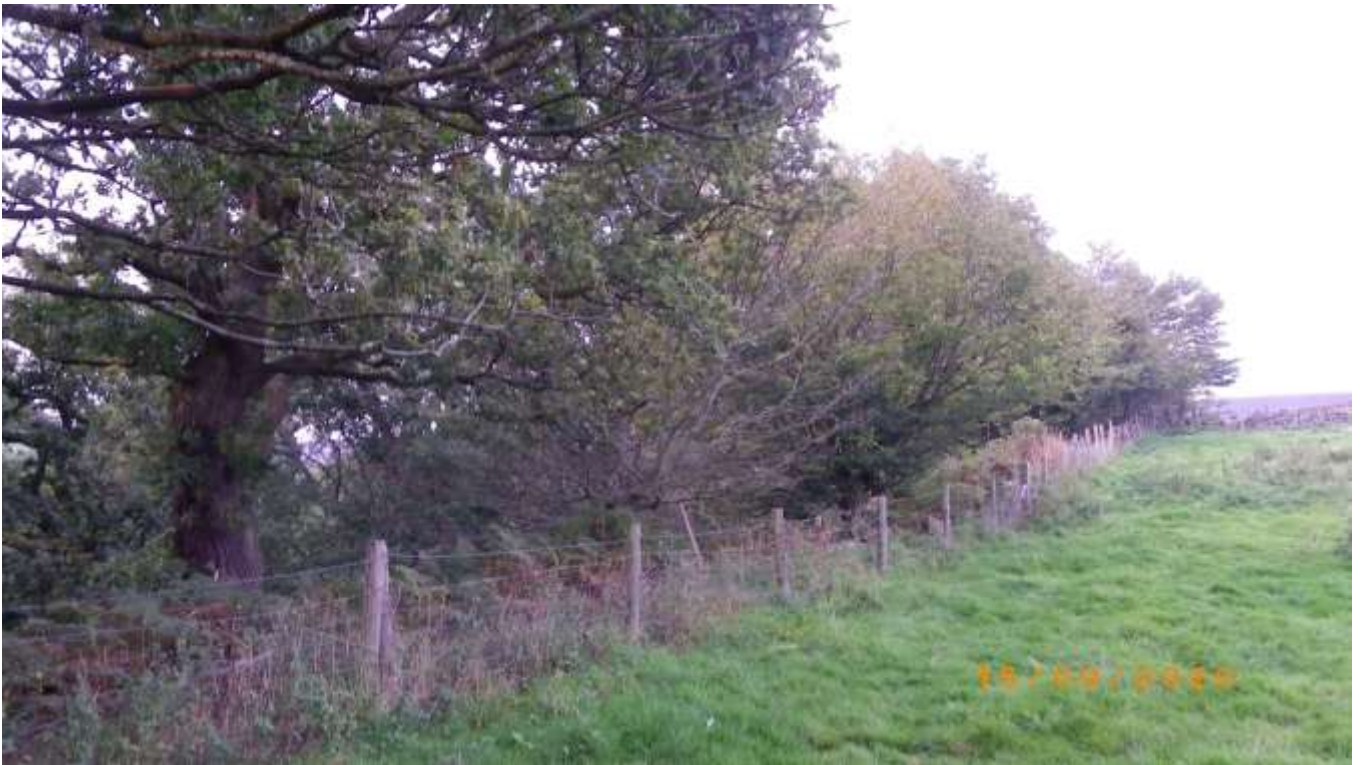
Photo 183 Cpt11a old fencing to the south of the wood

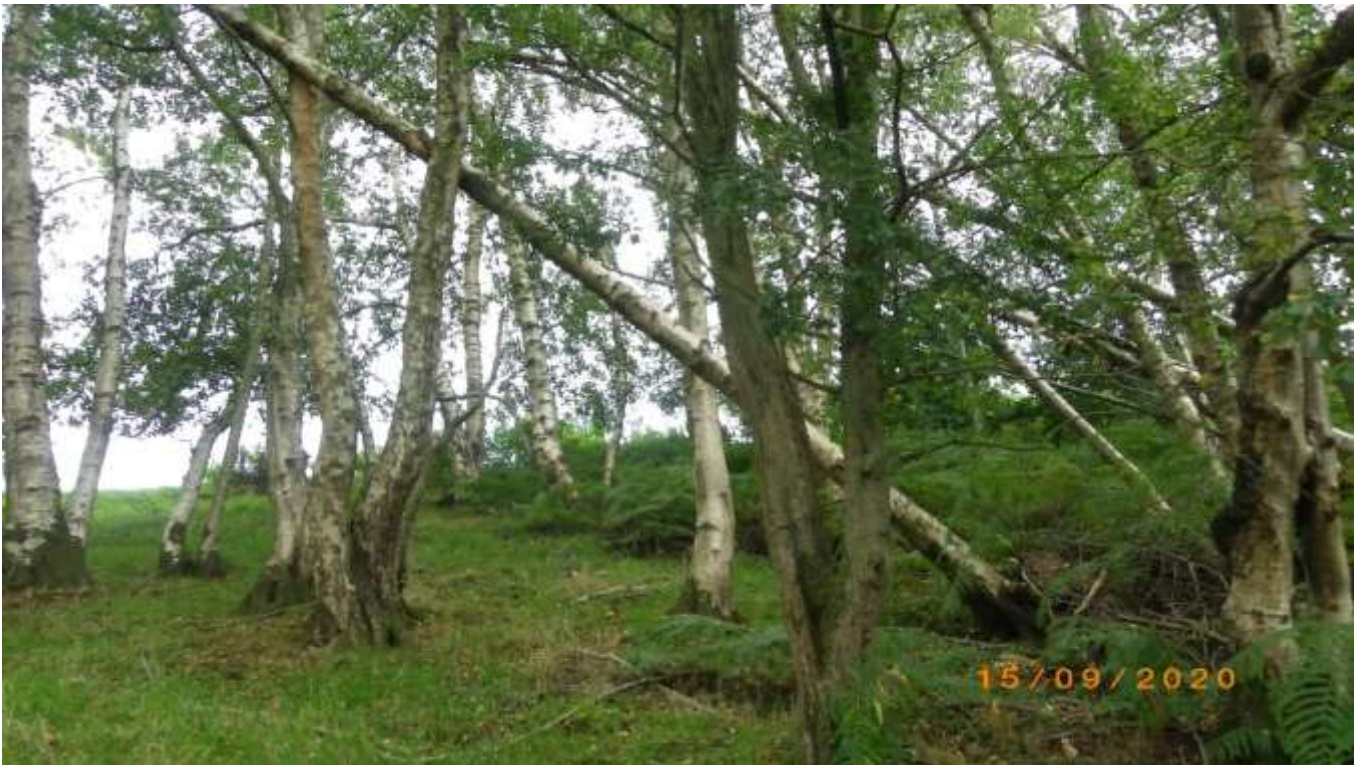
Photo 185 Cpt12a windblown birch above the bridge

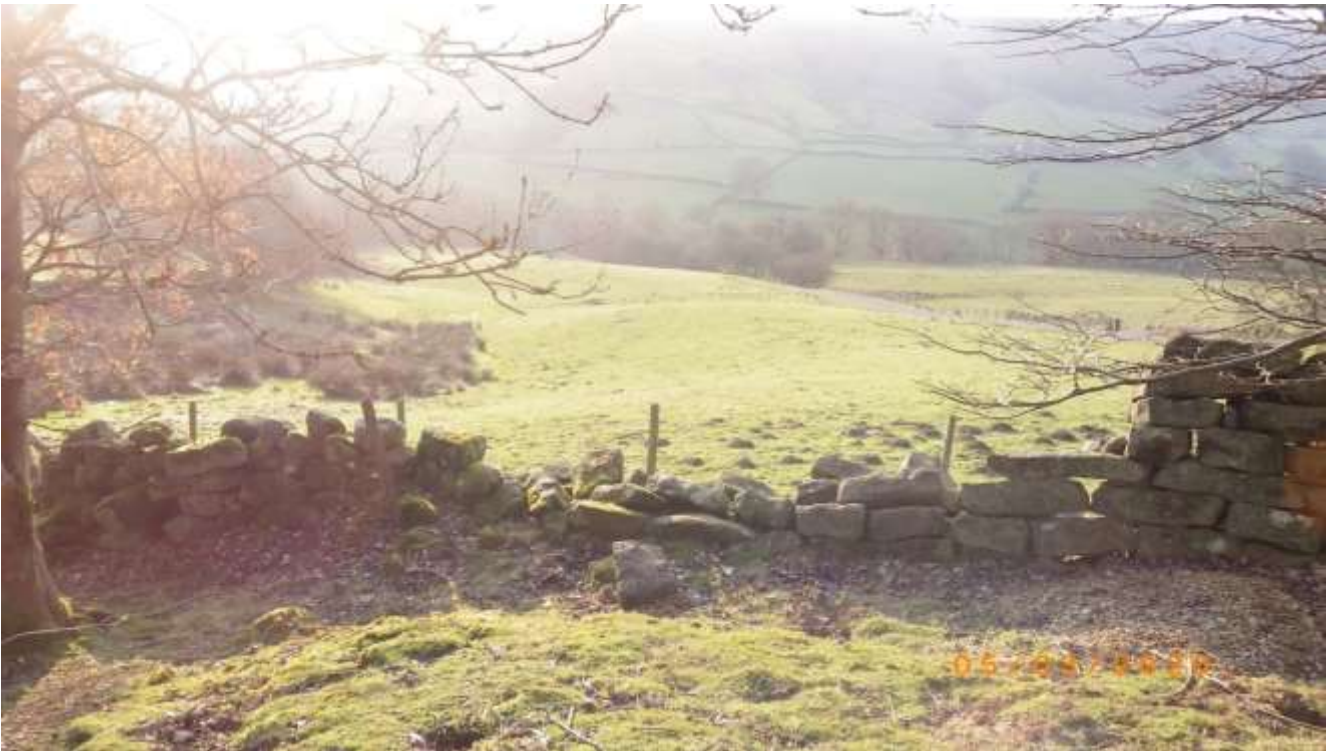
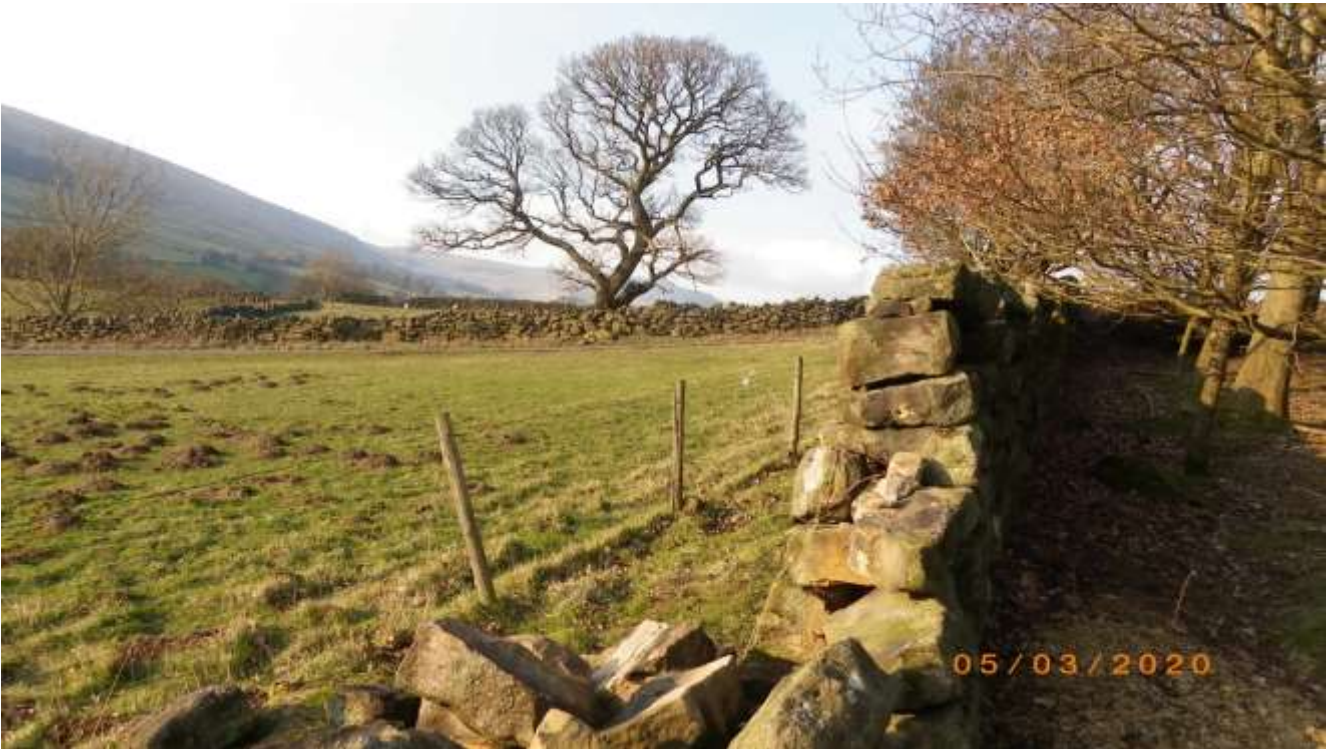
Photo 195 & 196 boundary to the west may not be stock proof

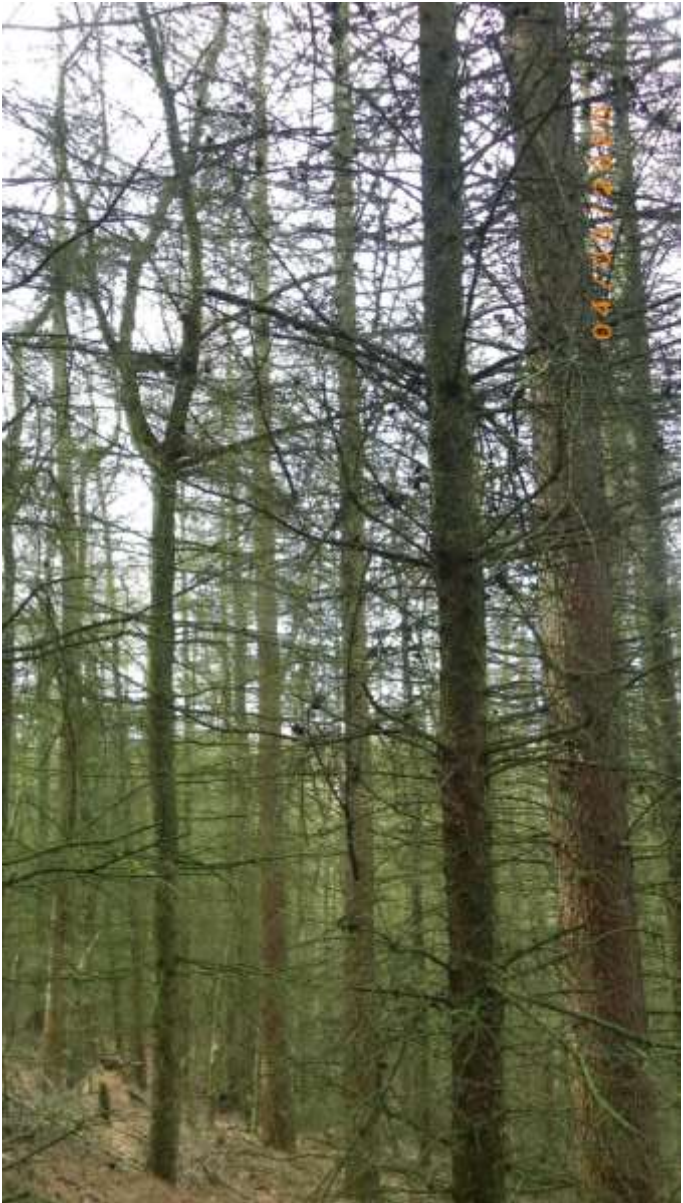
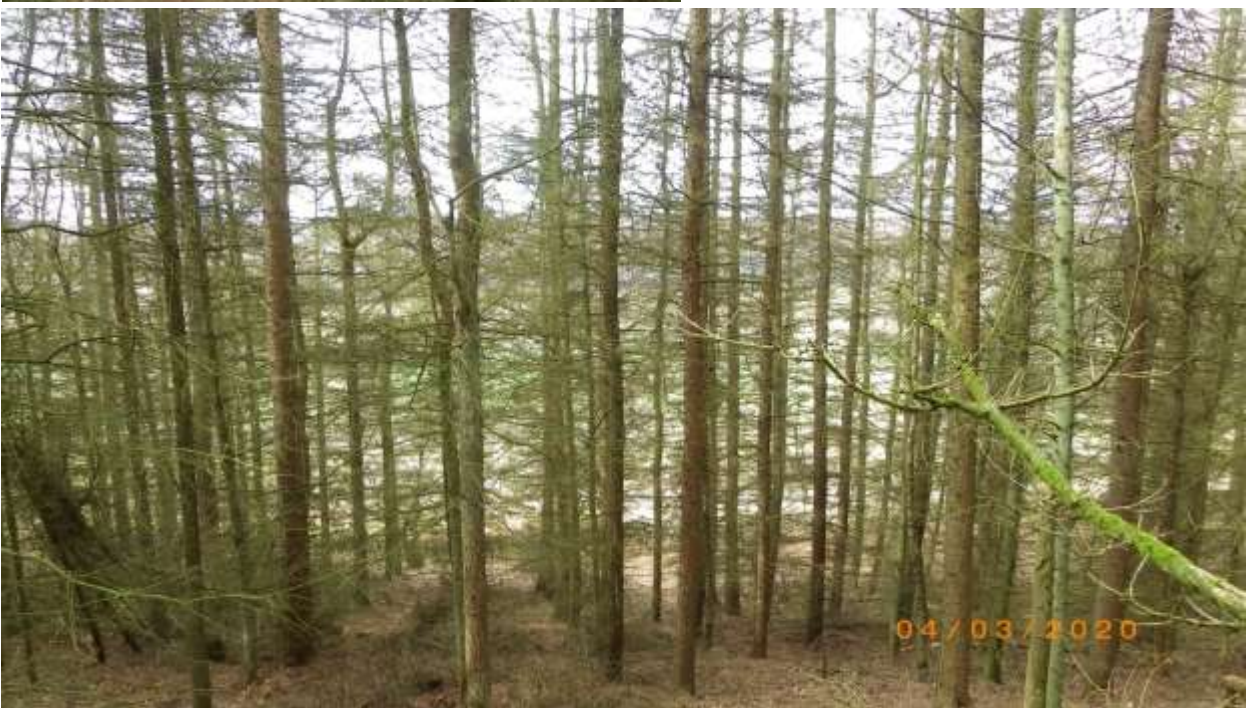
Photo 210 & 211 Cpt 14a Barker Plantation etiolated stand of unthinned larch

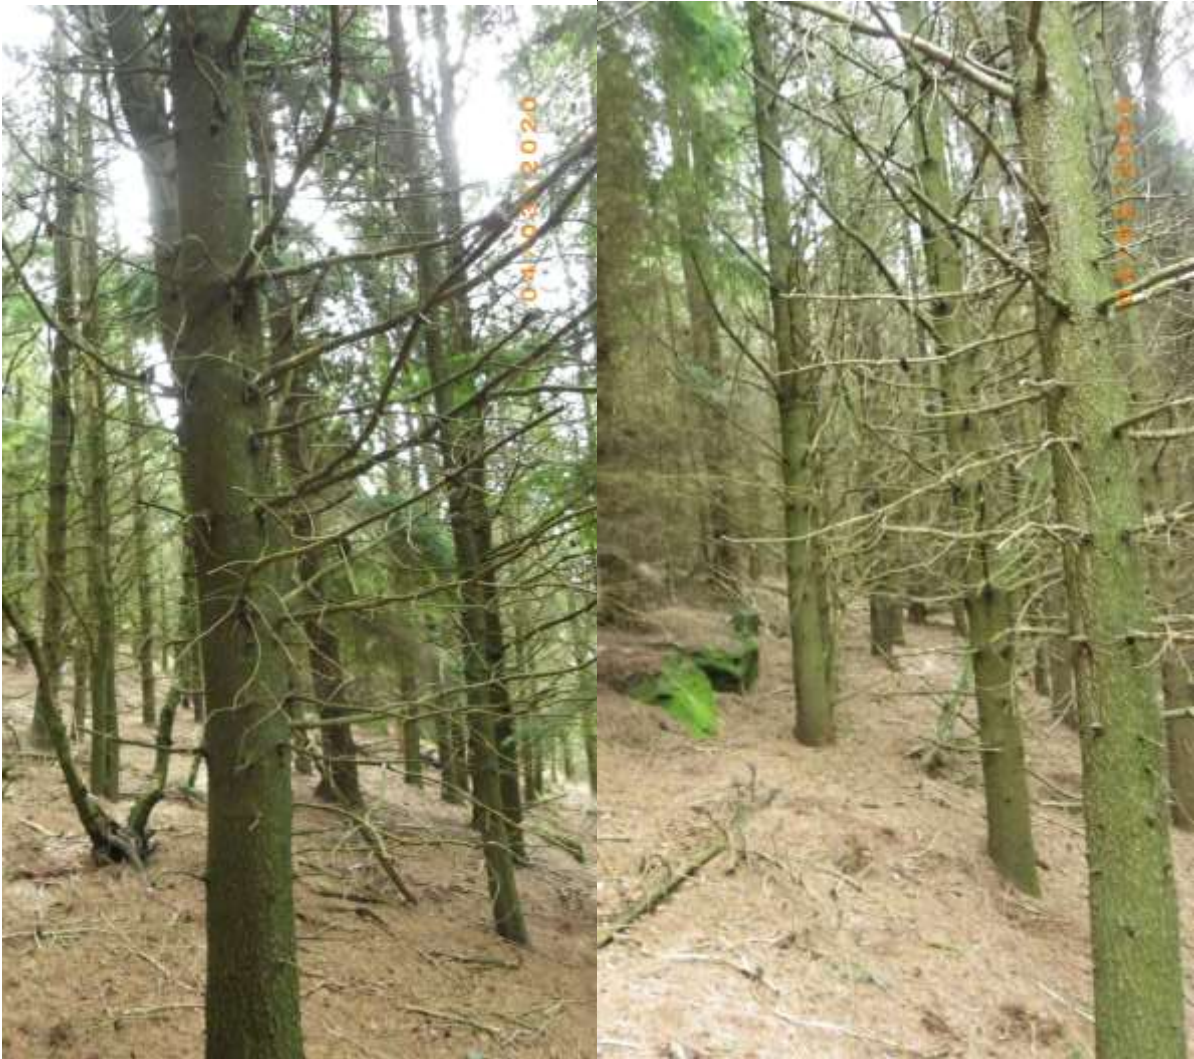
Photo 219 & 220 Barker Plantation cpt14b unthinned etiolated trees dbh average 19cm

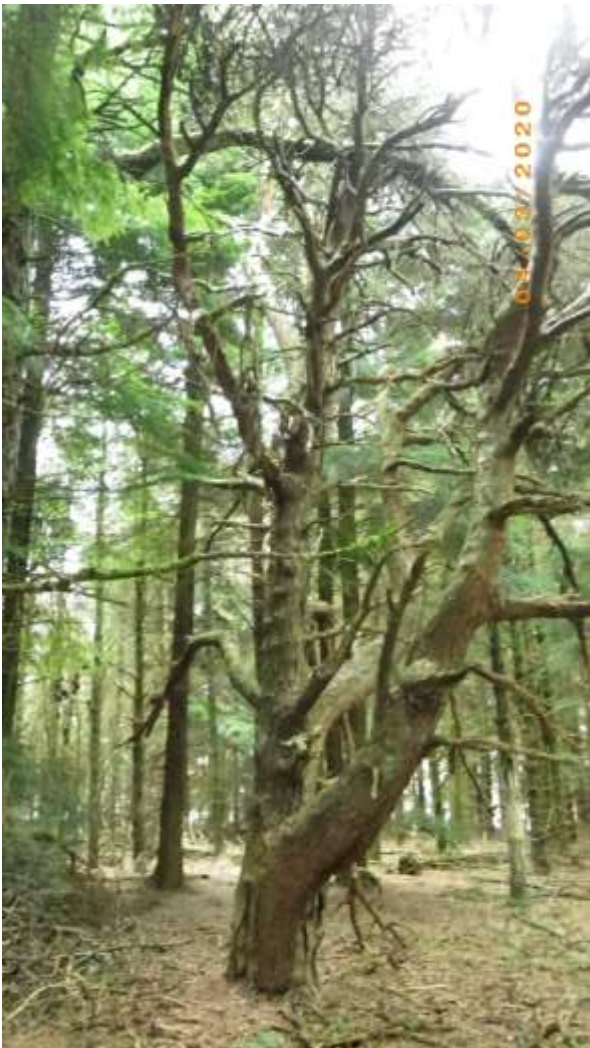
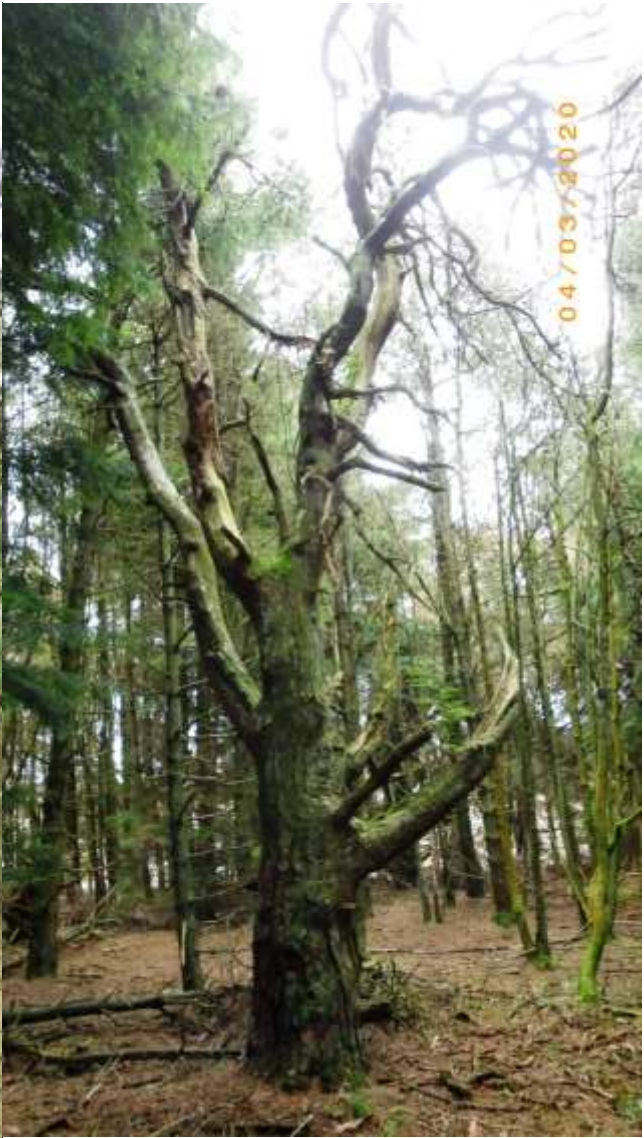
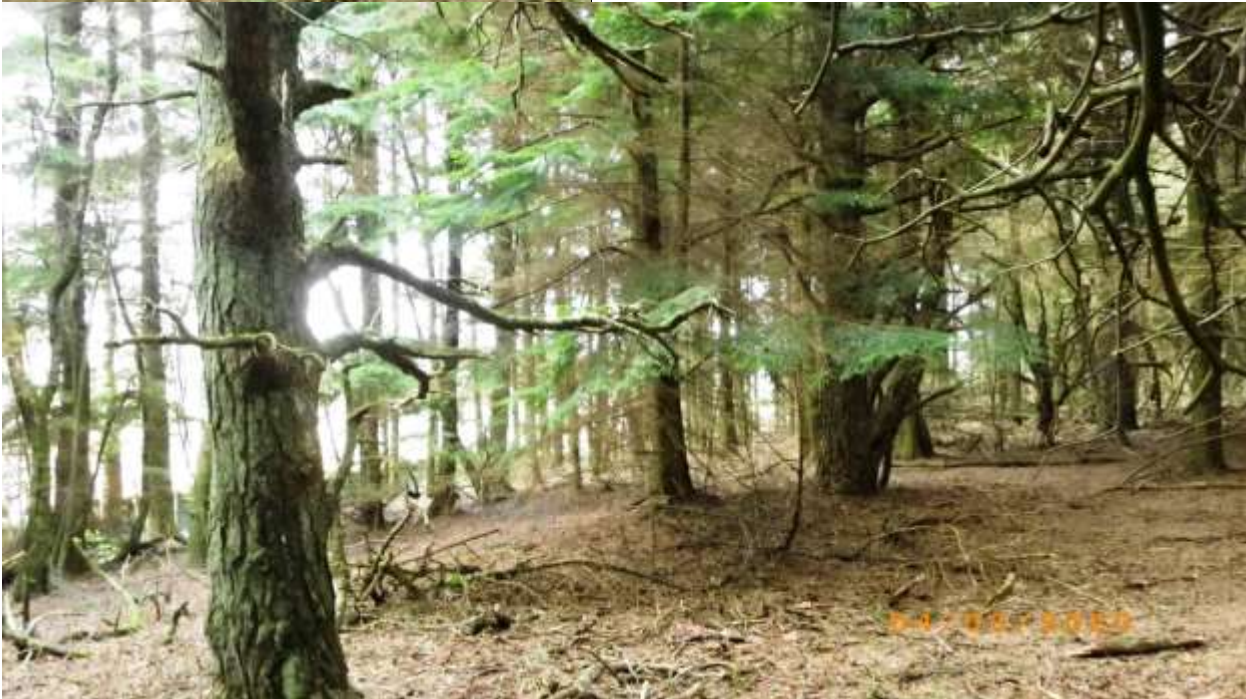
Photo 234, 235 & 236 Barker Plantation mature Scots pine over topped by the surrounding crop in cpt14b to the south east see map 16

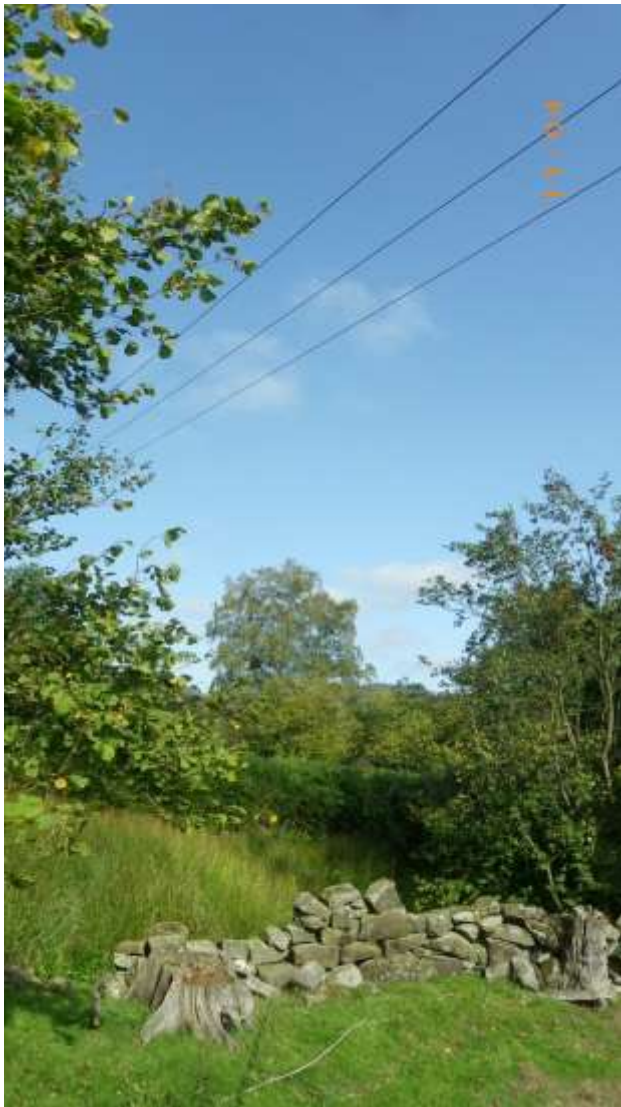
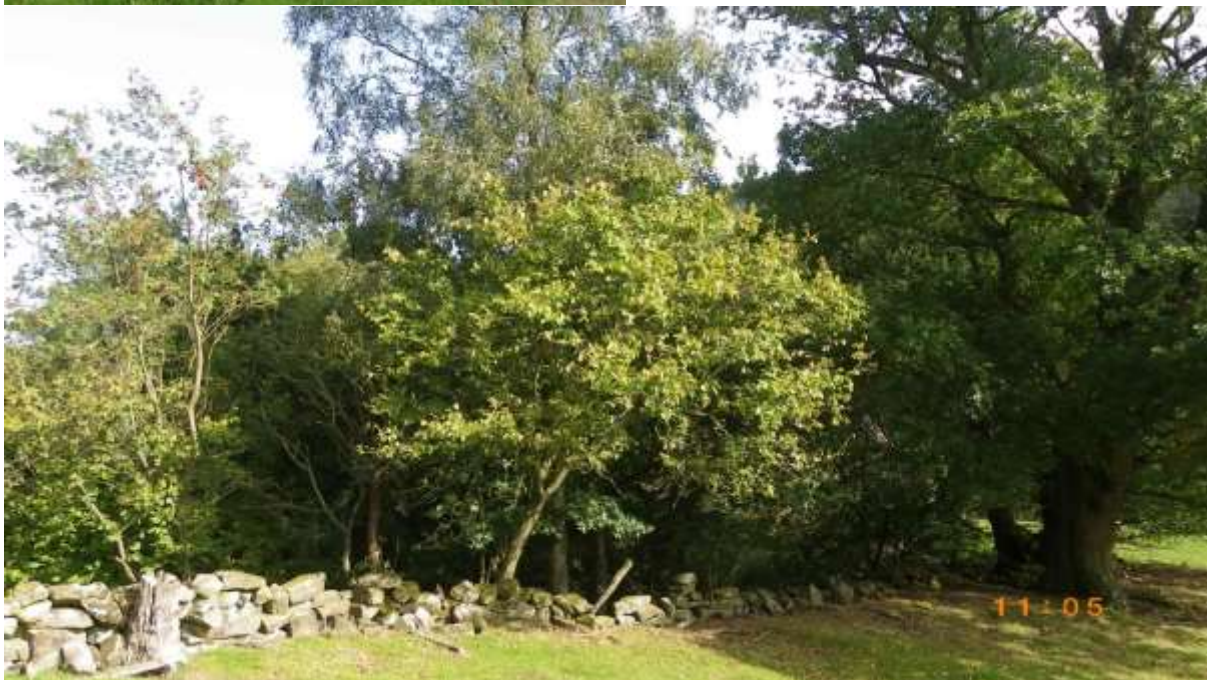
Photo 267 & 268 Cpt19a overhead electric wires & low stone wall not stock proof

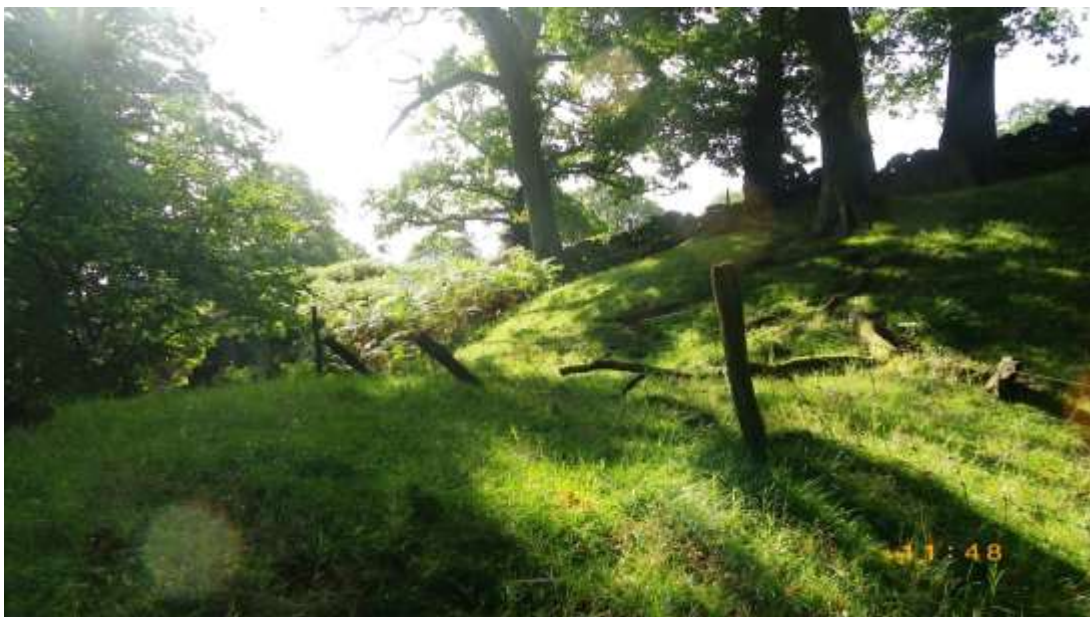
Photo 273 Cpt20a redundant internal fencing

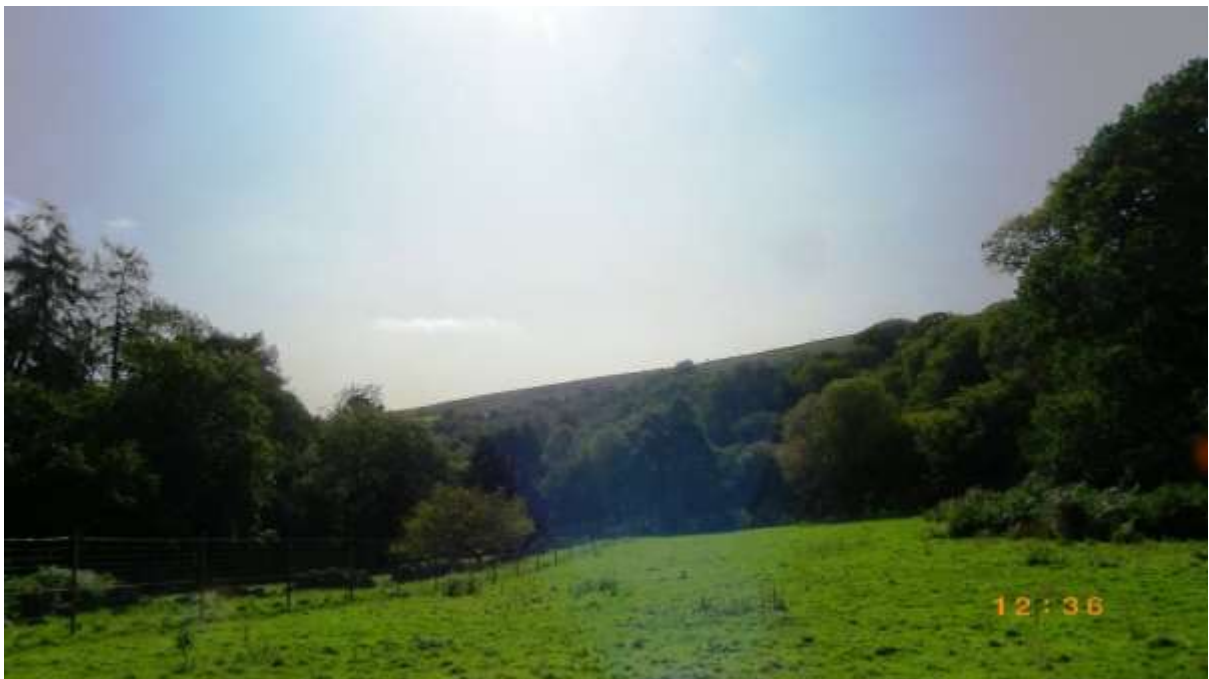
Photo 285 Cpt20c the deer fenced where natural regeneration will be promoted (unit 4)

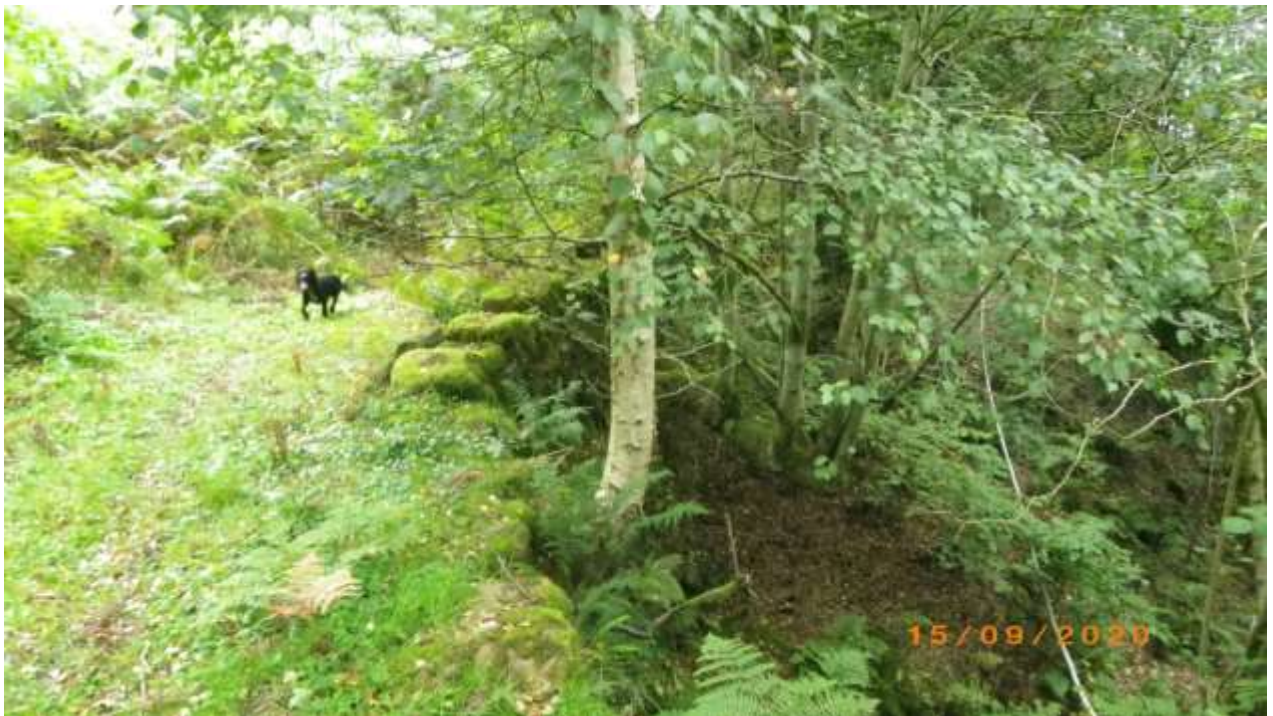
Photo 296 Cpt21 stone banking to the ride

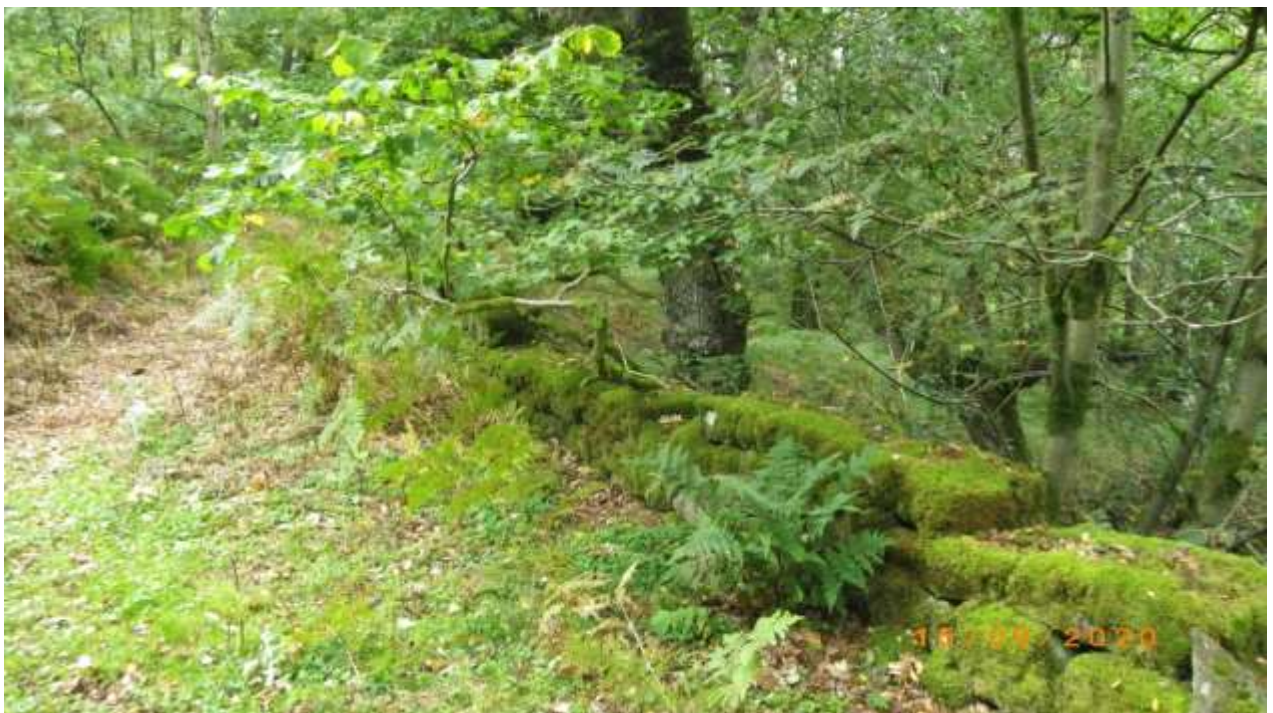
Photo 297 Cpt21 old stone walls possibly denoting old wood pasture grazing?

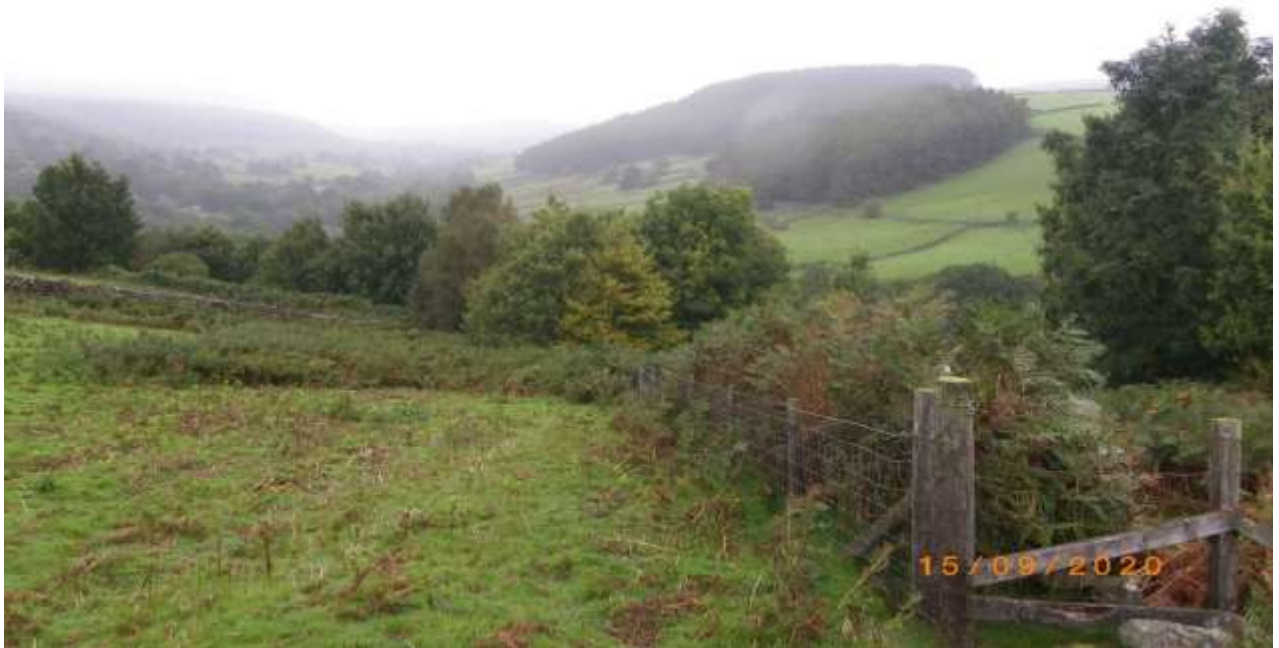
Photo 305 stock net on field side of the boundary wall towards Stork House
