National Trust Bransdale & Farndale Woodland Management Plan
Photo and Images Gallery 2021

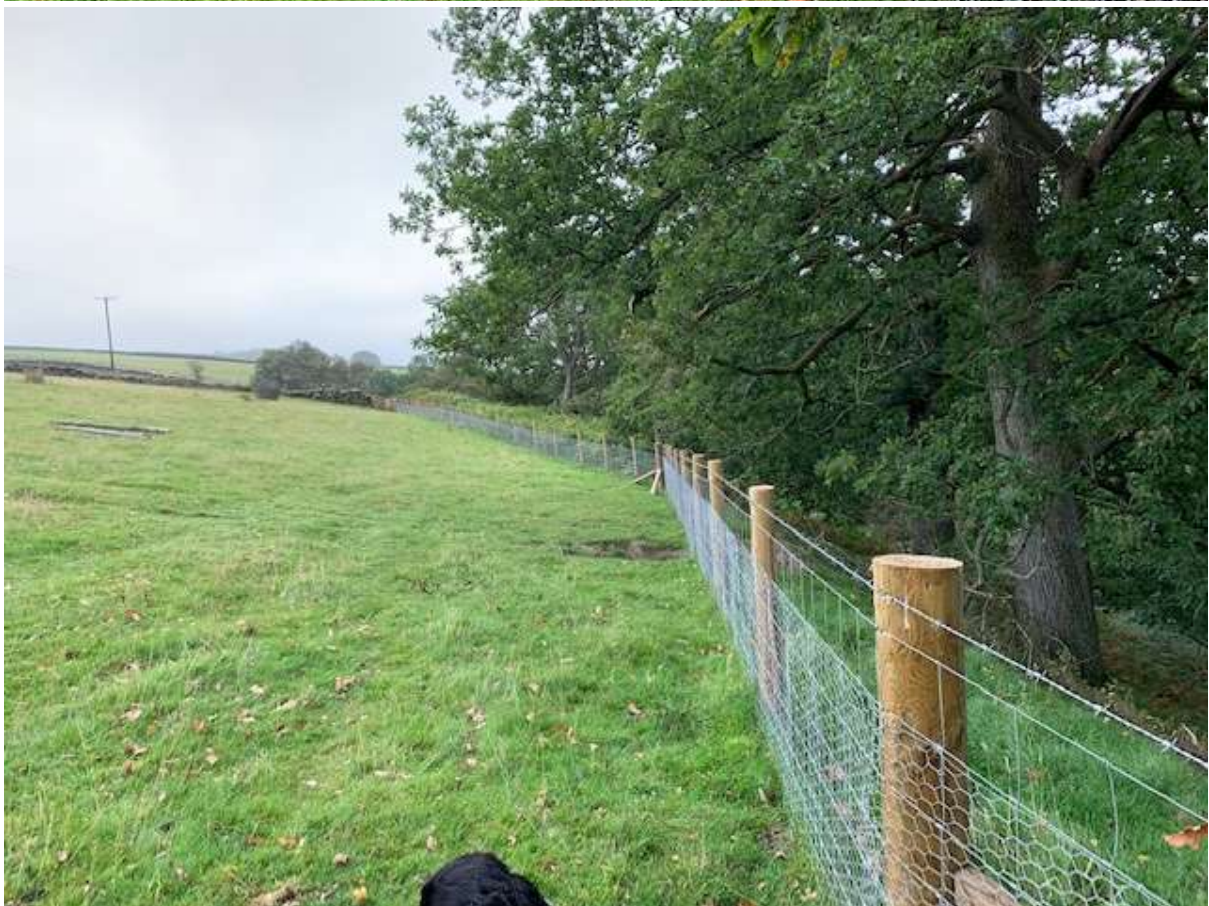
Photo 317 & 318 Cpt22a New stock fencing to the very east of Low Wood

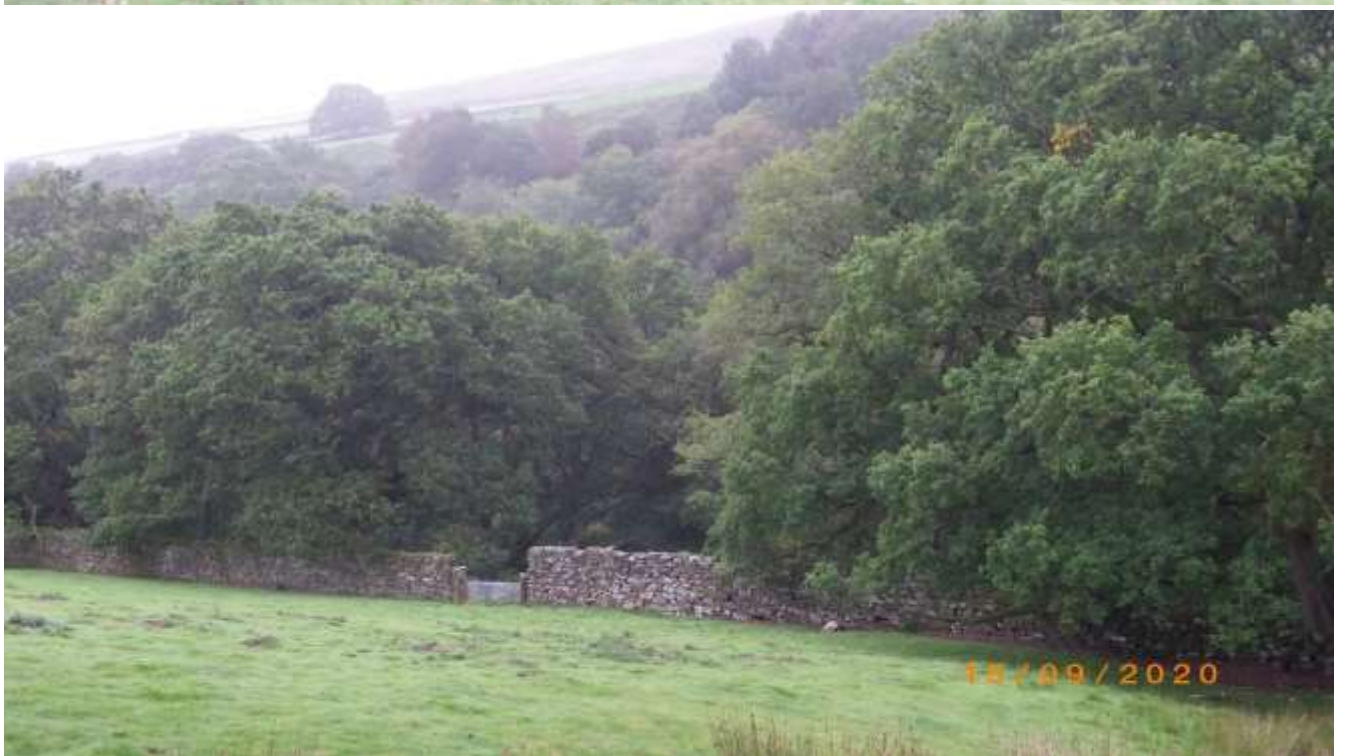
Photo 402 & 403 Cpt22a Low Wood boundary wall collapsed in several places to the north west and the wood is grazed in parts

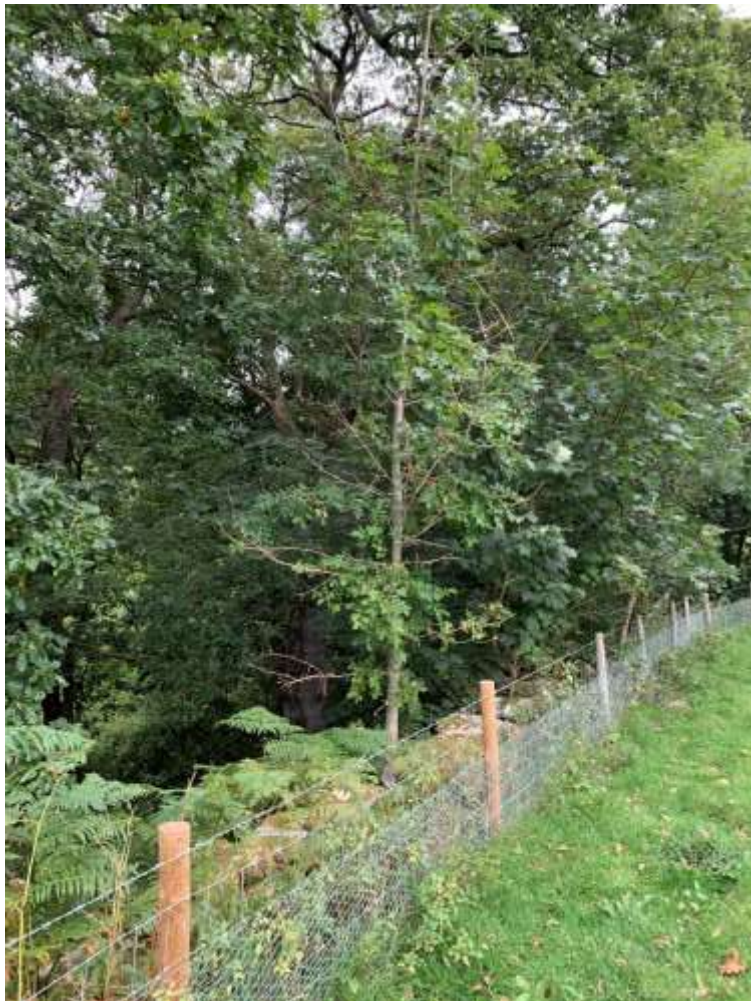
Photo 409 Cpt22a ash dieback symptoms on natural regeneration of ash

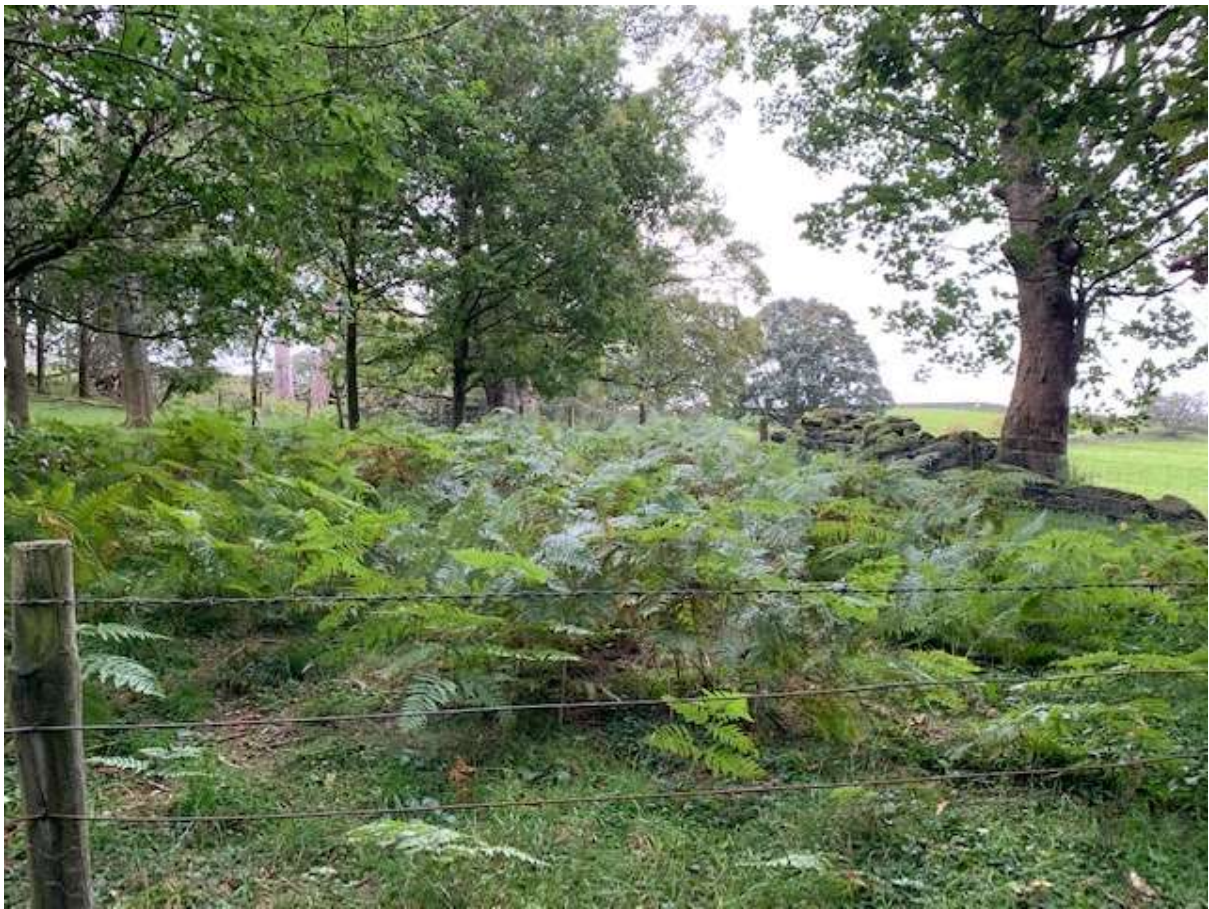
Photo 414 Cpt22c southern boundary stock fence inside the old wall boundary

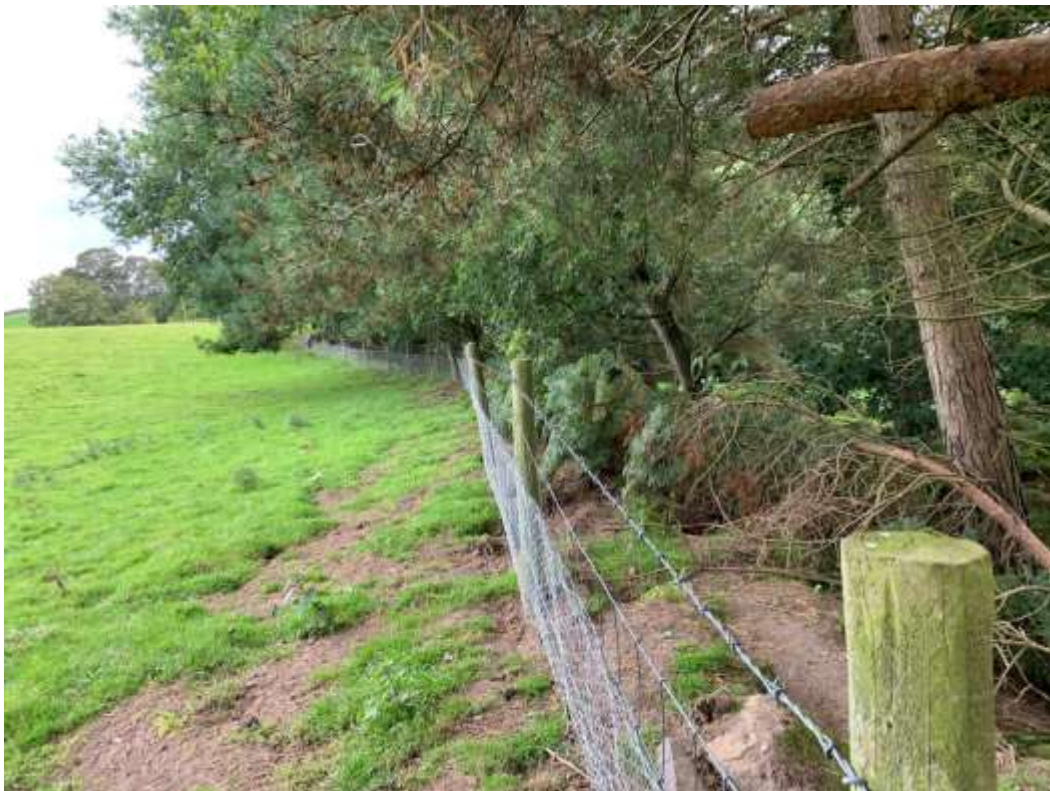
Photo 415 Cpt22c eastern boundary stock fence outside the old wall boundary

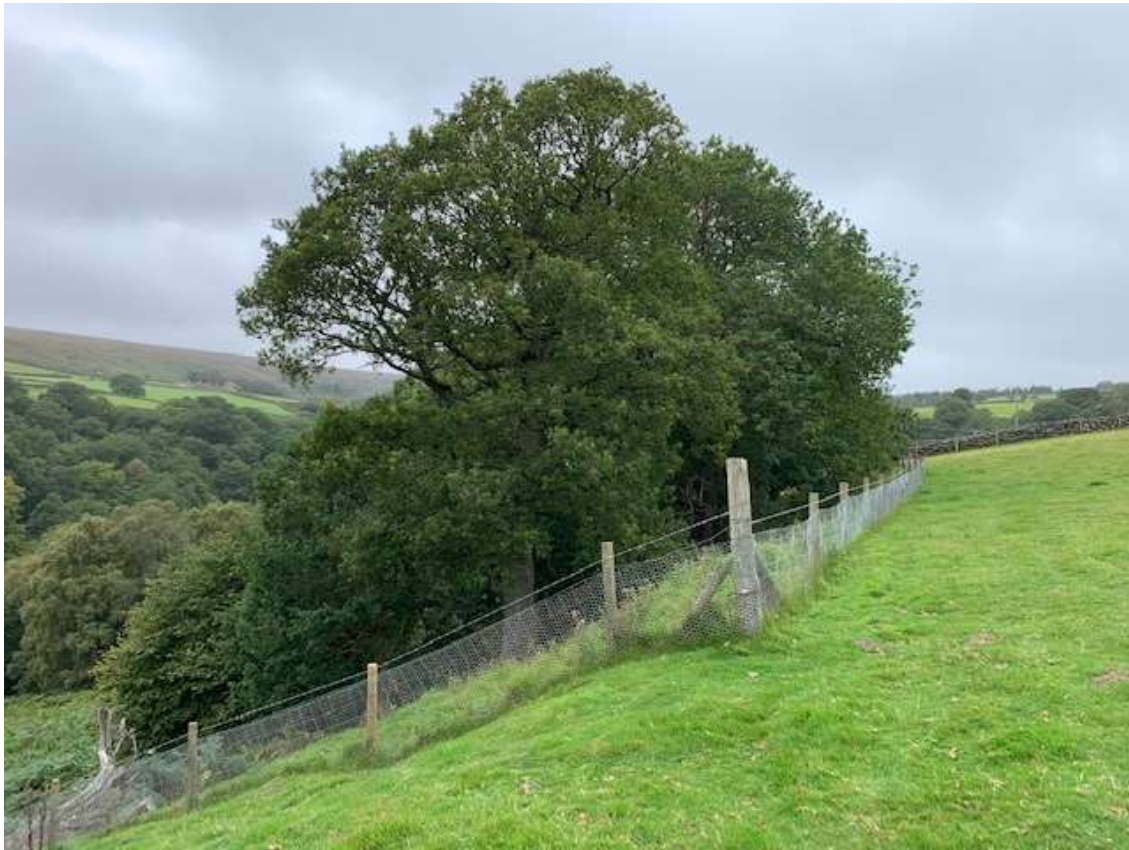
Photo 418 Cpt23a stock net fence to s/e of the wood

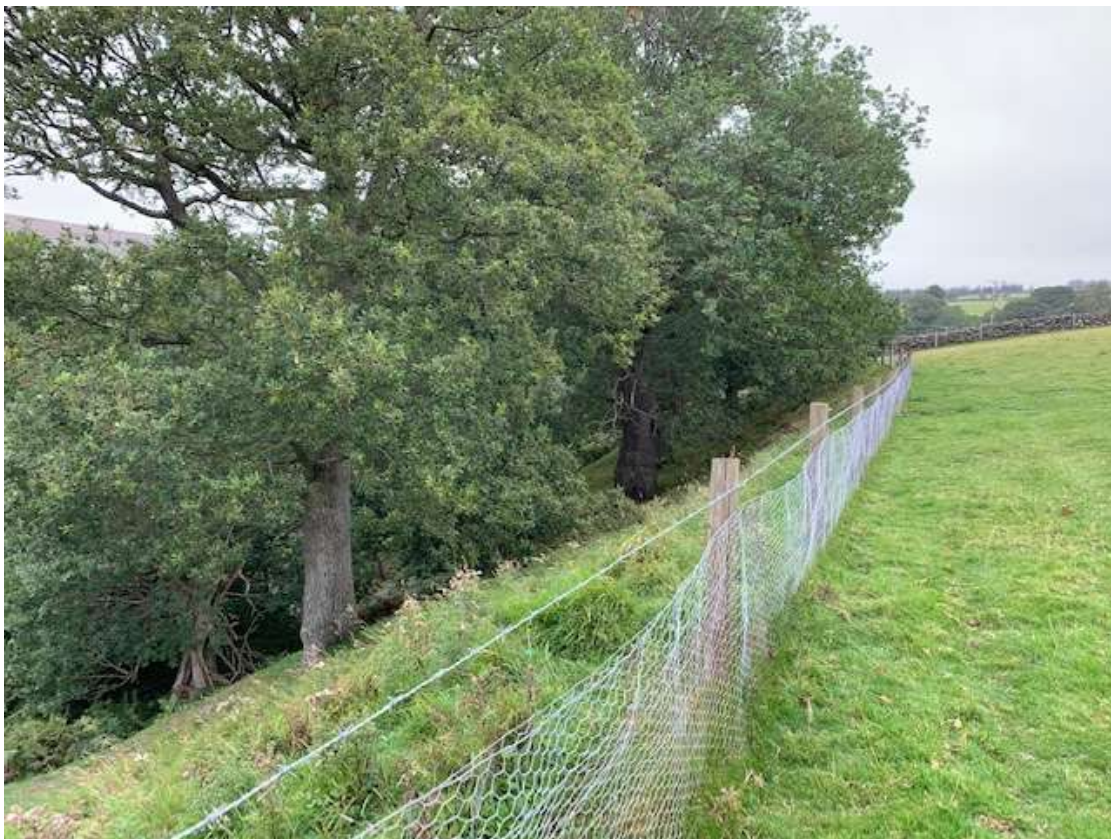
Photo 419 Cpt23a stock net fence to n/e of the wood

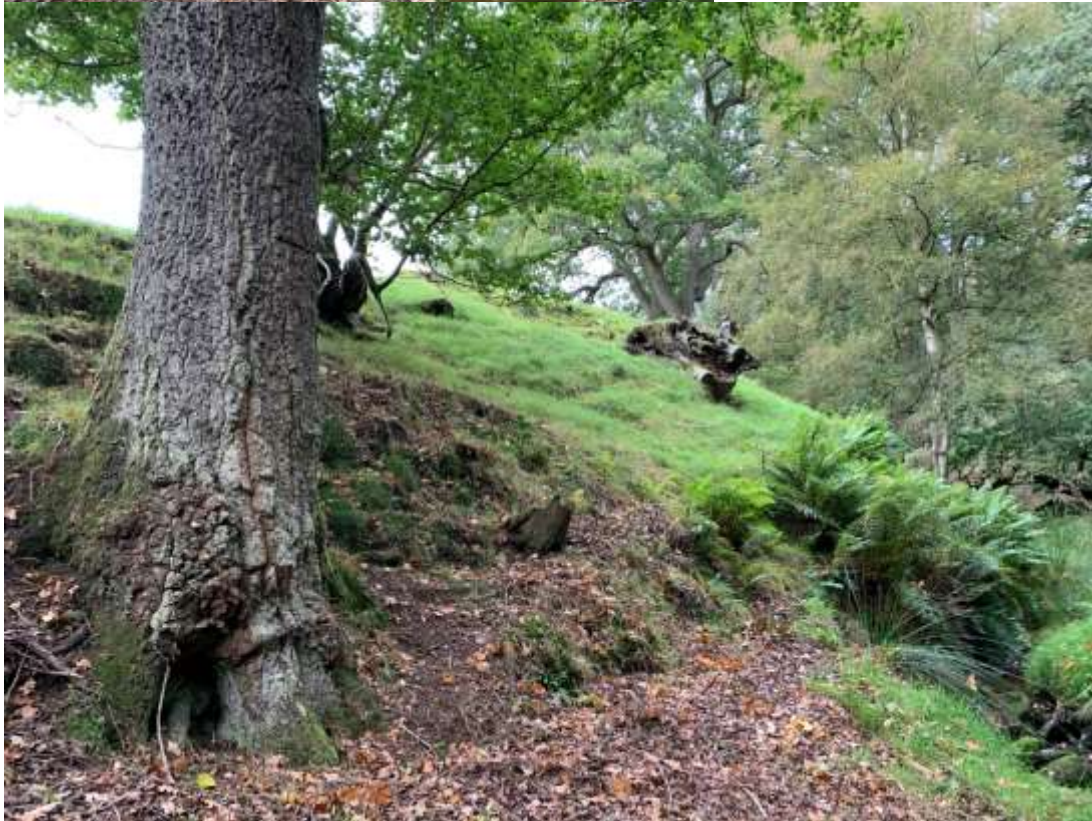
Photo 422 & 423 Cpt24a Shawbeck Wood no fence to the s/w boundary field

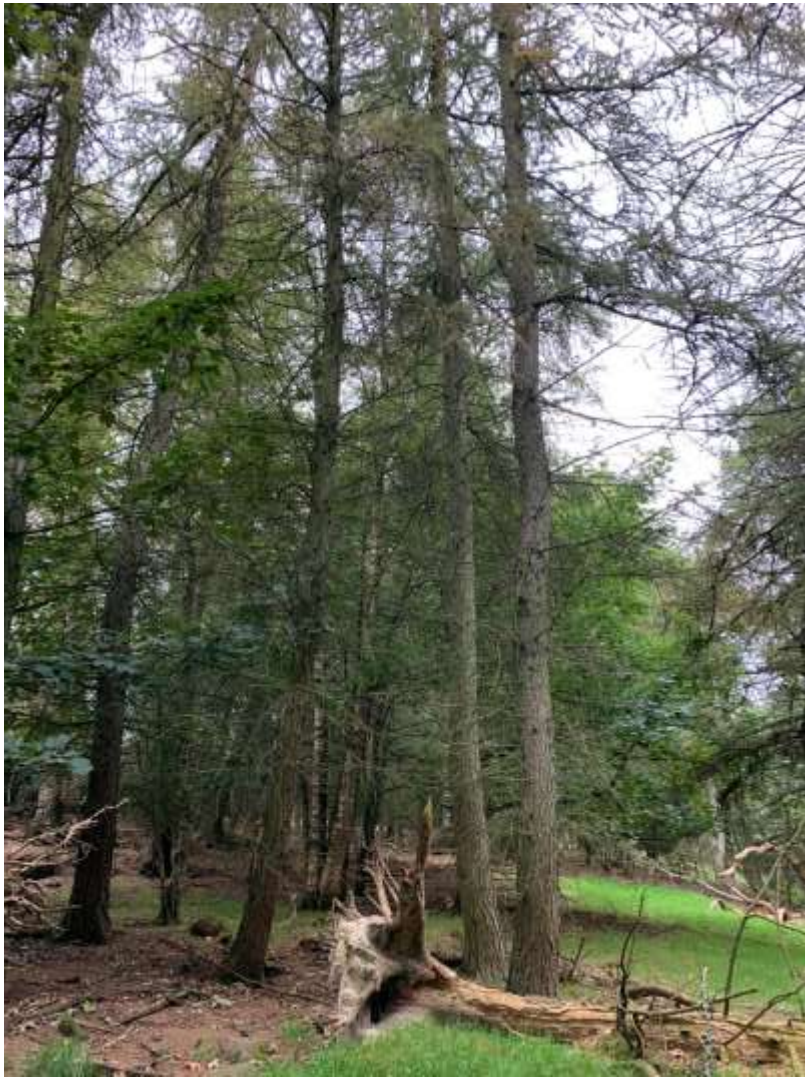
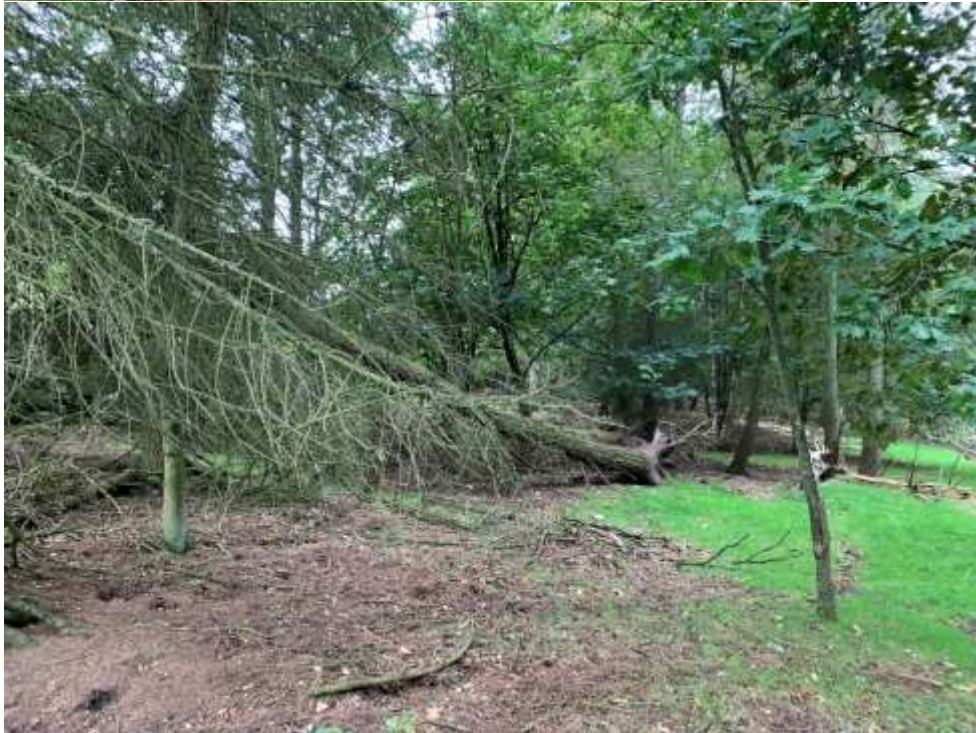
Photo 426 & 427 Cpt24a Shawbeck Wood mature unthinned larch windblown

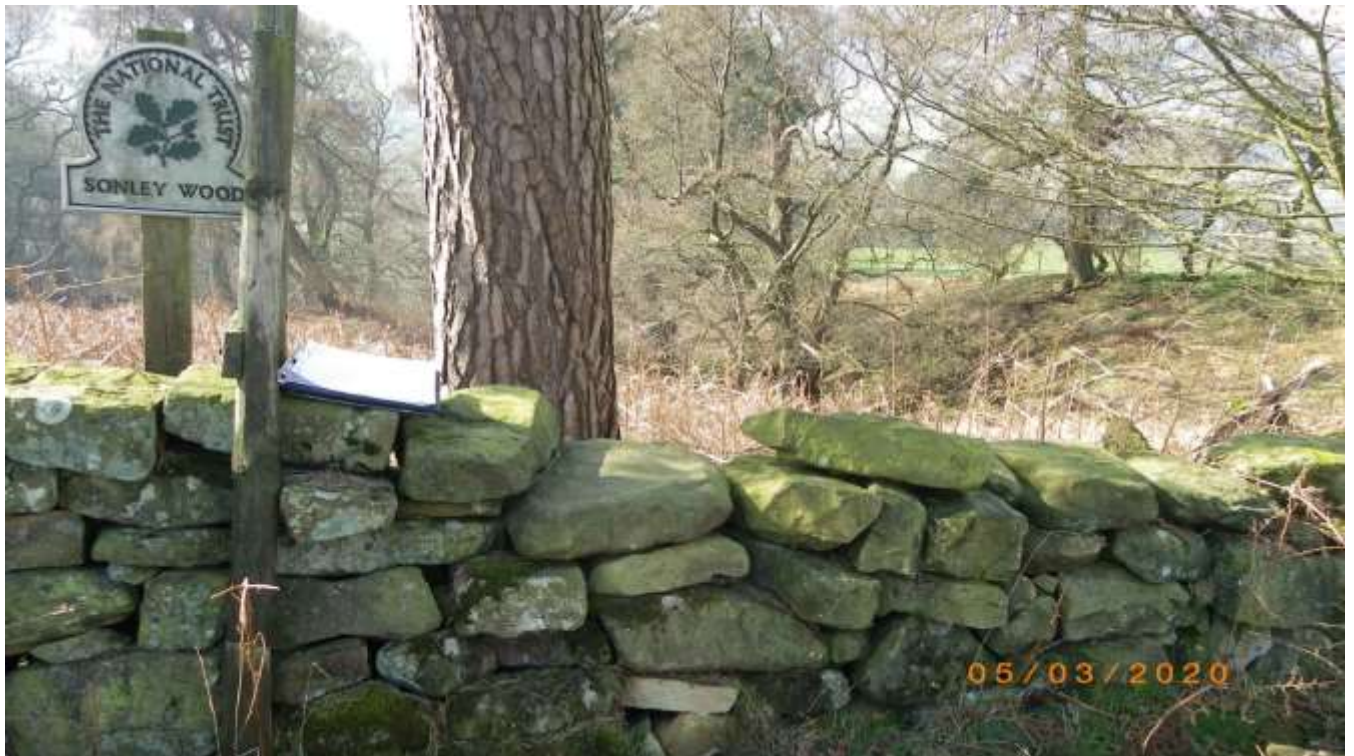
Photo 432 Cpt26 Sonley Woodland there is limited access to the wood

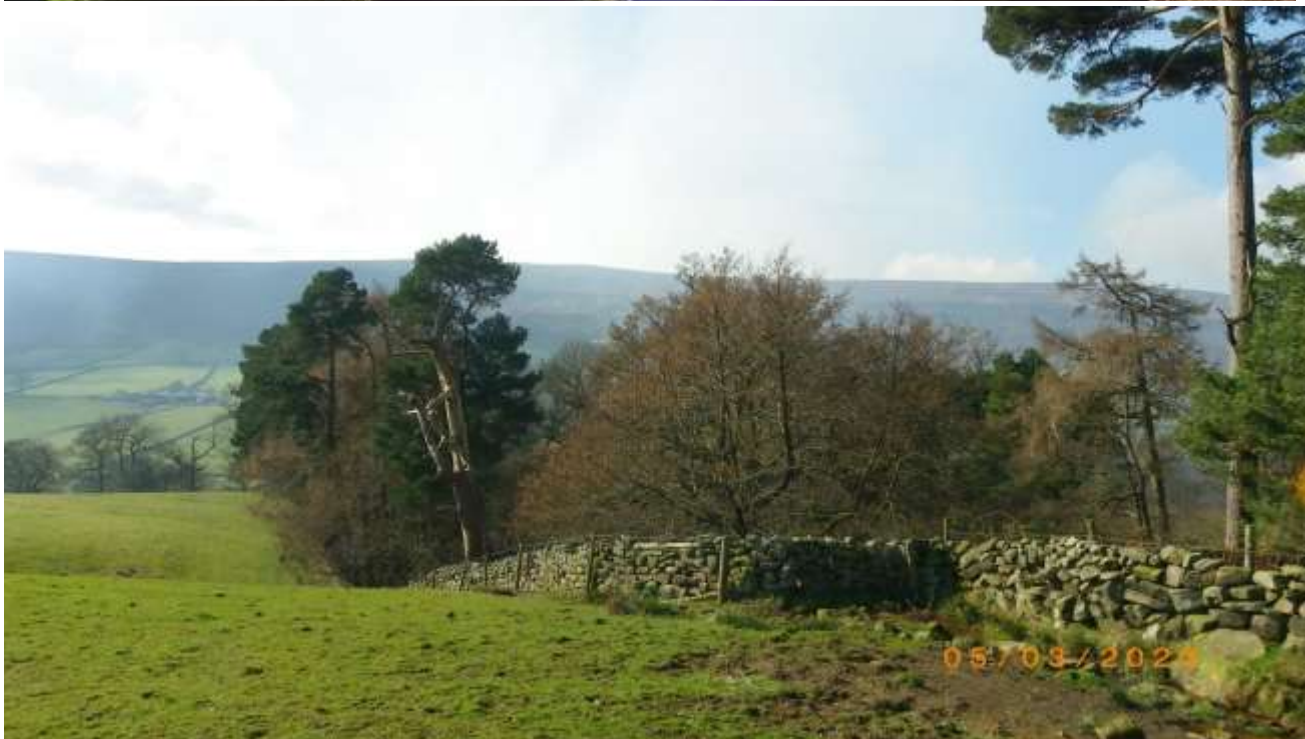
Photo 436 & 437 Cpt26 Sonley Woodland old wall boundaries mostly fenced to the field side or with top wires.

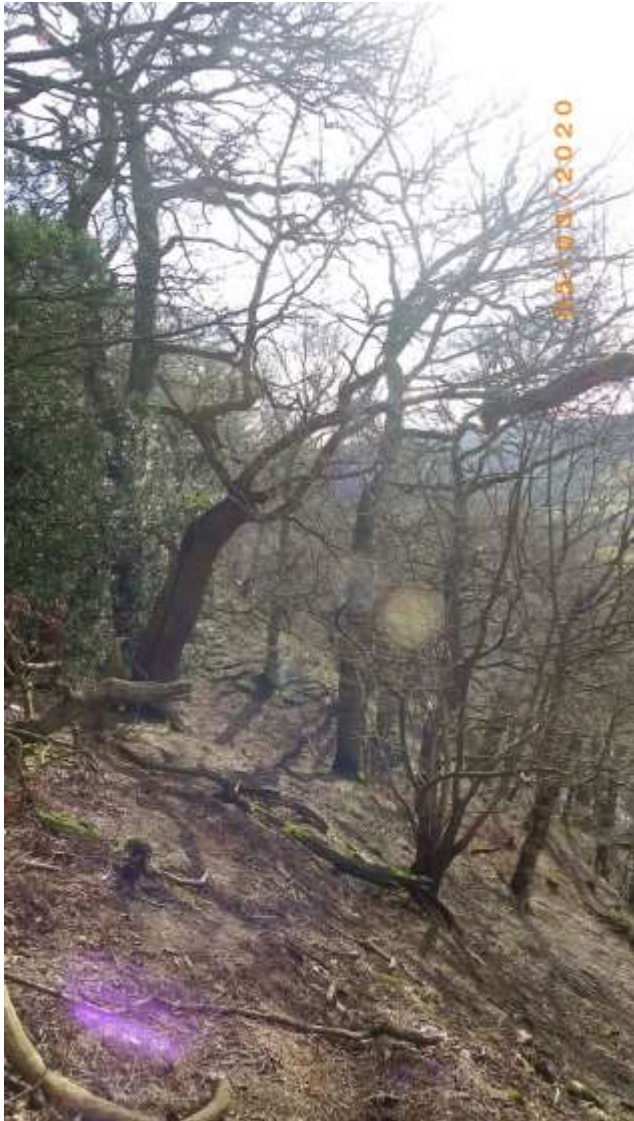
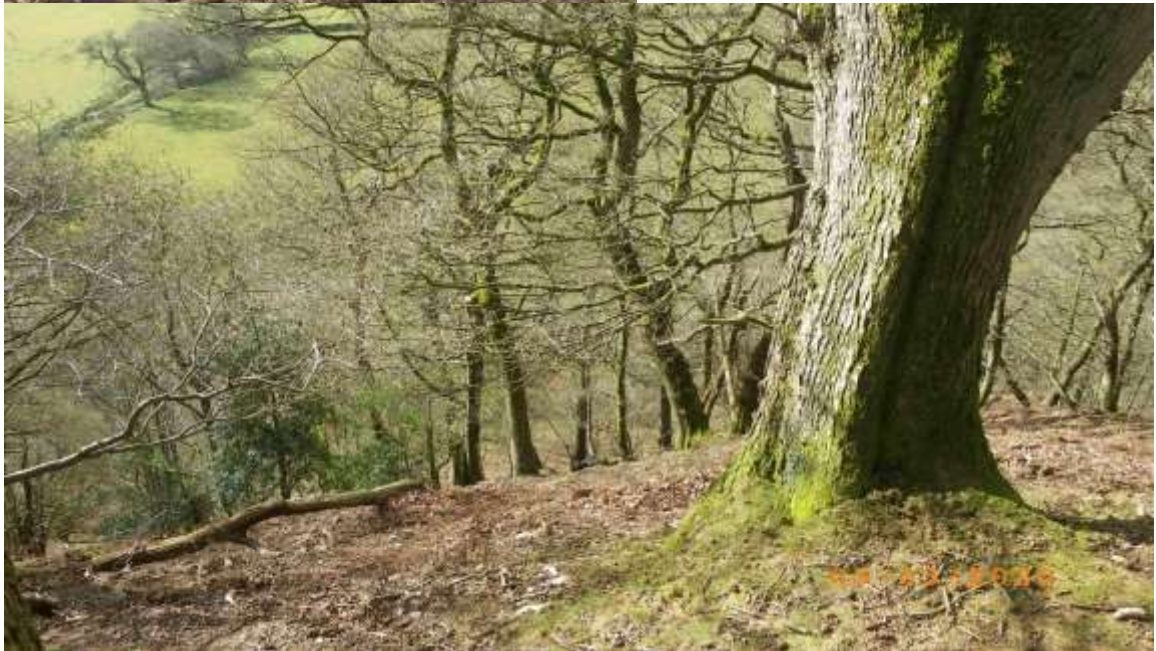
Photo 438 & 439 Cpt26 Sonley Woodland steep sides to the River Dove

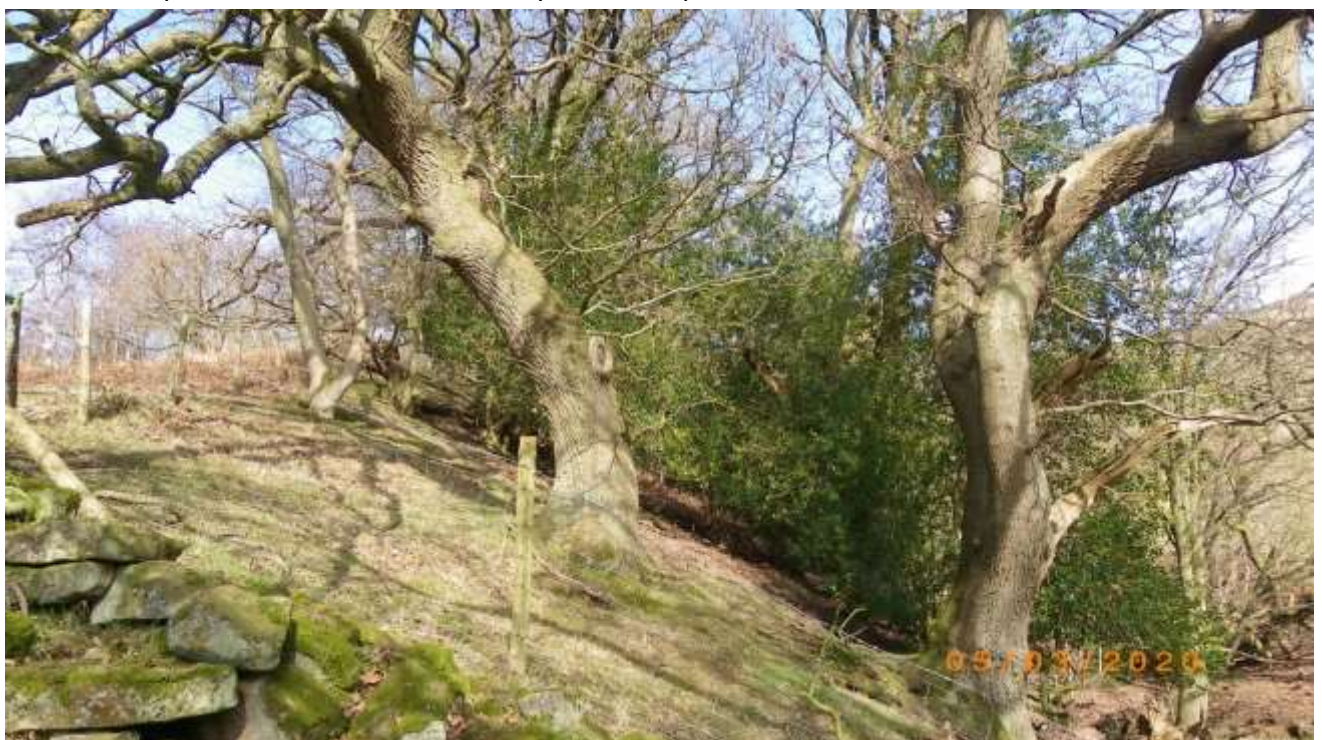
Photo 441 Cpt27 Sike Wood oak and holly on s/e slope

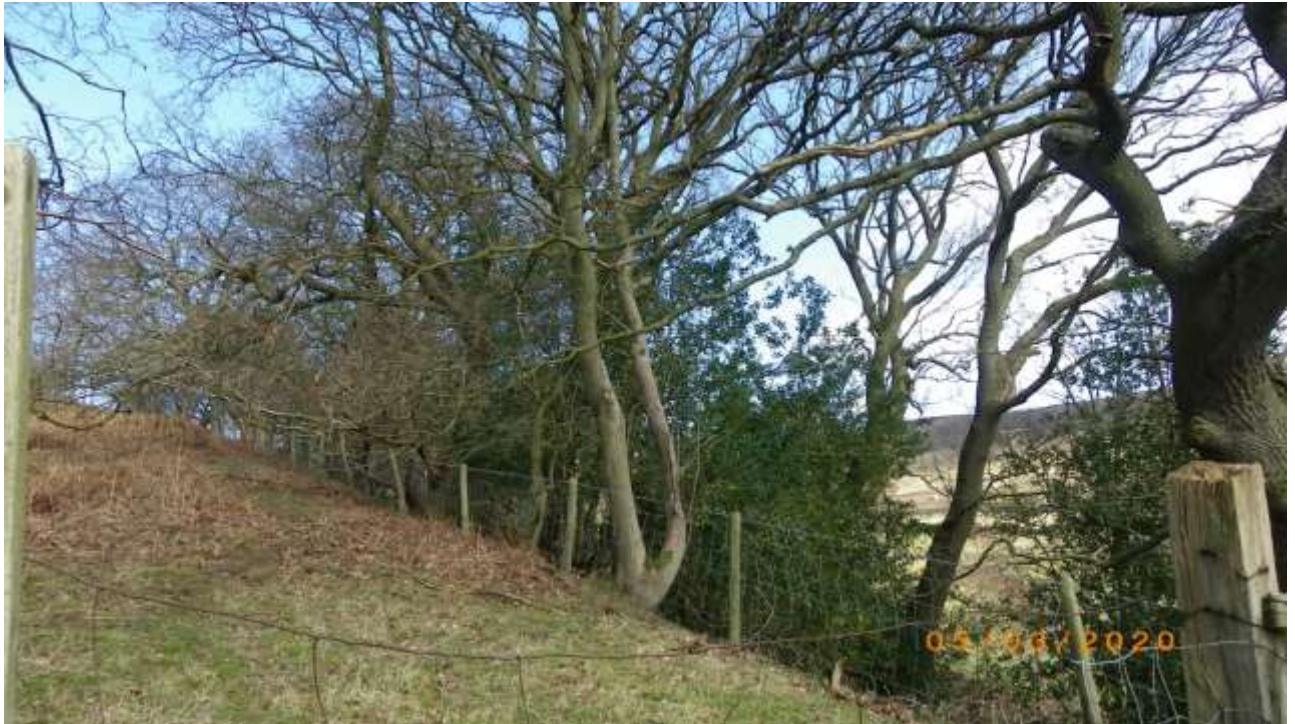
Photo 441 Cpt27 Sike Wood north east boundary – old posts

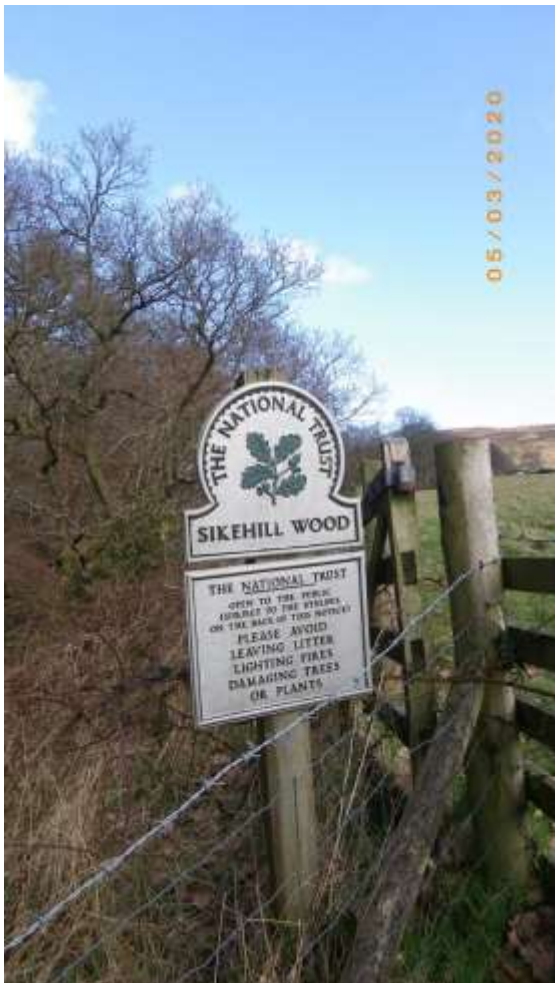
Photo 442 Cpt27 Sike Wood entrance point to s/e boundary

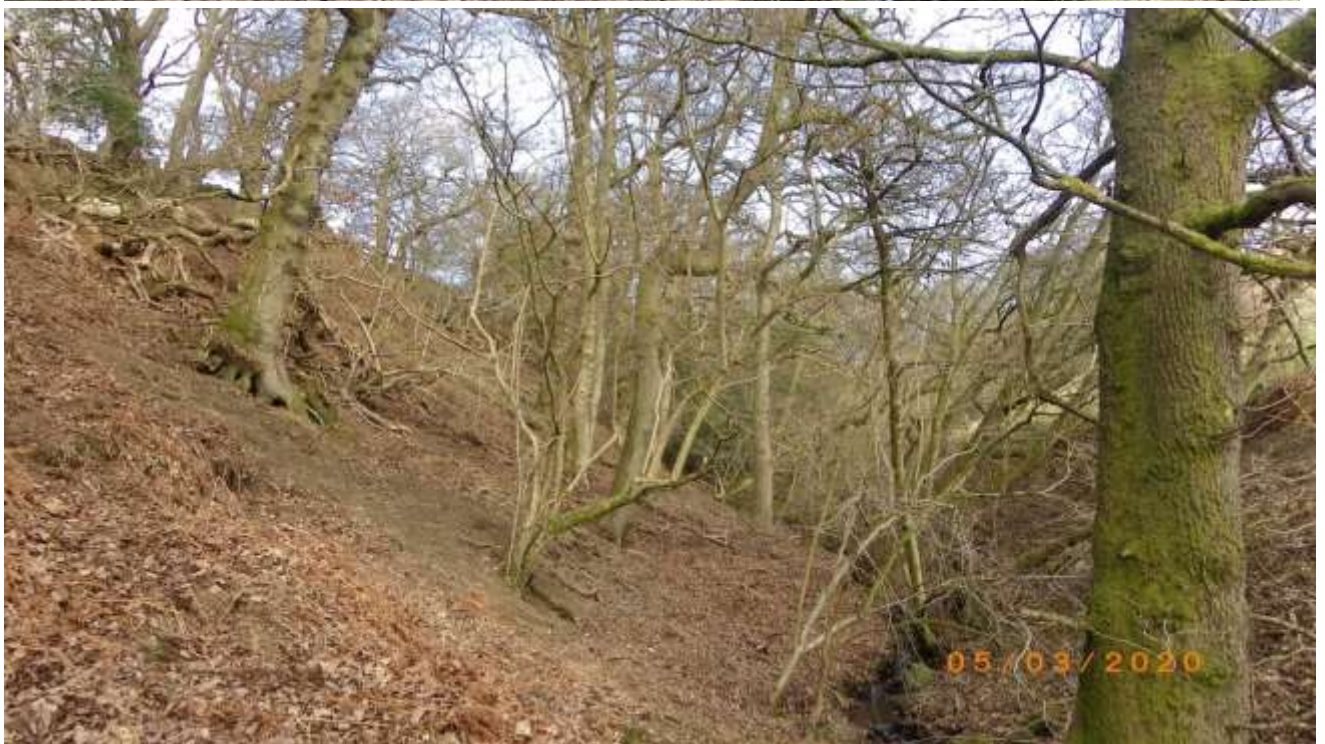
Photo 443 & 444 Cpt27 Sike Wood mature woodland along a narrow watercourse

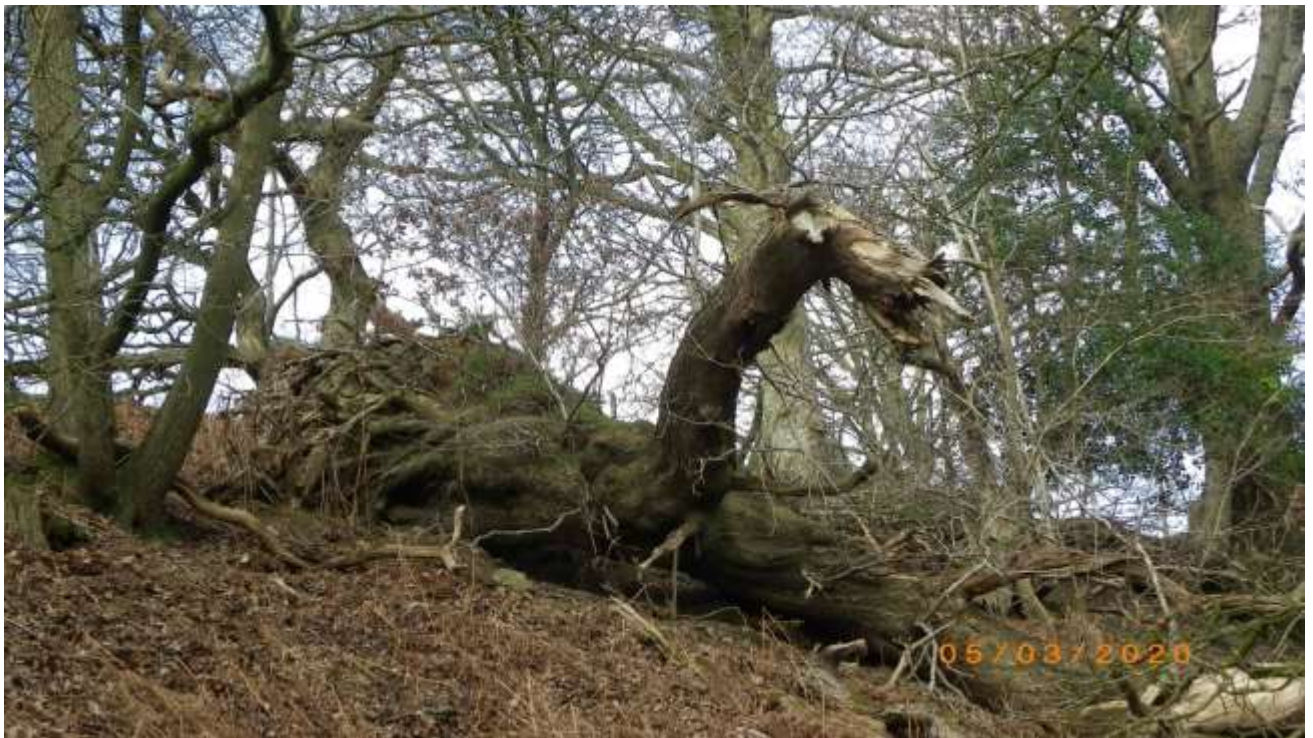
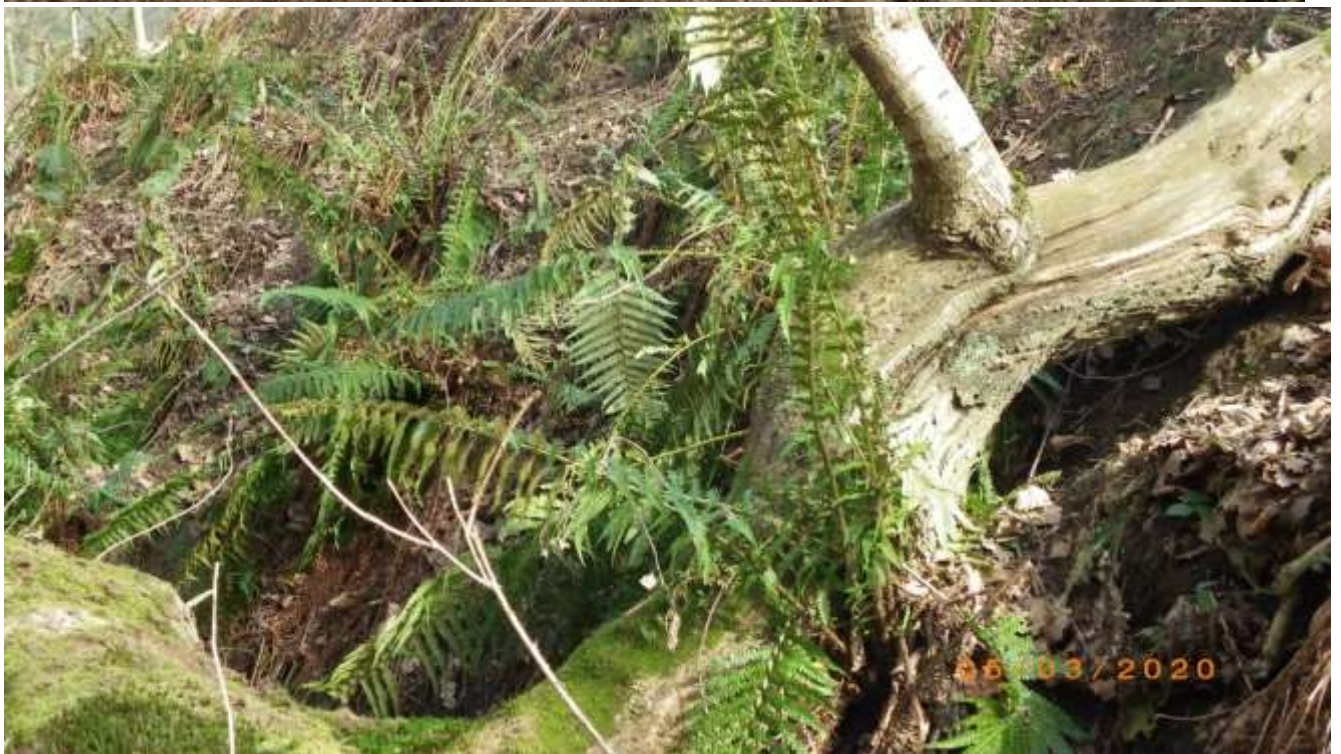
Photo 445 & 446 Cpt27 Sike Wood large woody debris within the wood

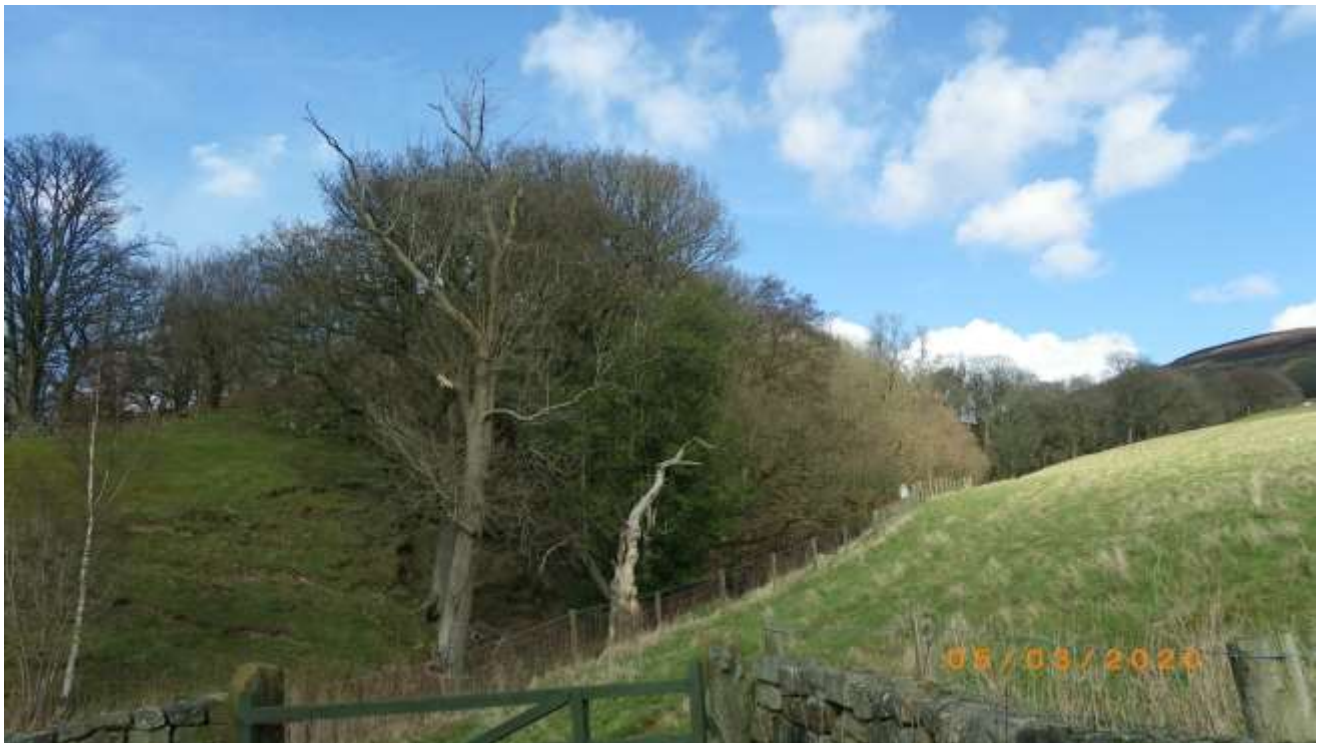
Photo 447 Cpt27 Sike Wood following the watercourse which comes off Farndale Moor.

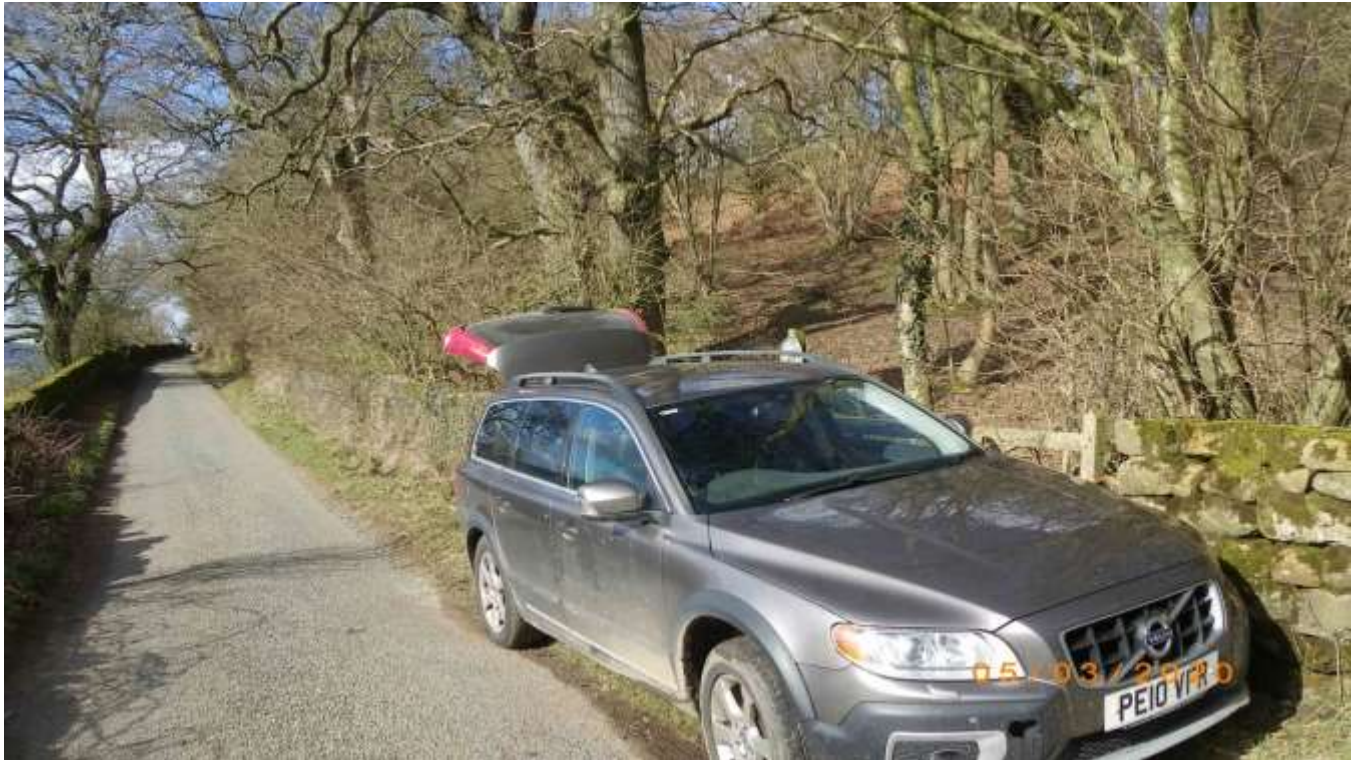
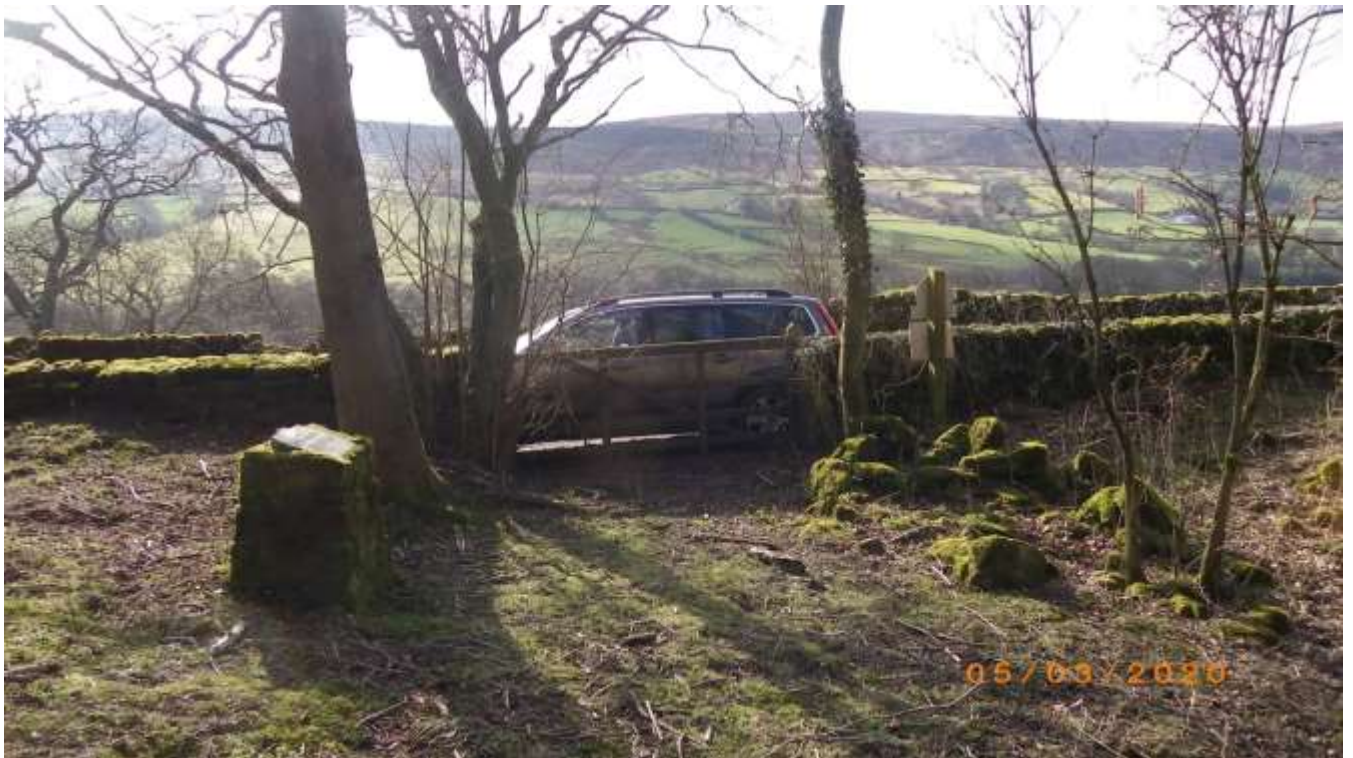
Photo 448 & 449 Cpt28 Hall Wood narrow verge at entrance

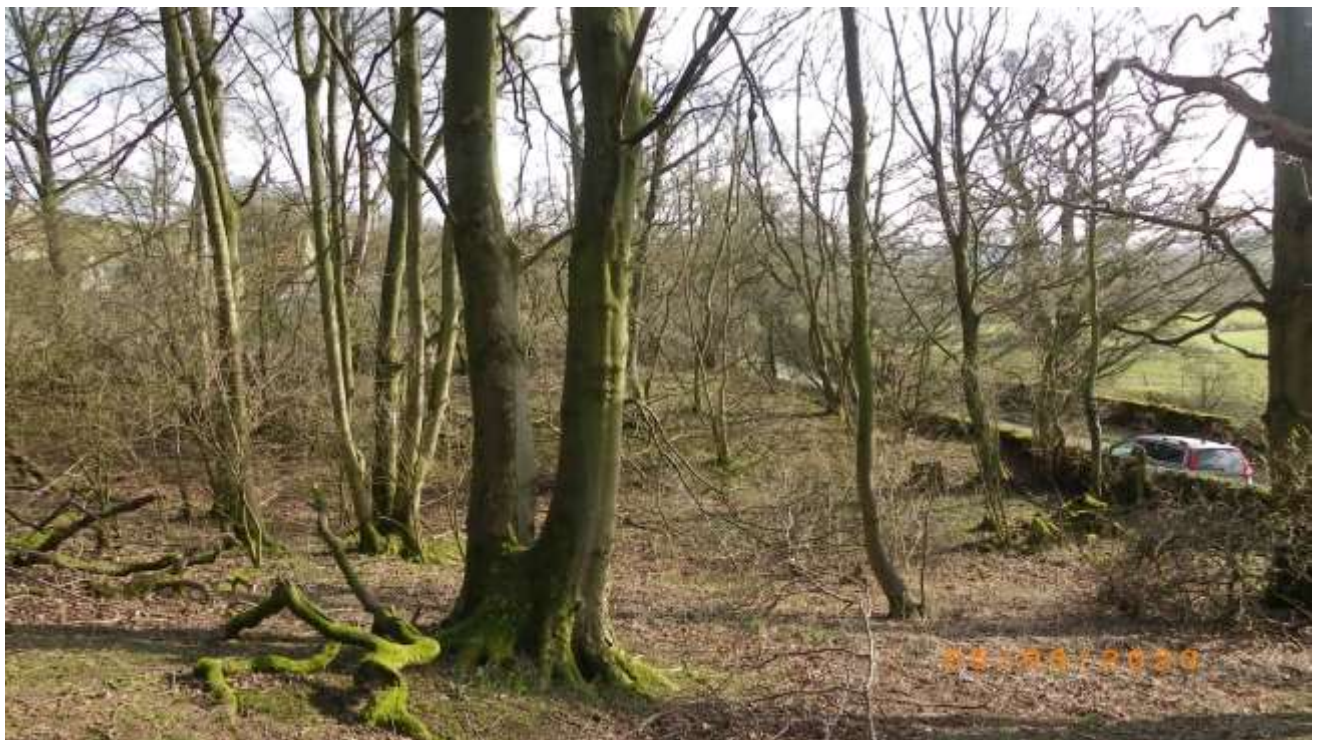
Photo 451 Cpt28 Hall Wood mixed broadleaved & conifer woodland
