National Trust Bransdale & Farndale Woodland Management Plan
Photo and Images Gallery 2021

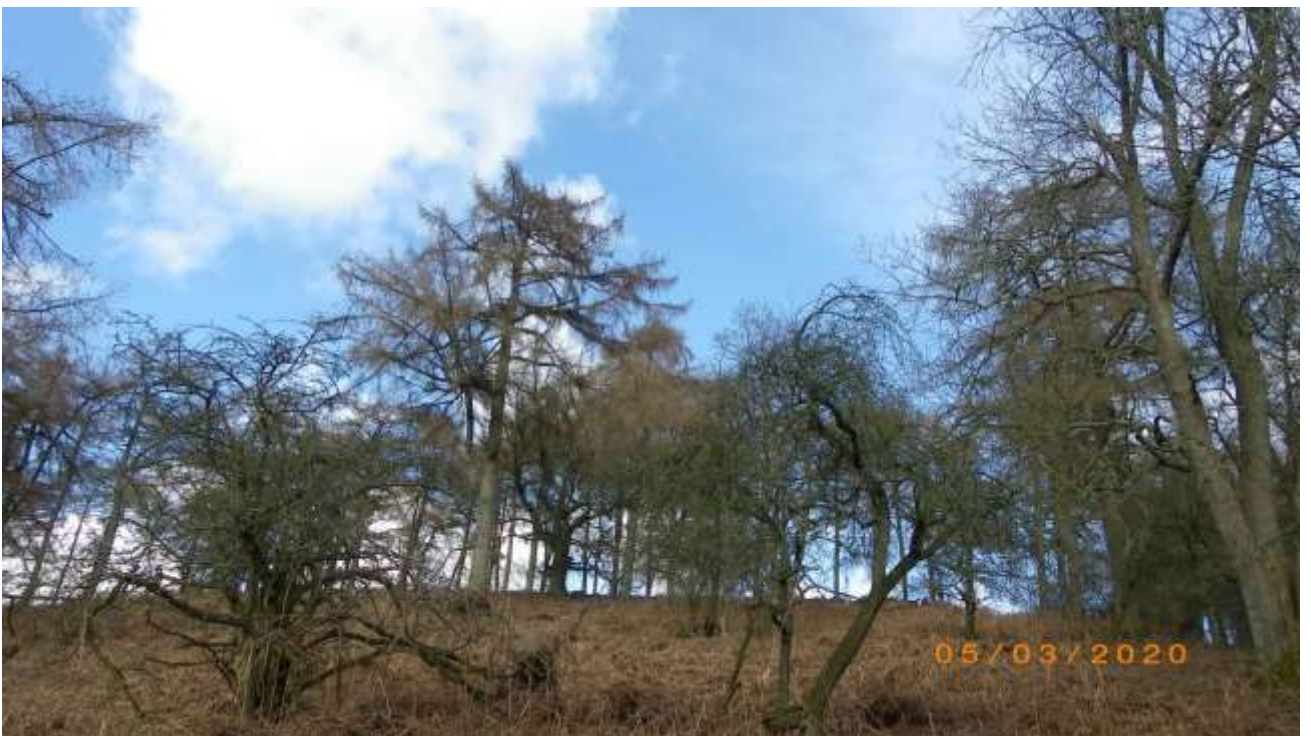
Photo 454 & 455 Cpt28 Hall Wood mature large with bracken dominant in more open areas

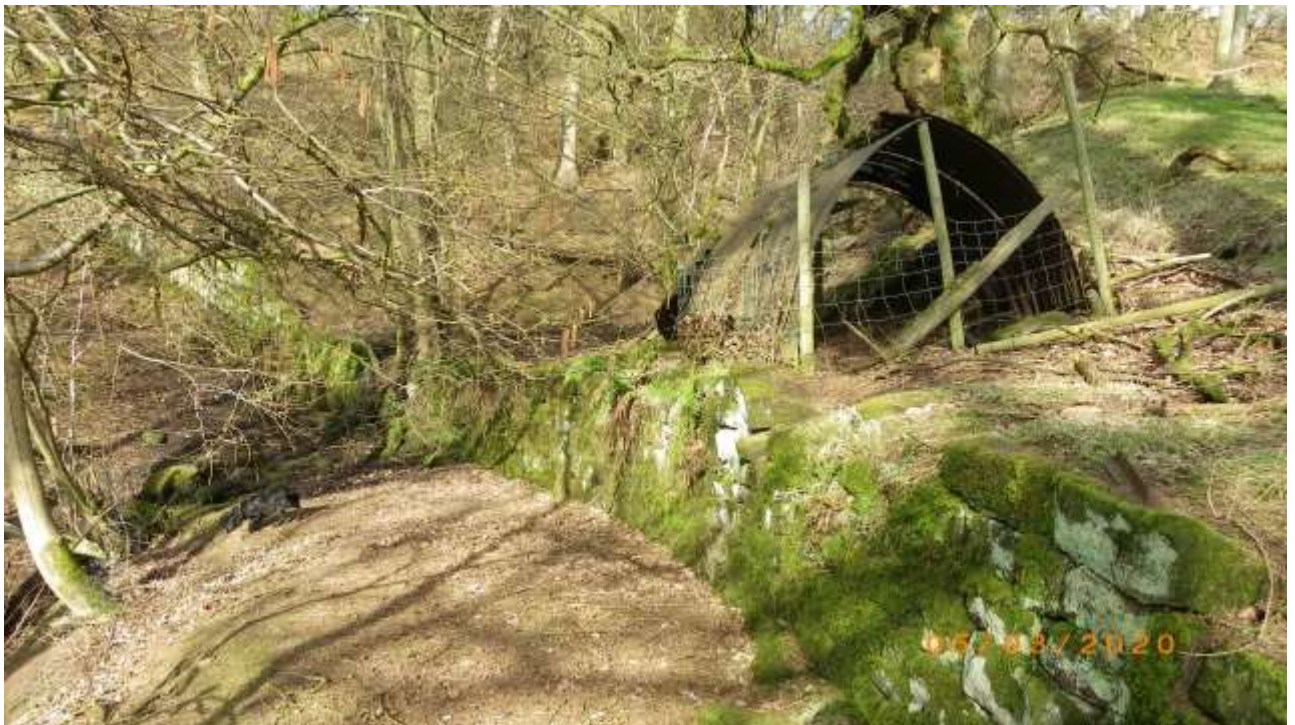
Photo 459 Cpt28 Hall Wood old animal shelter within wood above access route
